AMENDED BLIGHT STUDY

WEST BOTTOMS STUDY AREA

FORESTER VIADUCT/BLUFF ROAD/W 12TH STREET/HICKORY STREET
KANSAS CITY, MISSOURI

NOVEMBER 17, 2023
RECORD No. 1800

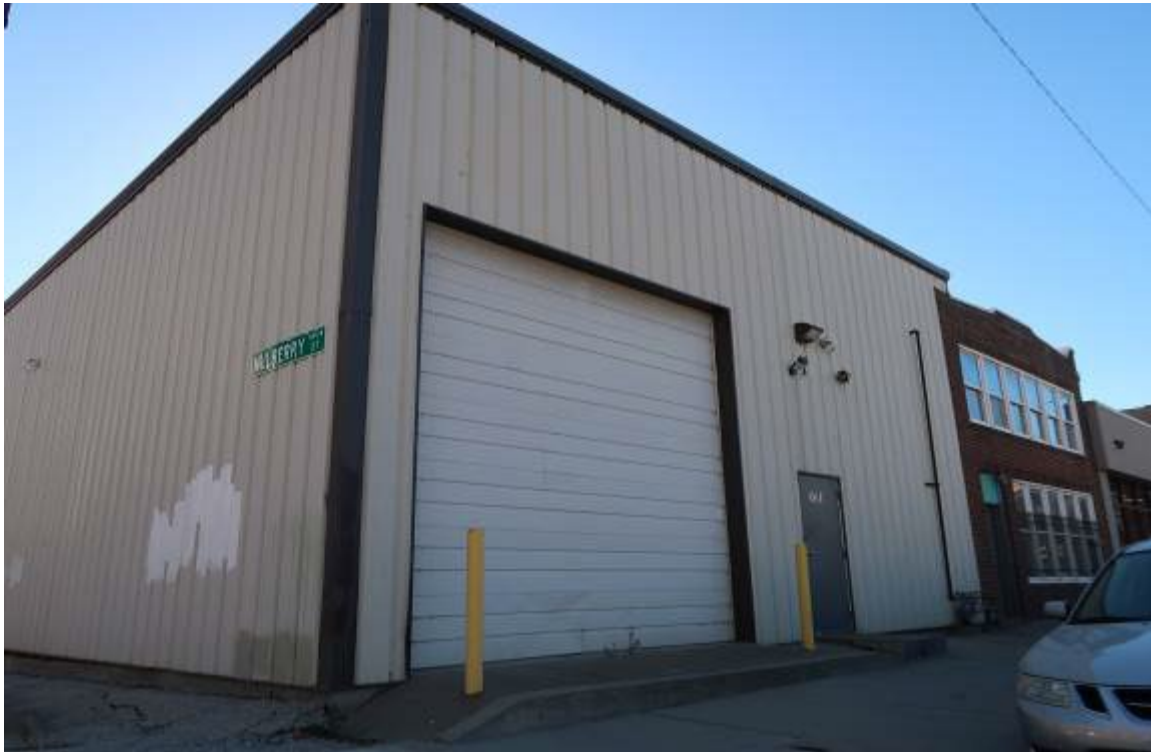
Blight issues involving Insanitary Or Unsafe Conditions observed at the subject tax parcel include loading over an adjoining pedestrian sidewalk. Access to the rear overhead door likely requires use of the adjoining property to the south as the adjoining alleyway is only 10 feet wide. The tenant's trash dumpster sits in the alleyway behind the building and trash is strewn around the dumpster. The roof drains onto the pedestrian sidewalk along the east side of the subject building. Significant settling has occurred along the easterly adjoining sidewalk and the east elevation of the building. The owner indicated a significant expenditure was needed to stabilize the foundation of the building. A building of this age should be free from environmental hazards.

Loading Over Adjoining Pedestrian Sidewalk

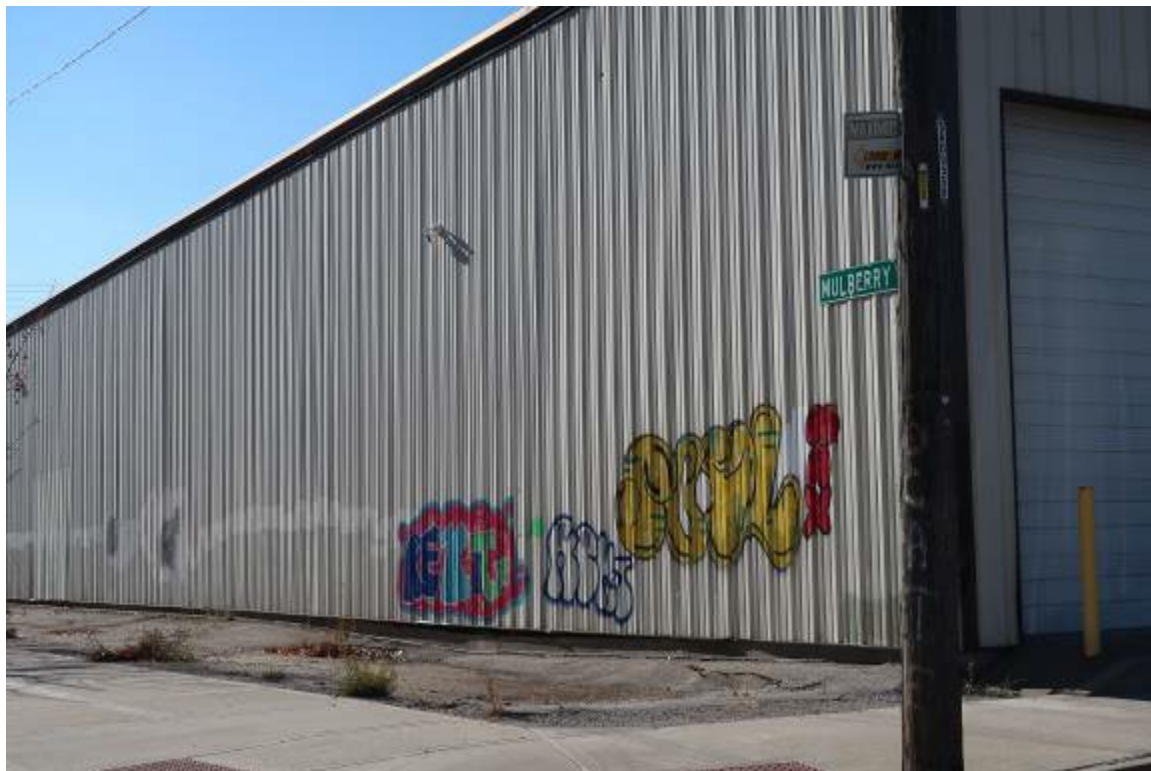
Graffiti Along The East Elevation Facing Mulberry Street

Graffiti Was Not Present At The Initial Re-Inspection (11/7) But Was During Second Re-Inspection (12/5)

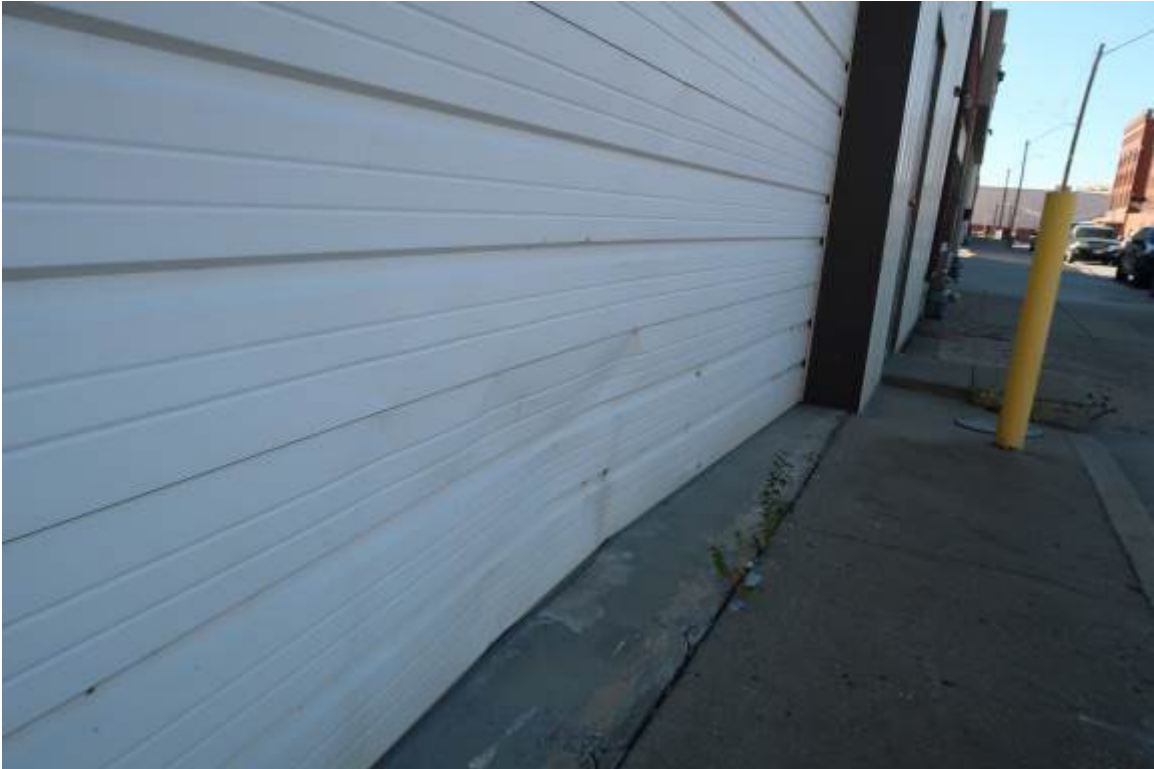
Damaged Loading Door Along Union Avenue Pedestrian Sidewalk

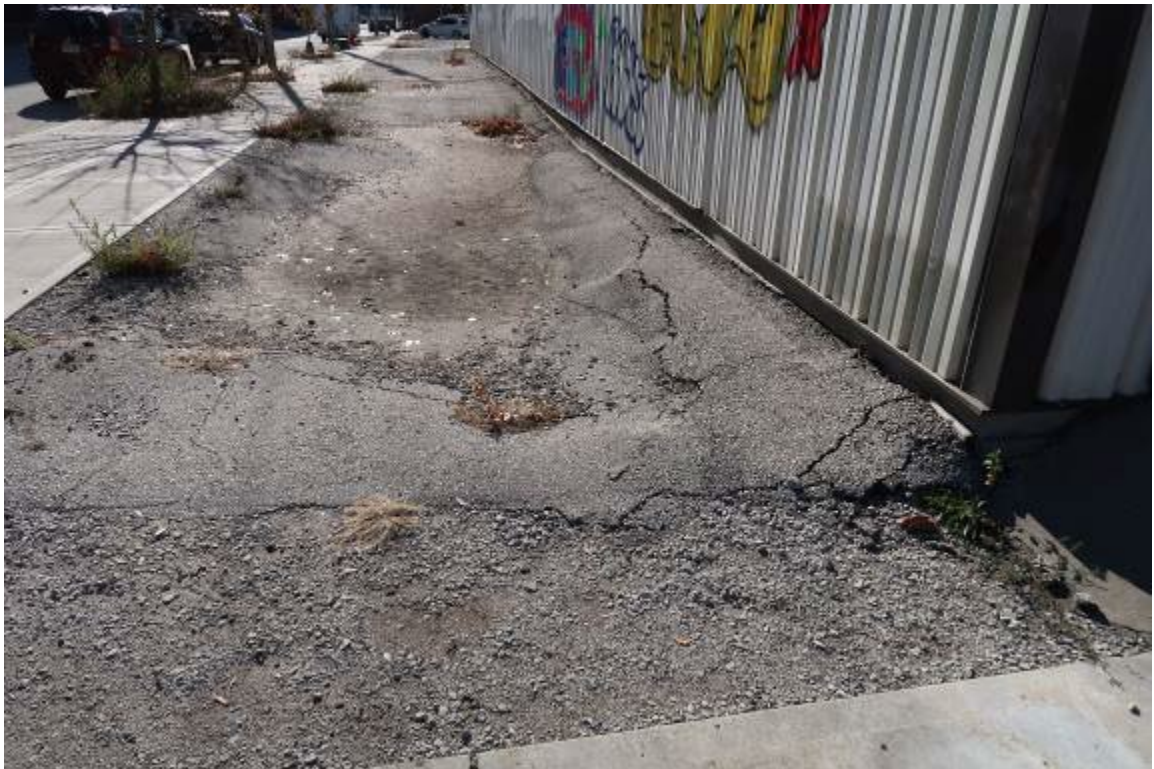
Settling In The Easterly Adjoining Pedestrian Right-Of Way (Along Mulberry St.)

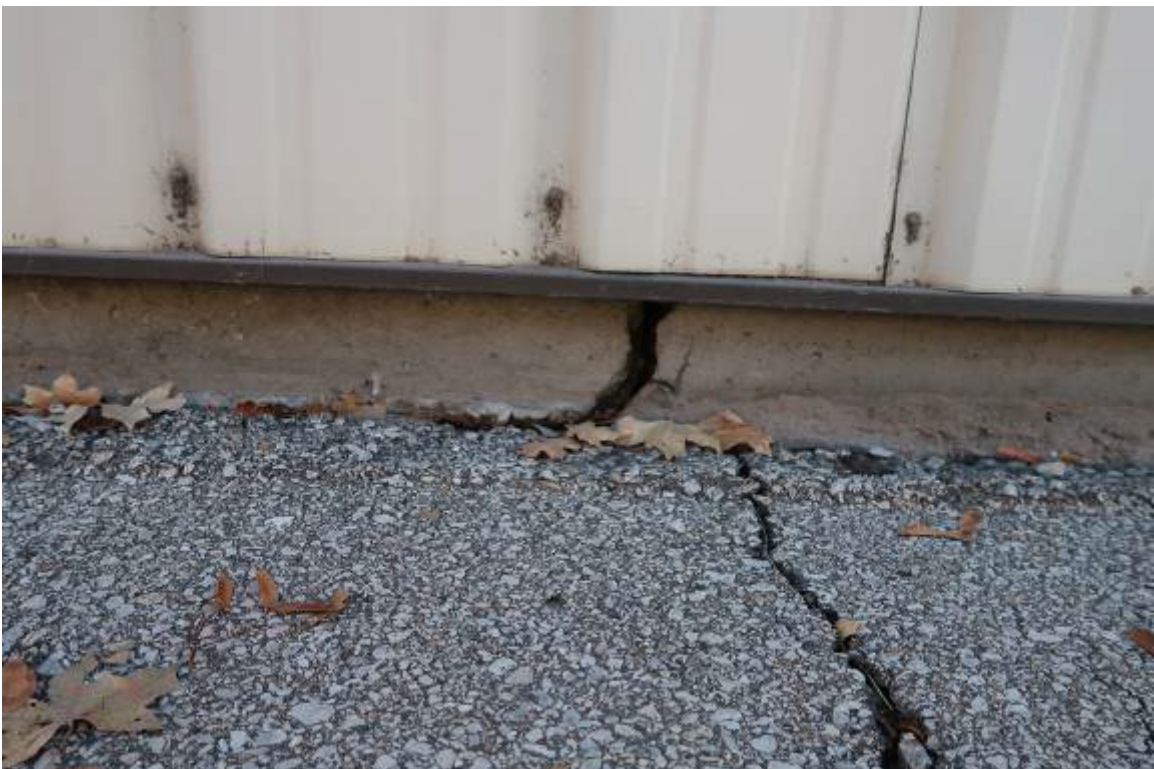
Settling Beneath The East Foundation

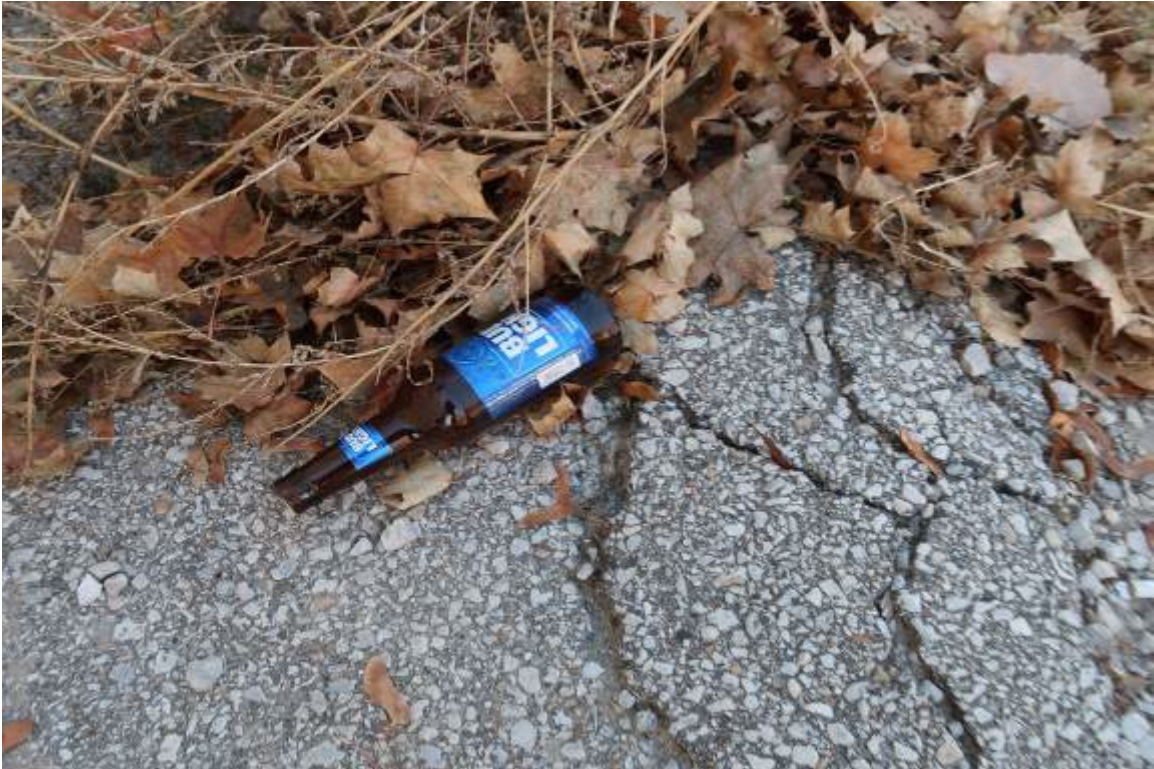
Crime – Loitering & Trash Along The East Foundation

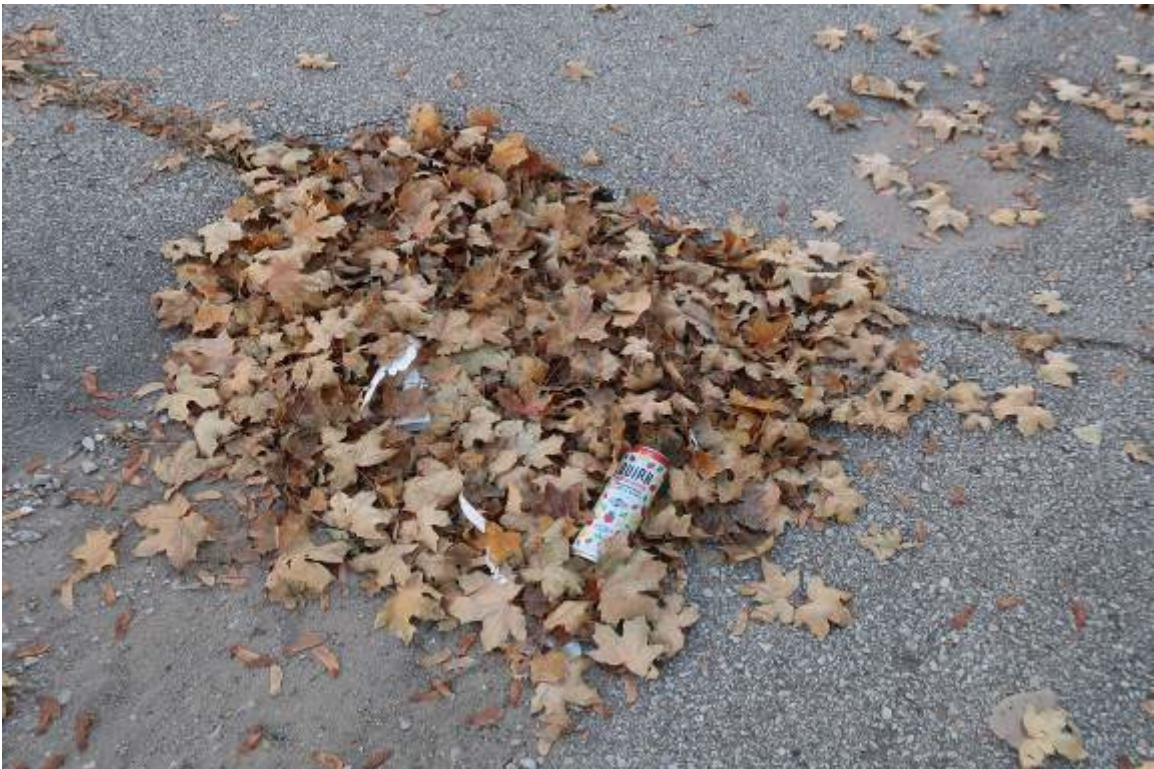
Crime – Loitering & Trash Along The East Foundation

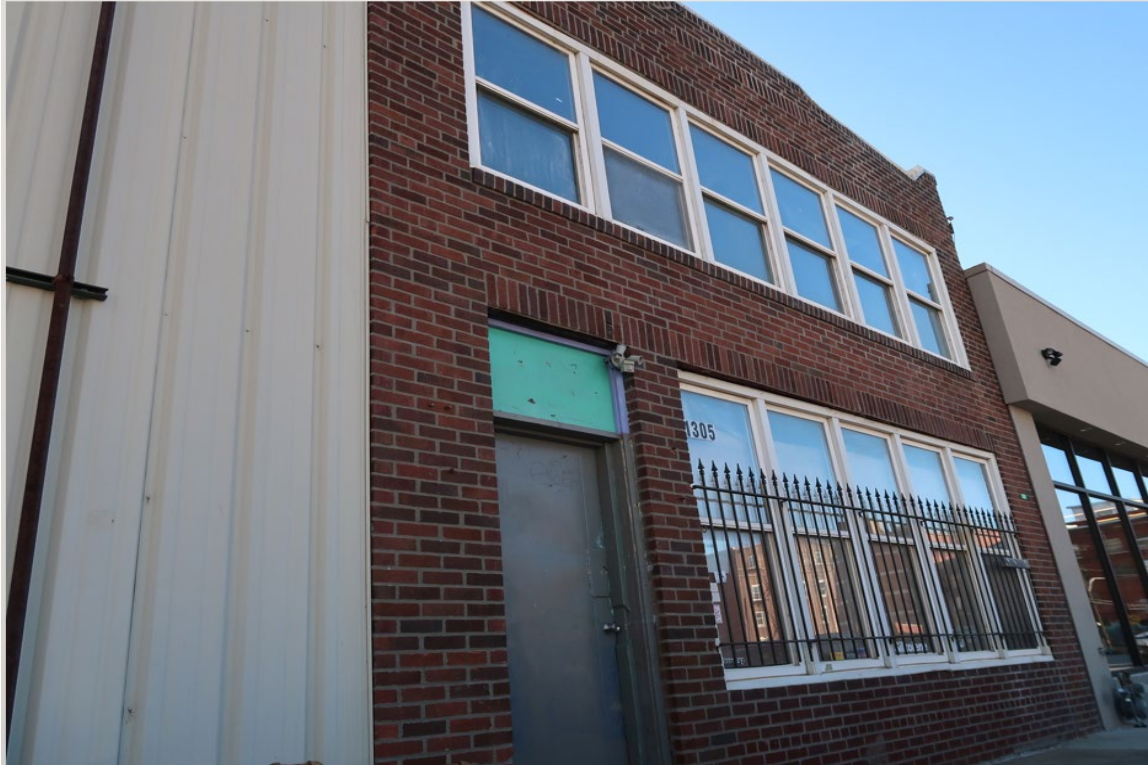
Security Bars Over The Front Windows

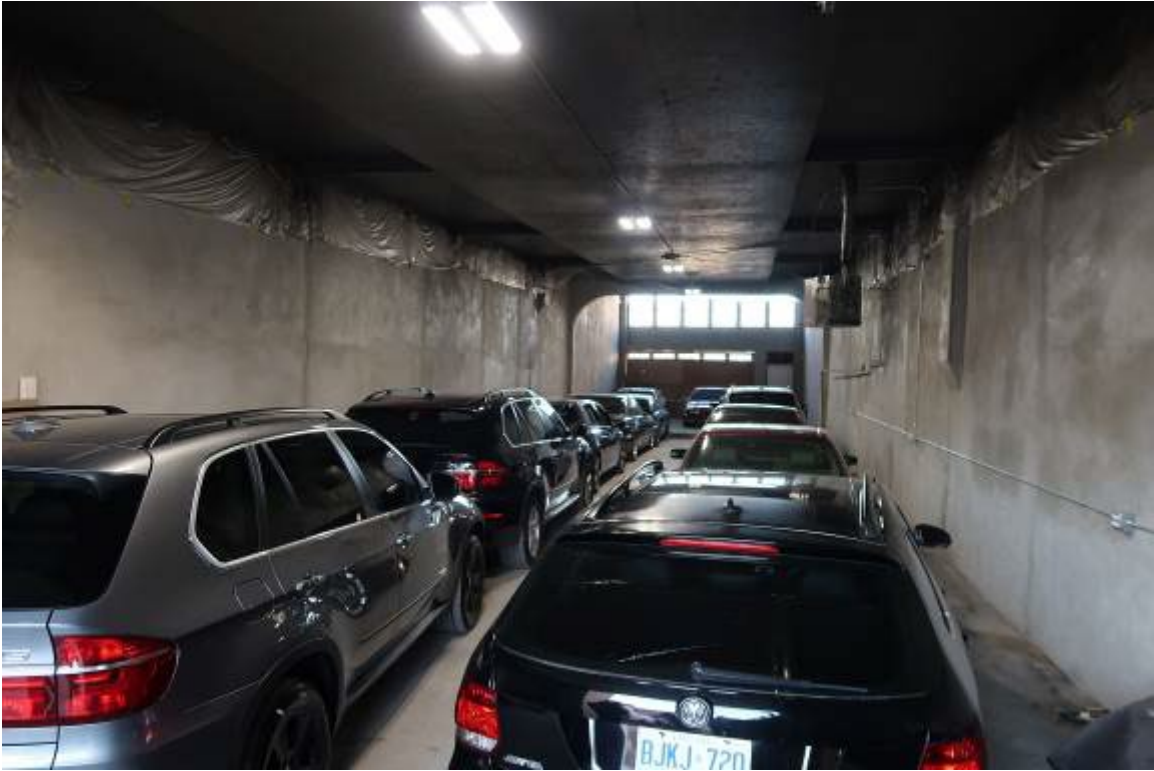
Concrete Interior Lacking Finish

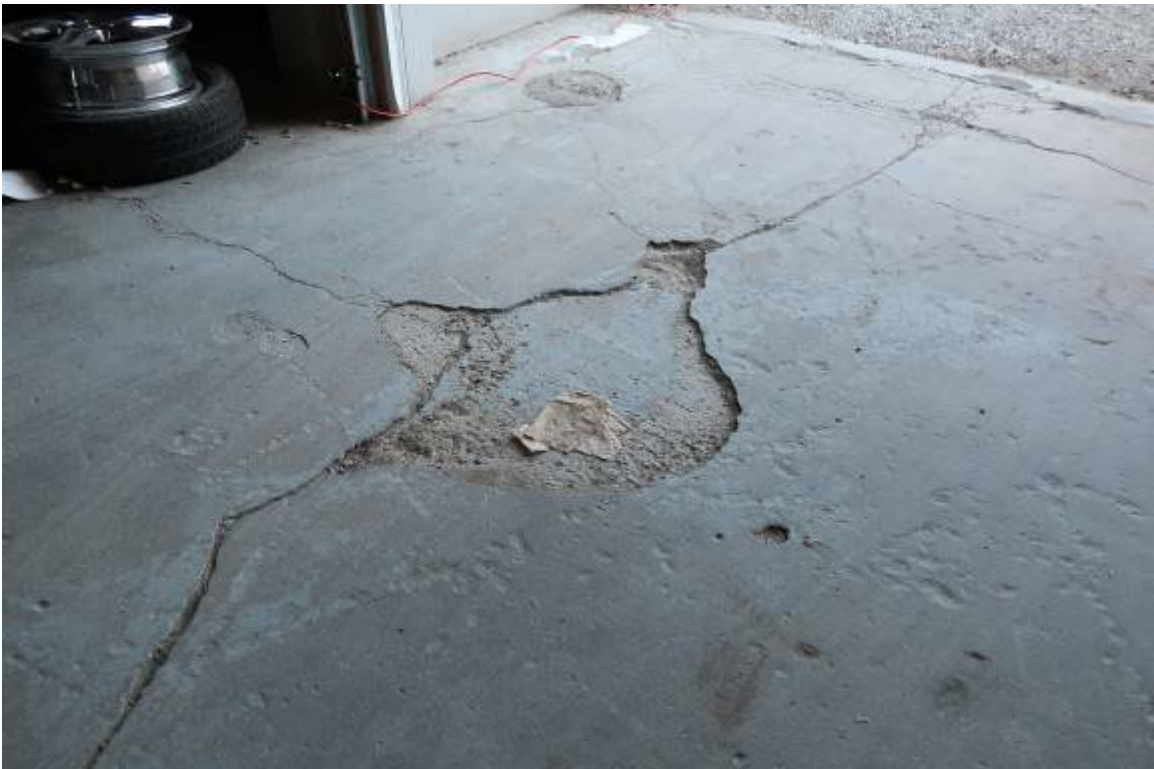
Damaged Flooring

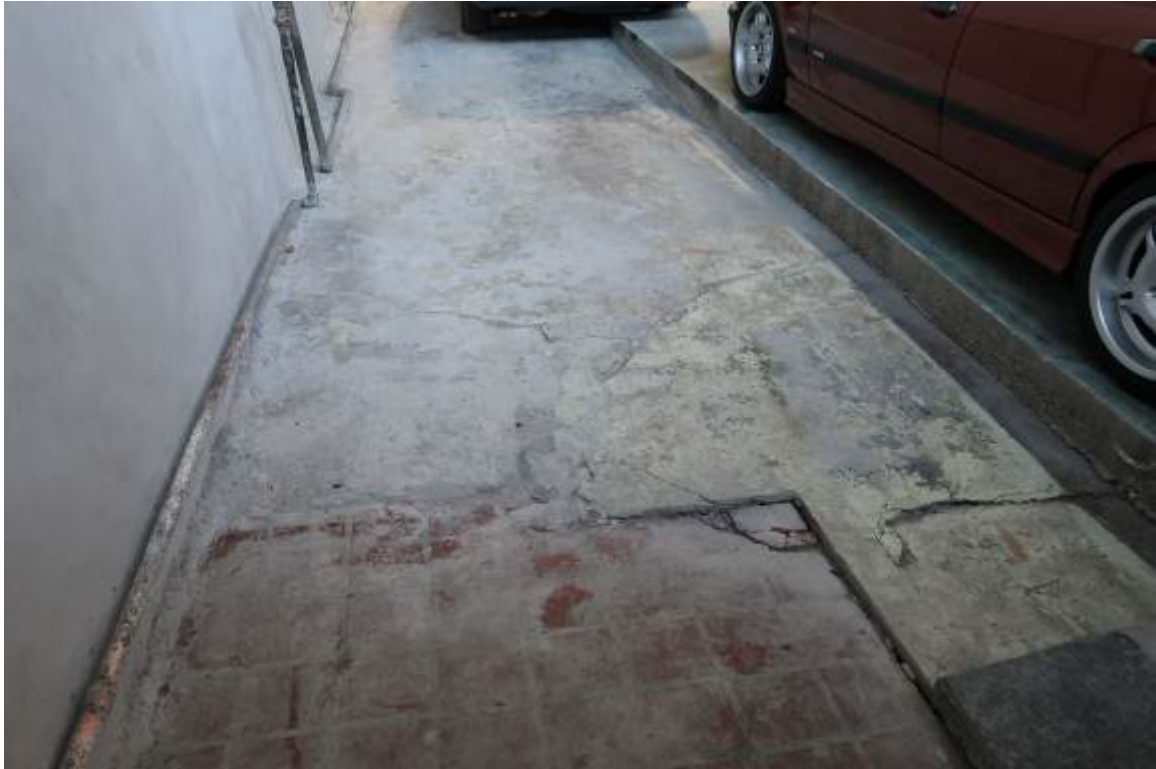
Varying Floor Levels & Damage

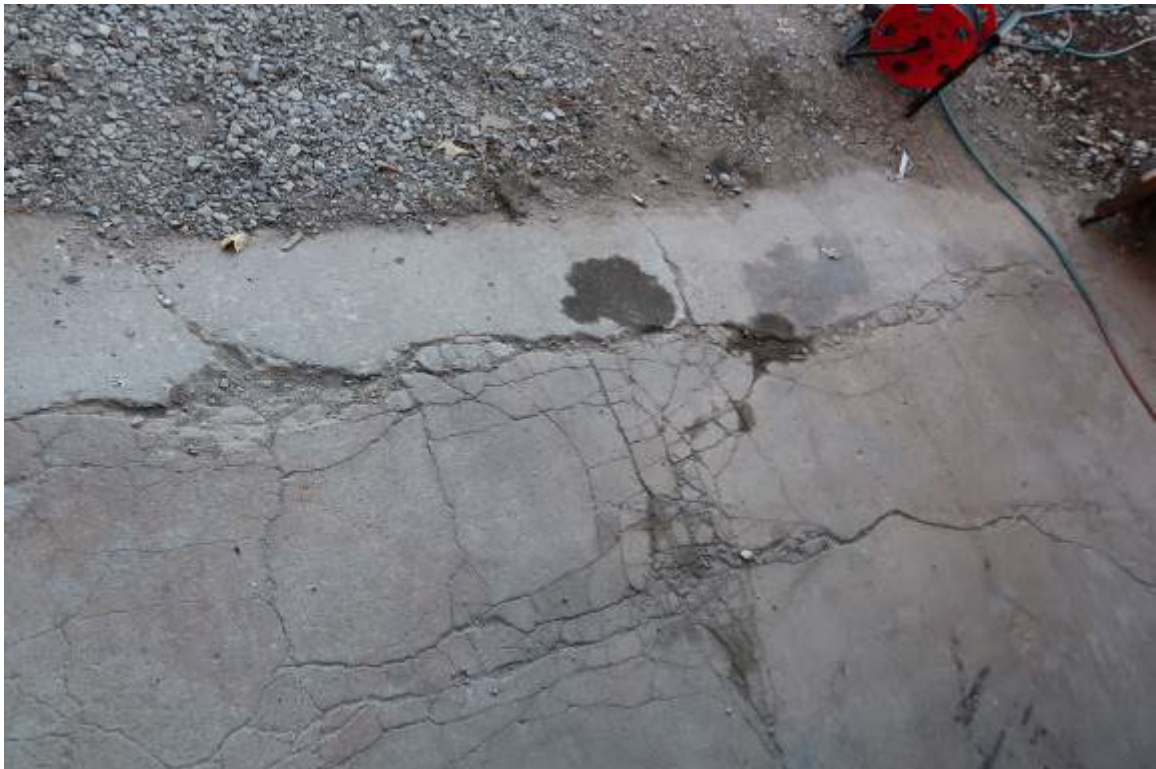
Floor Damage

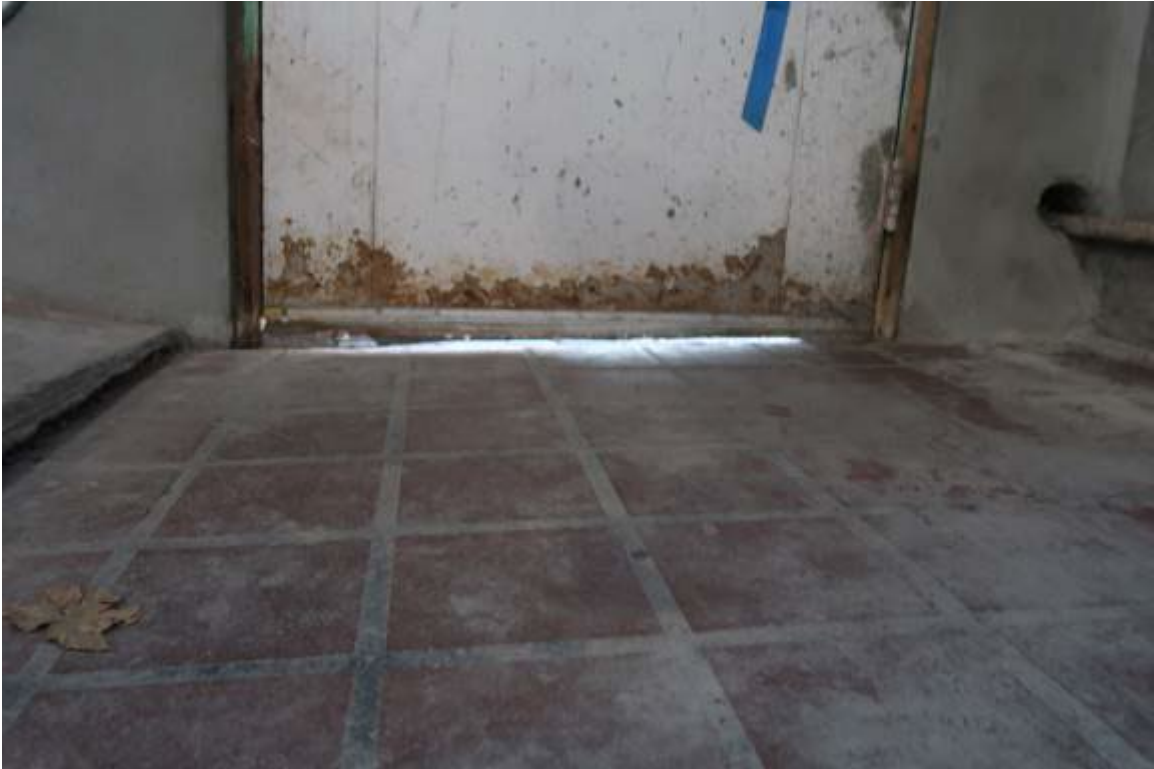
Settling & Rusted Entry Door

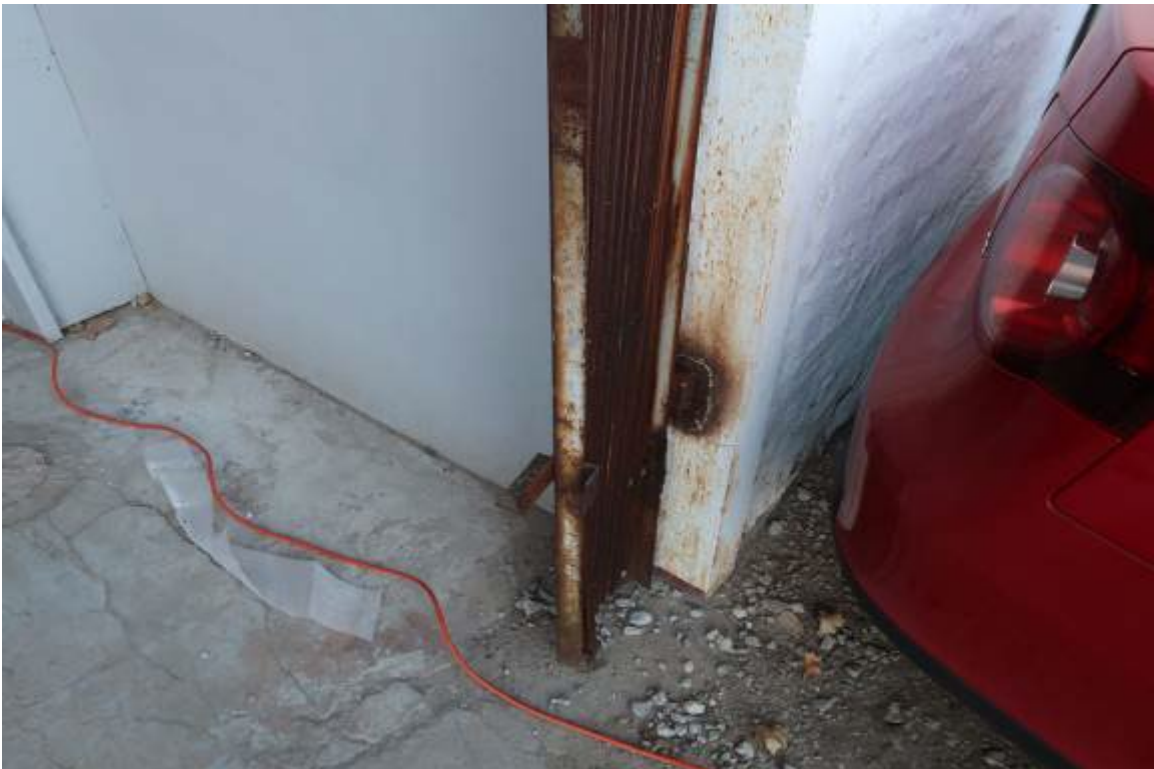
Garage Door Railing Damage

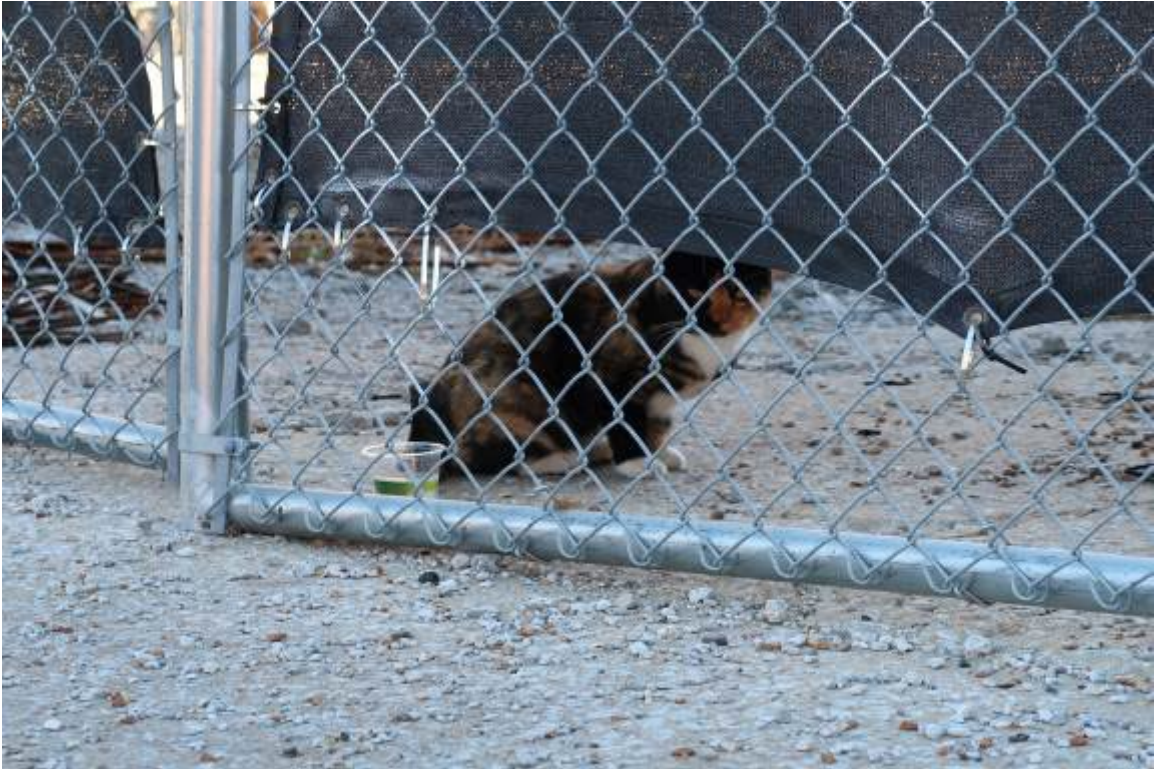
Gravel lots with access over adjoining public sidewalks creates safety concerns. Storage yards, even if fenced may create opportunity for loitering, vermin, and stray animals.

Storage Yard Safety Concern – Stray Animals

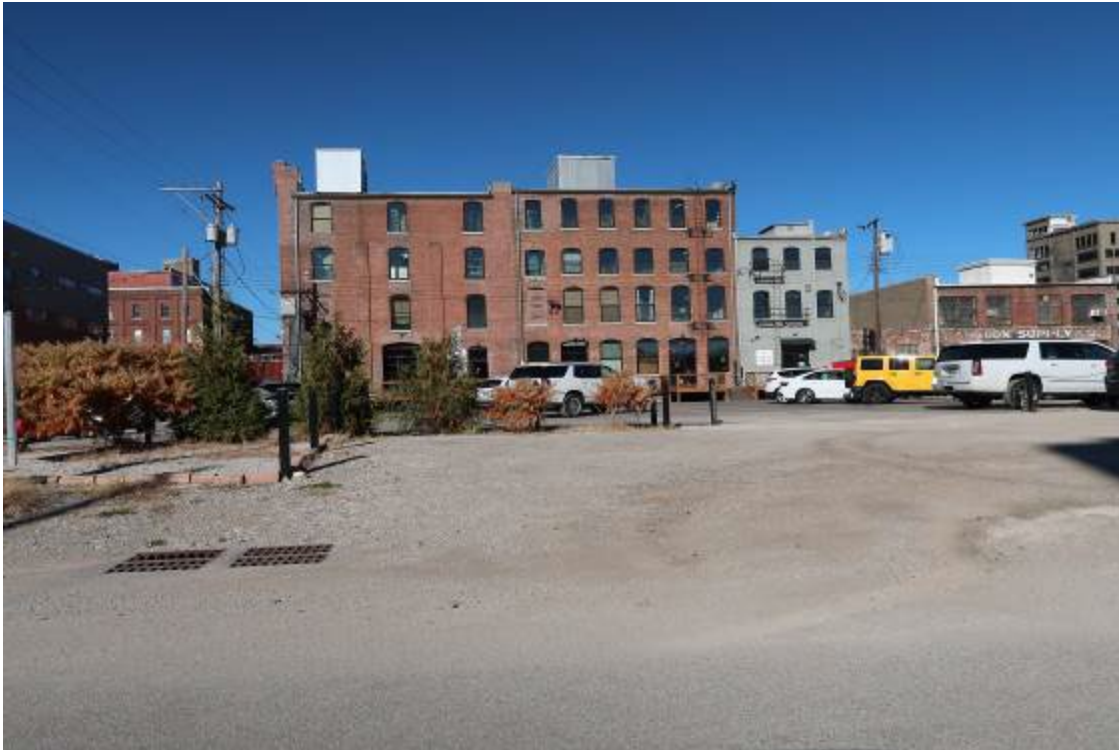
Gravel parking/storage lots in the urban setting can be a nuisance (dust in the air, dirt on adjoining sidewalks and streets). Pedestrian sidewalks and curbs along Hickory Street are in poor condition creating safety concern. Pedestrian sidewalks and curbs are lacking along E 11th Street.

Looking North Across 1027 Hickory Street At The Dirt Access From E 11th Street

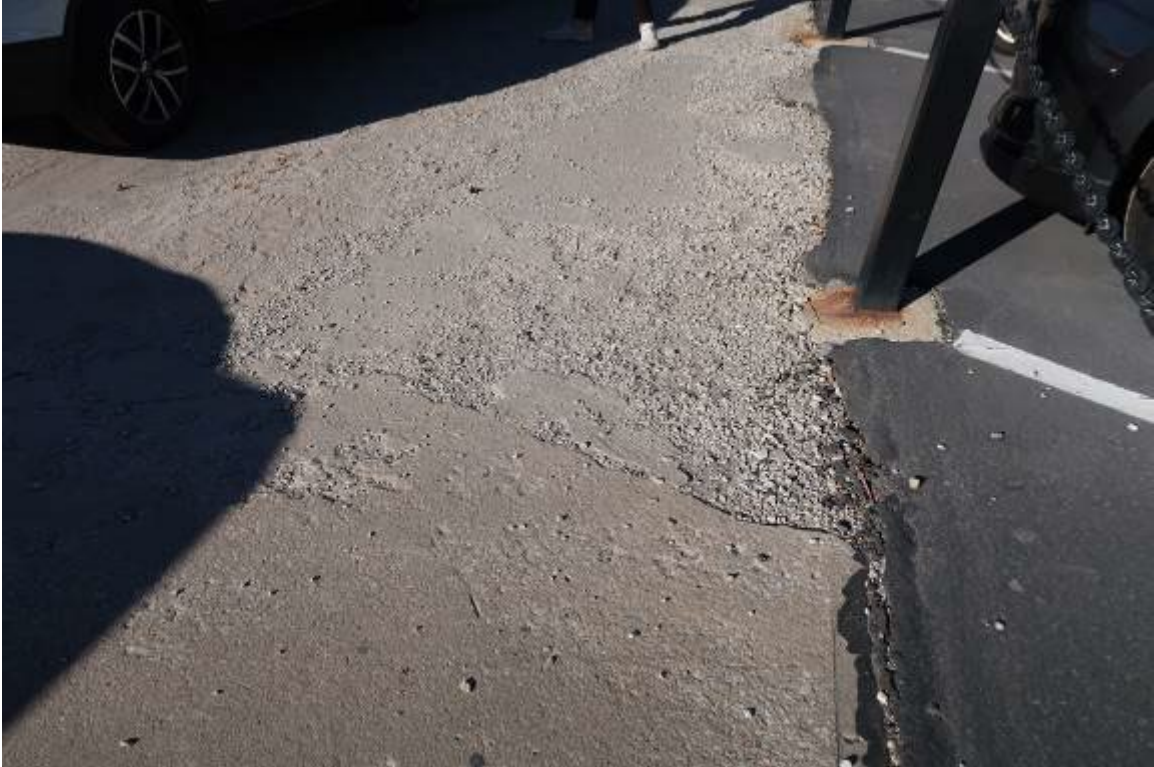
Damaged Pedestrian Sidewalk Along Hickory Street

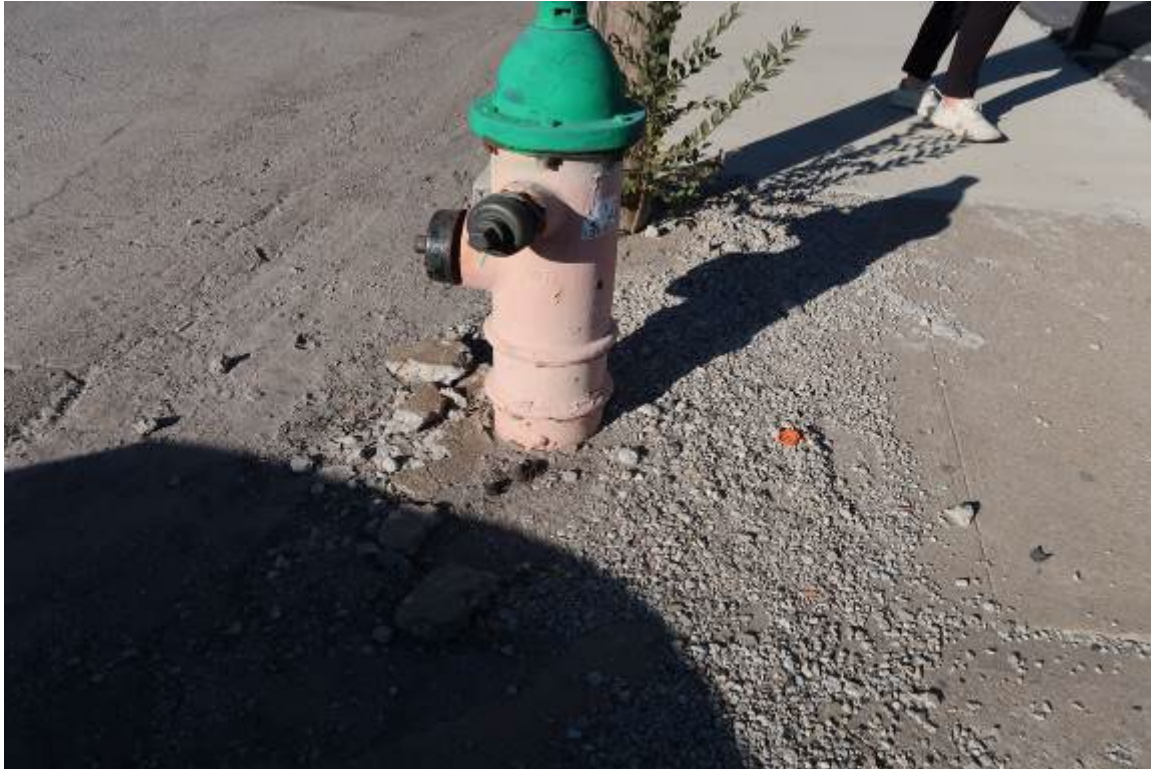
Damaged Pedestrian Sidewalk Along Hickory Street

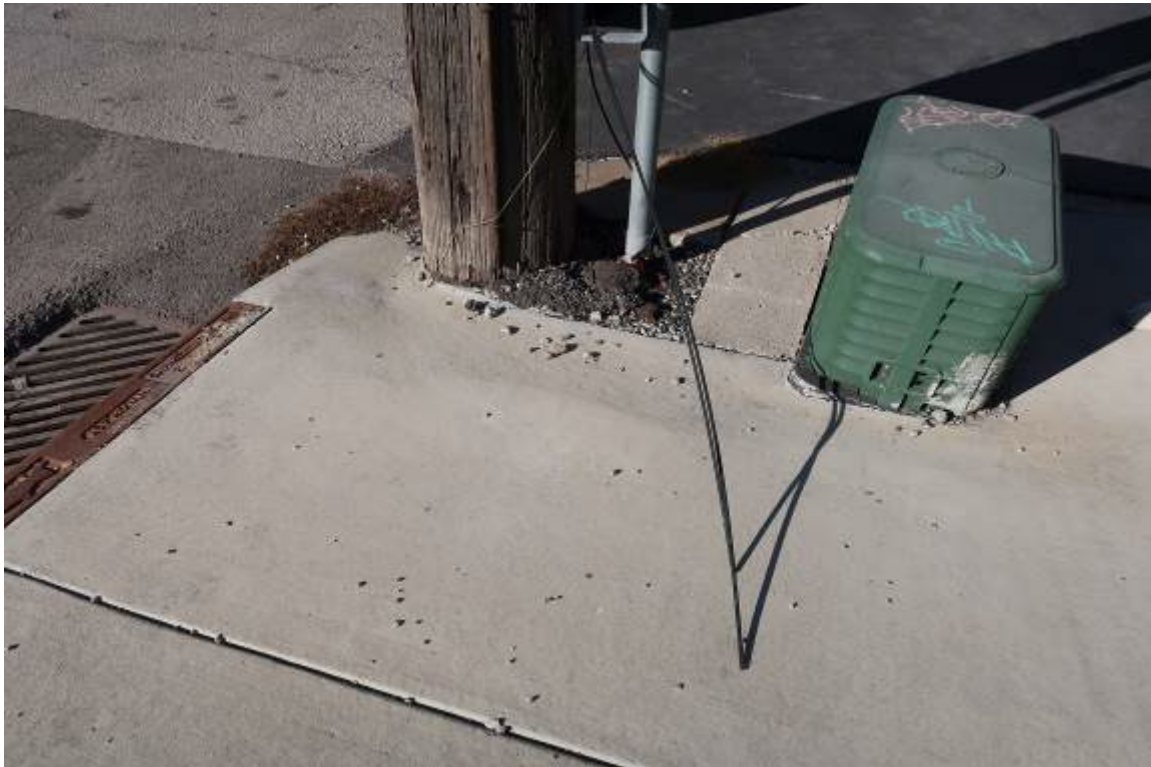
Wiring Hanging From Utility Pole Along Hickory Street Pedestrian Sidewalk
