STATUS REPORT

Auditorium Parking Garage

On Tuesday, March 31, 2020, TranSystems, pkmr Engineers, and City of Kansas City, Missouri General Services staff toured the Auditorium Parking Garage (APG).

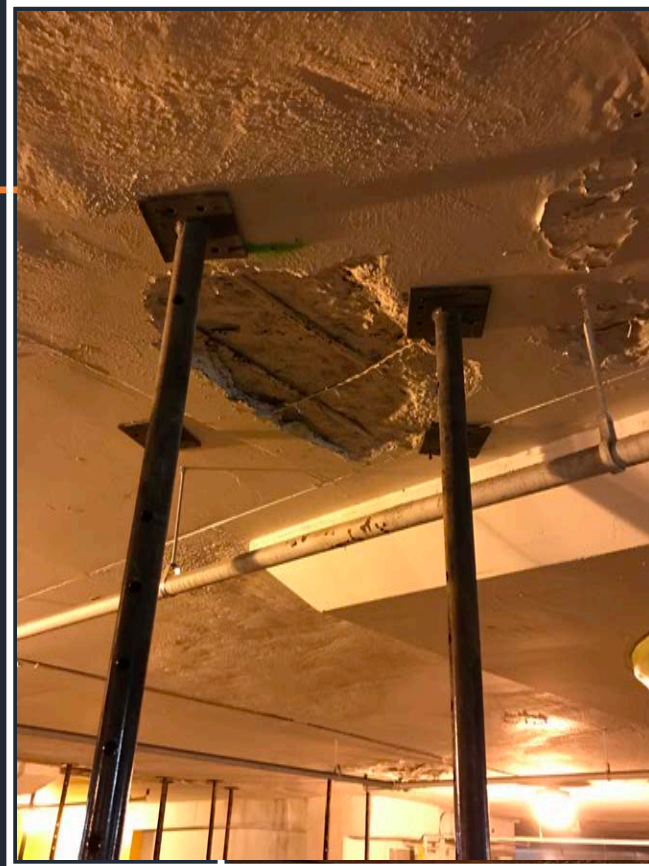
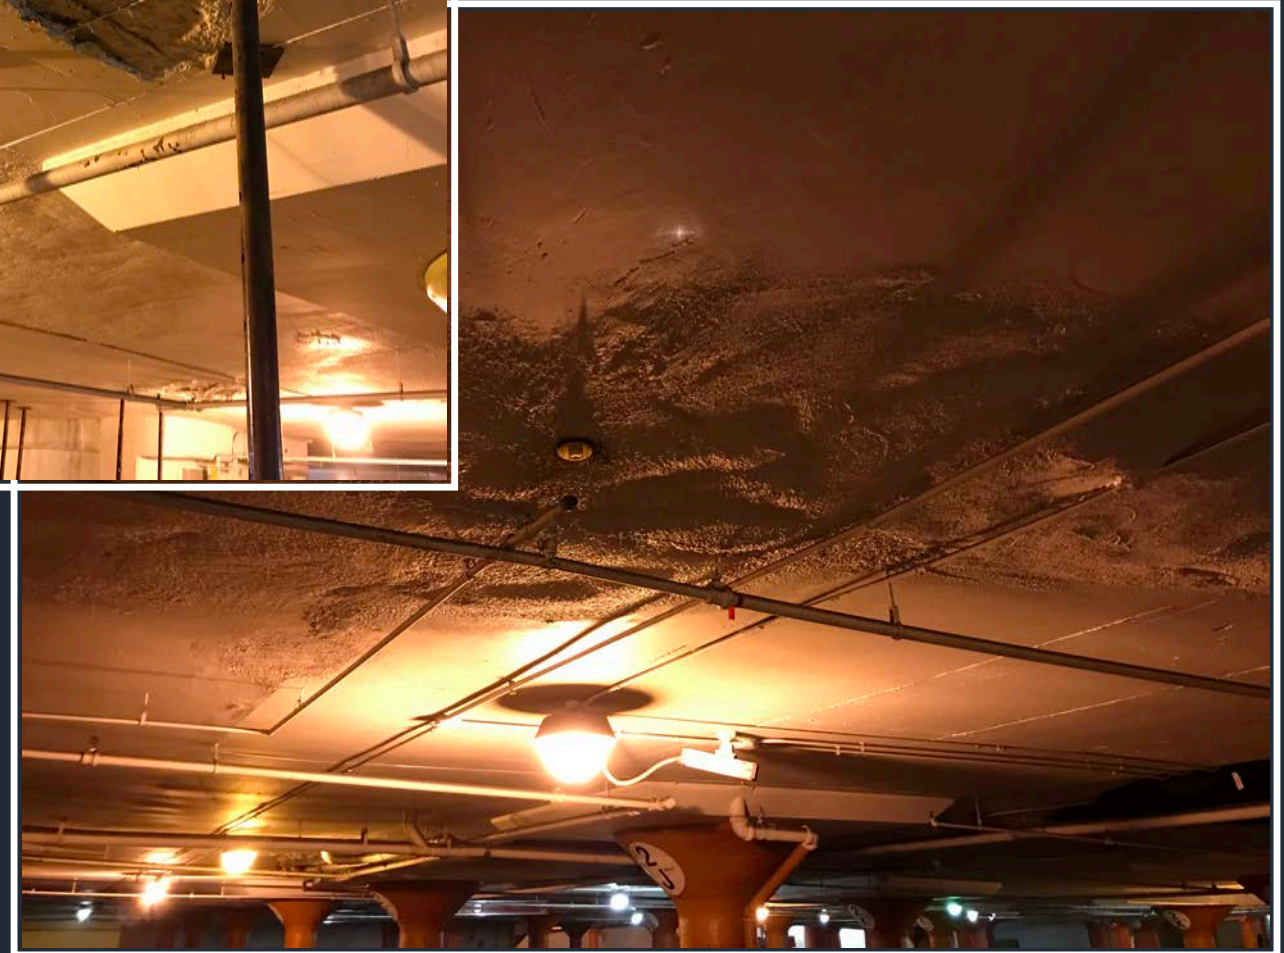
- The existing concrete structure has had several strengthening and repair projects over the last 20 years.
- Significant repairs and stabilization has been done since 2017.
- Levels 1 and 2 showed the same cracking/leaking.
- The observed concrete structure did not show signs of immediate structural integrity issues for the main parking areas of the garage.

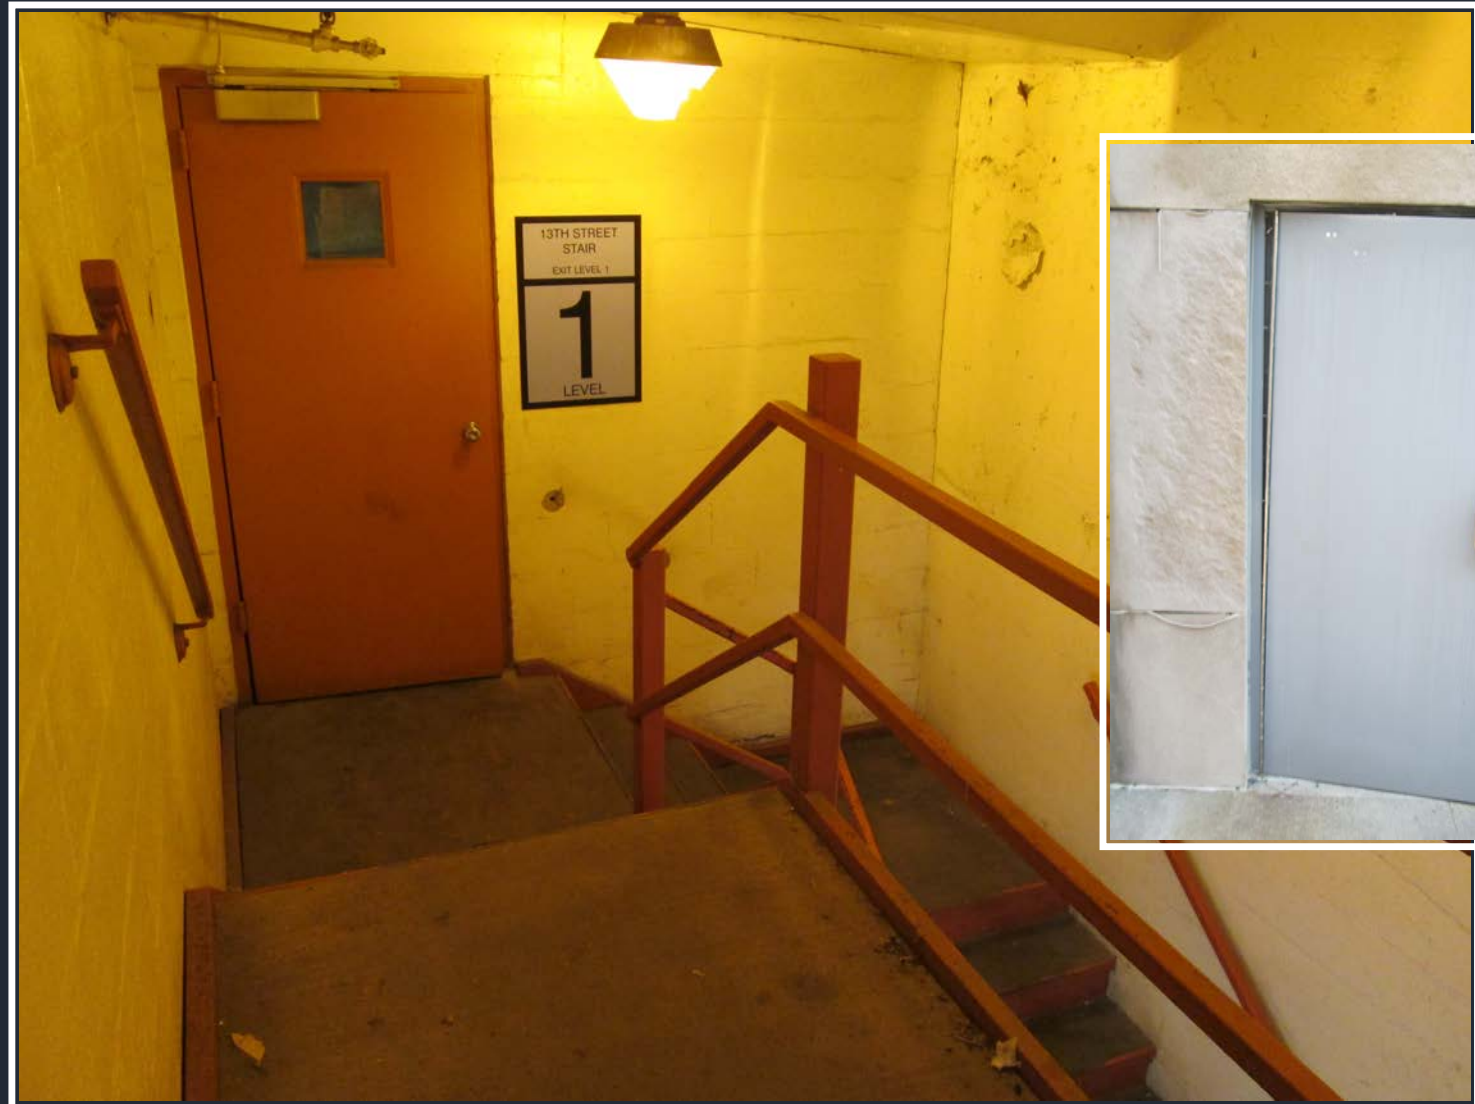
- The existing stairs within the garage are not code compliant because the configuration of the handrails and guardrails do not meet current code requirements.
- Some doors do not close properly to provide a safe fire enclosure.
- Perimeter sidewalks have numerous areas of serious spalling that have created hazardous walking conditions and a danger to accessibility.

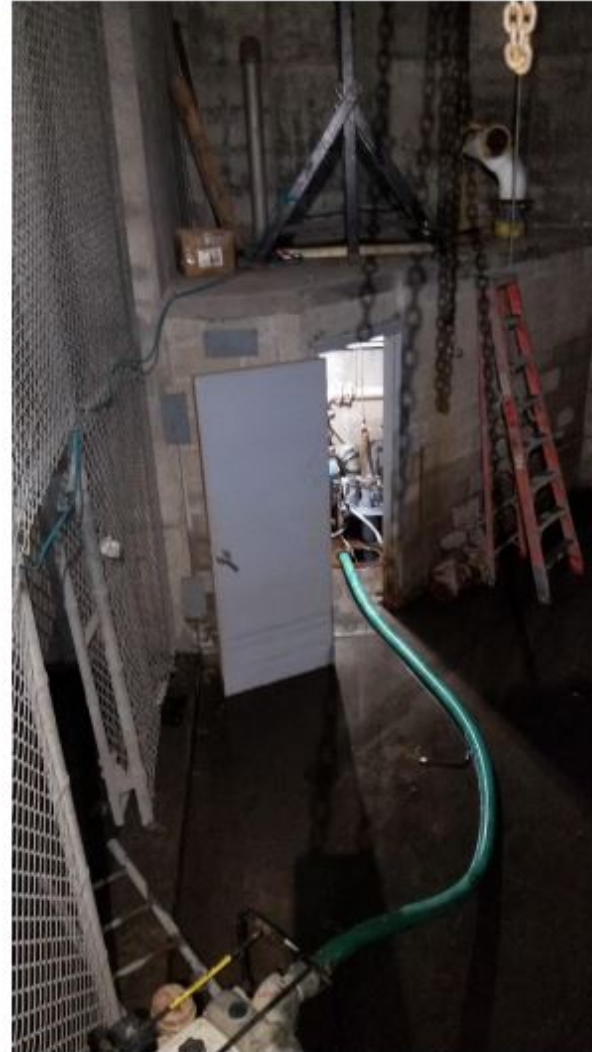
Fig. XX SE Fan room sump pump repair underway

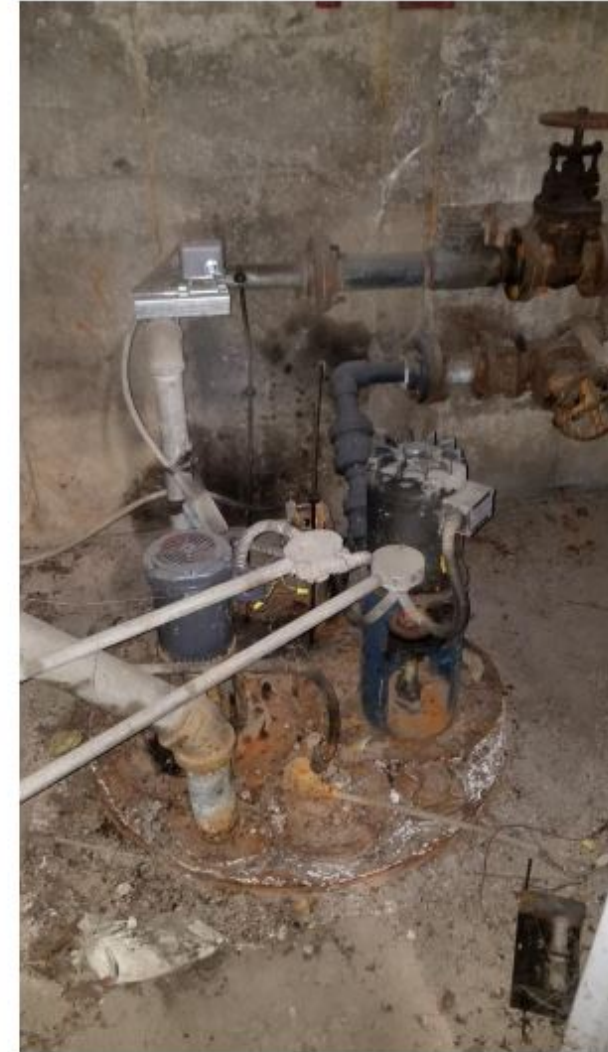
Fig. XX SW Fan room sump pumps

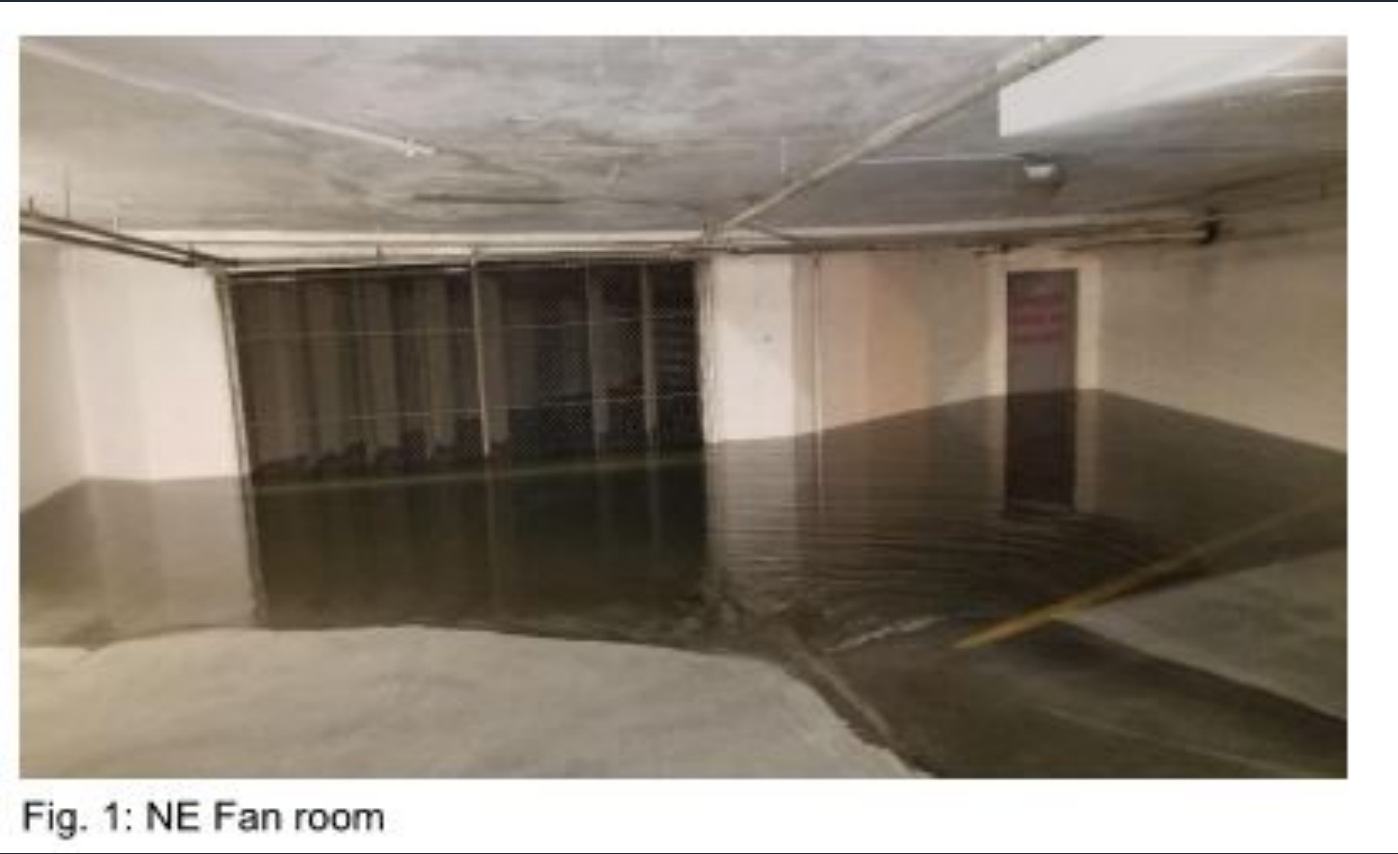
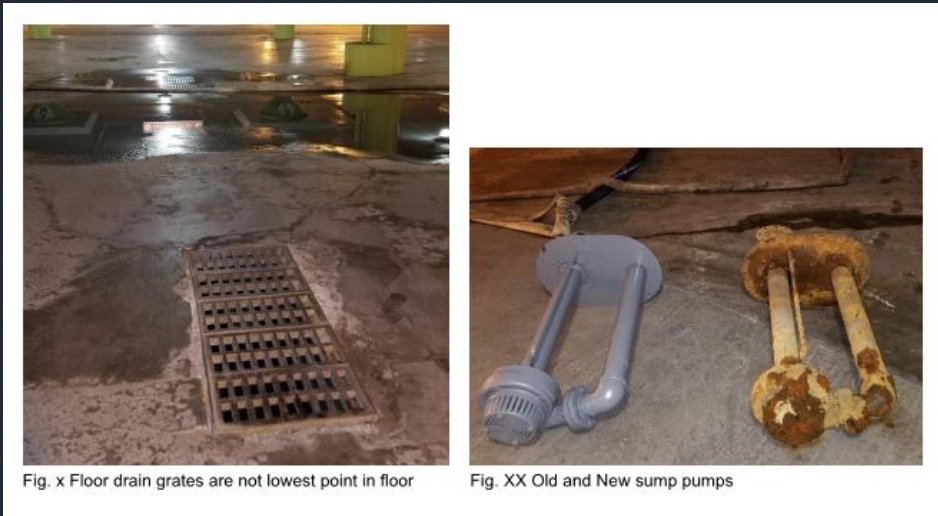
- 3 of the fan rooms are flooded which prevent the ventilation fans from operating.
- Significant repairs and service is required to prevent the ongoing flooding conditions in the mechanical rooms.

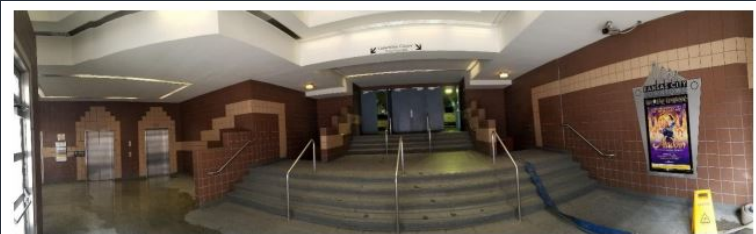
Fig. XX No discernable emergency lights at south street indoor entrance

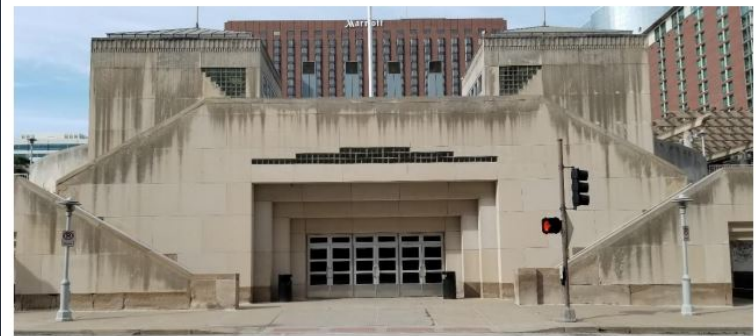
Fig. XX No discernable egress lights at south street exit

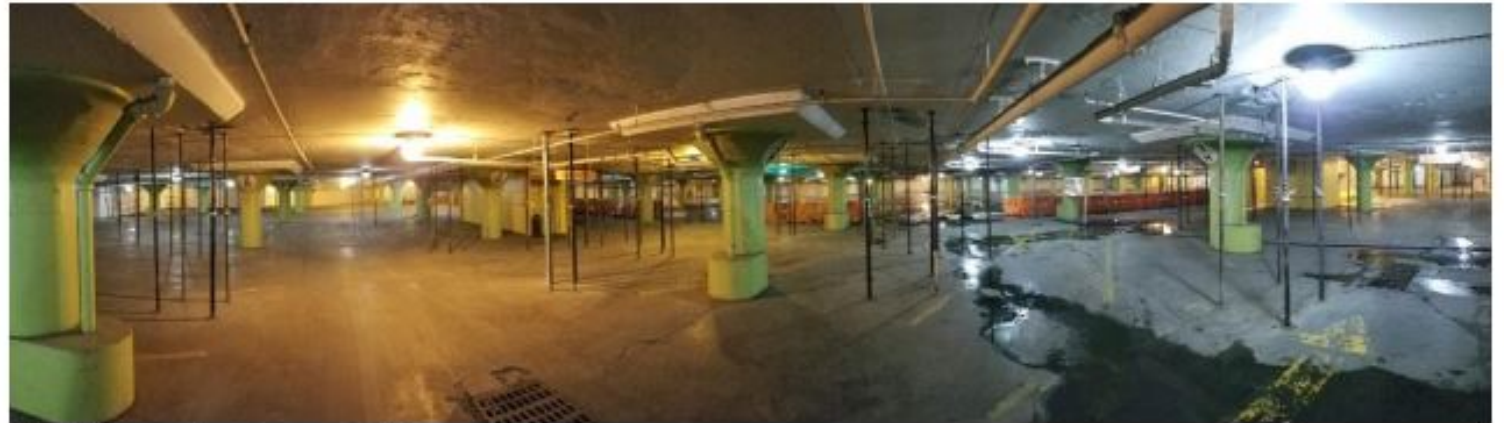
The only emergency/exit lighting appeared to be at the exits, and there was not any emergency lighting at the main parking areas

Fig. XX Lower level garage lighting

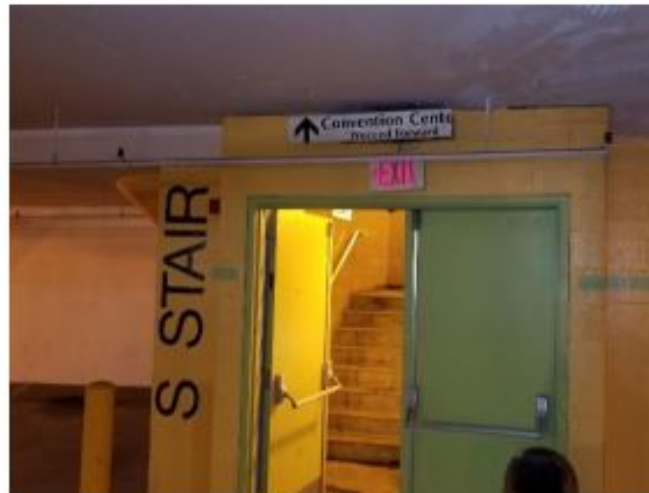
Fig. XX Exit sign at door

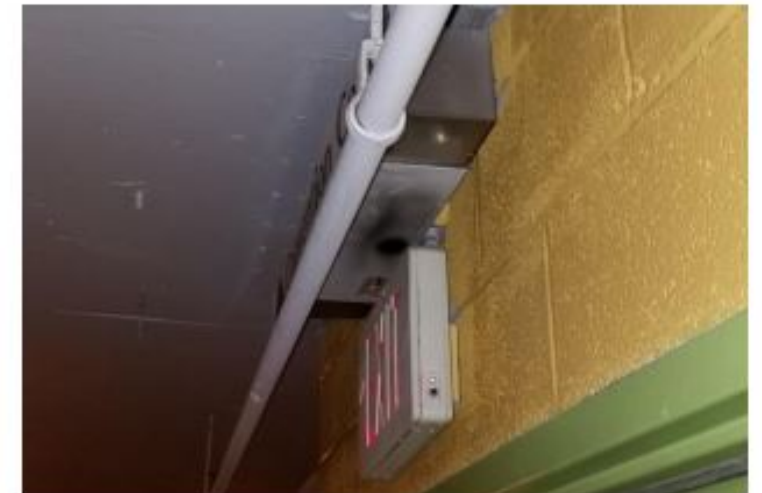
Fig. XX Non-working emergency light above exit

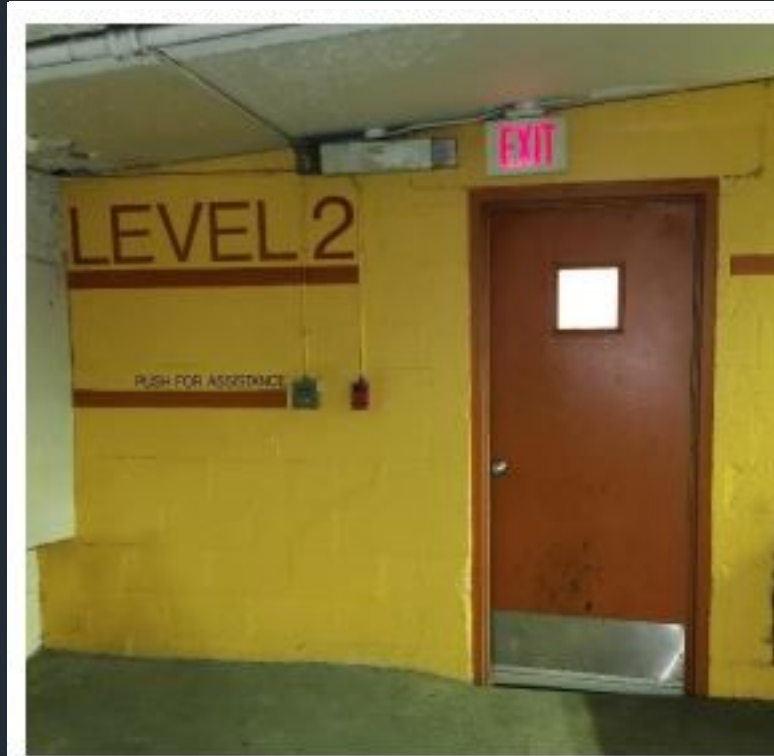
A few call stations exist and appear to work at the central stair/escalator, but they are not well identified or marked.

Fig. XX Call station at SW corner

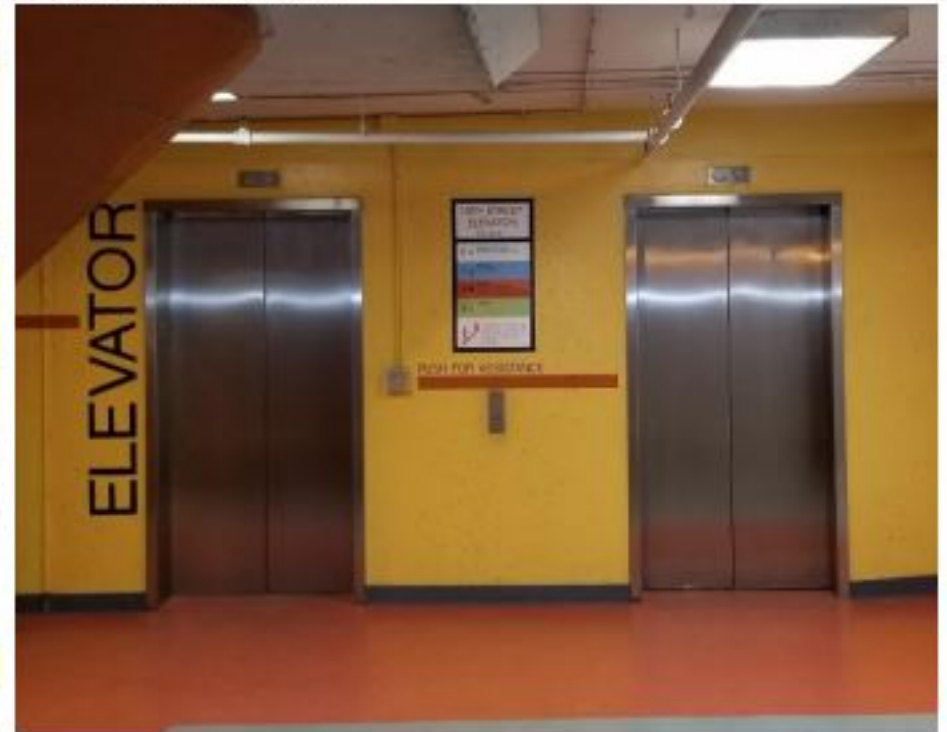
Fig. XX Call station at elevators

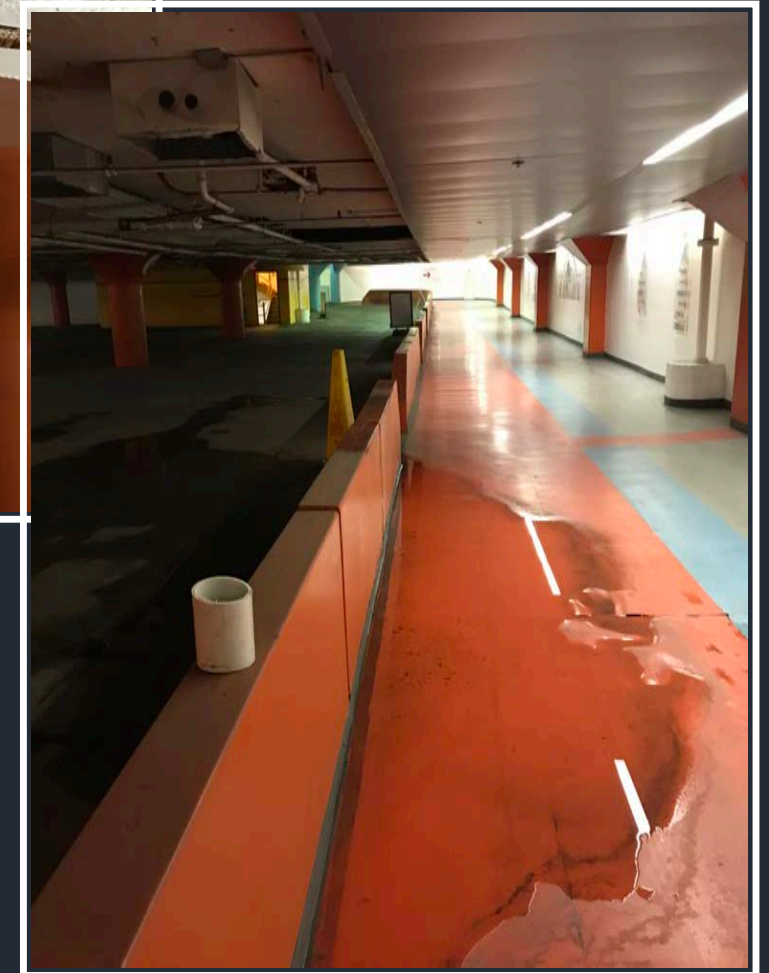
- Most of the sprinkler system observed appears original.
- Deterioration of the system and components are expected, and accessories and monitoring equipment is antiquated and in need of replacement.
