# QUALIFICATION ANALYSIS

29<sup>TH</sup> & BENTON PIEA STUDY AREA  
NWQ BENTON BOULEVARD & E 29<sup>TH</sup> STREET  
KANSAS CITY, MISSOURI

APRIL 3, 2020  
RECORD NO. 1730

BELKE APPRAISAL & CONSULTING SERVICES, INC.

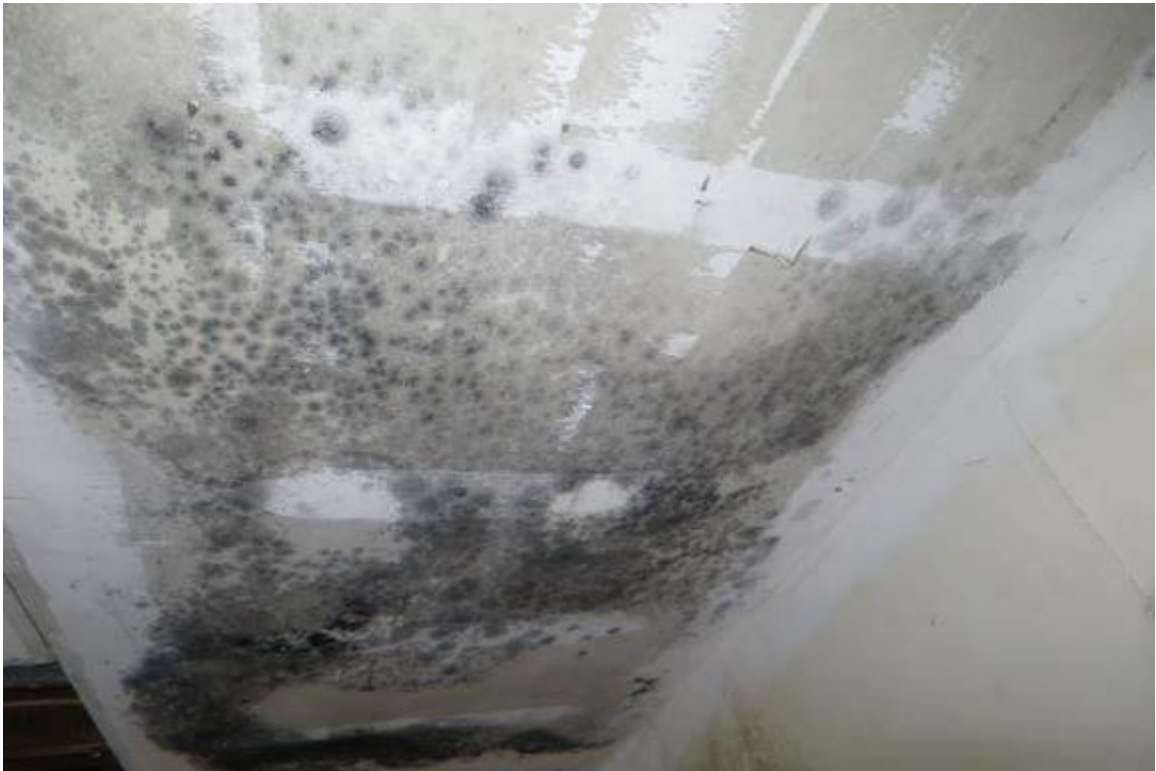
Water Infiltration & Potential Mold – 2644 E 29<sup>th</sup> Street

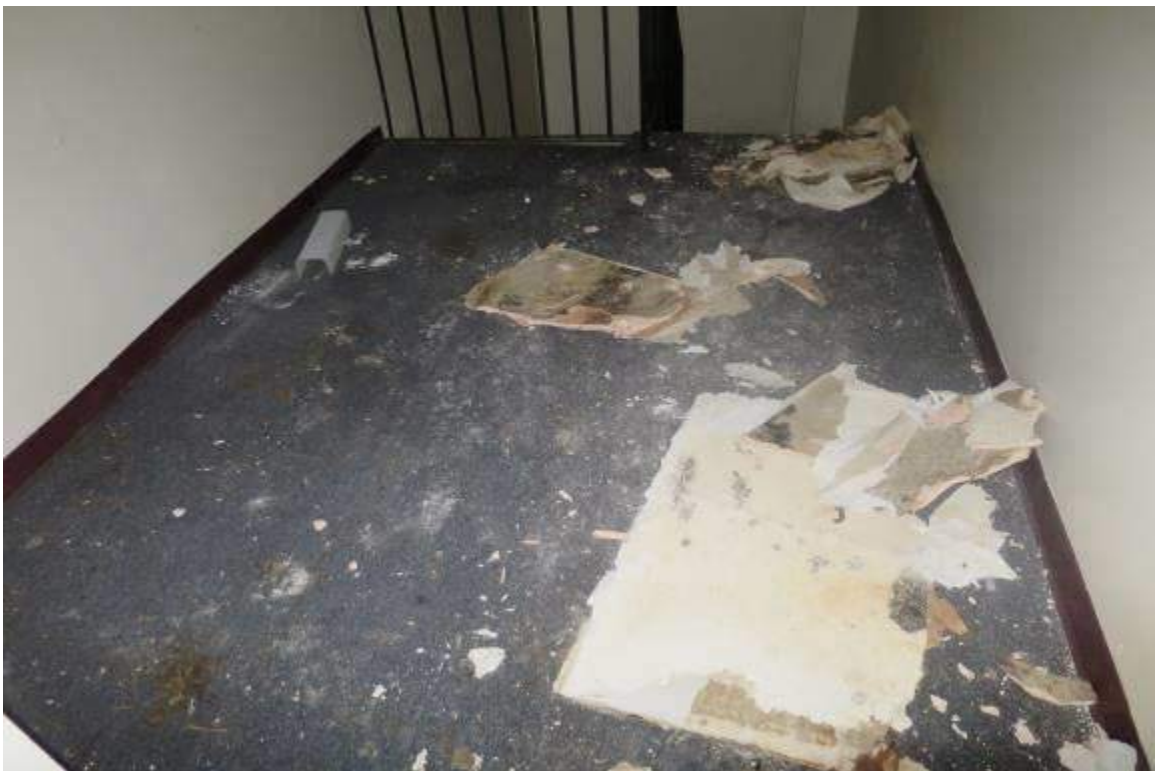
Collapsing Ceiling Structures – 2644 E 29<sup>th</sup> Street

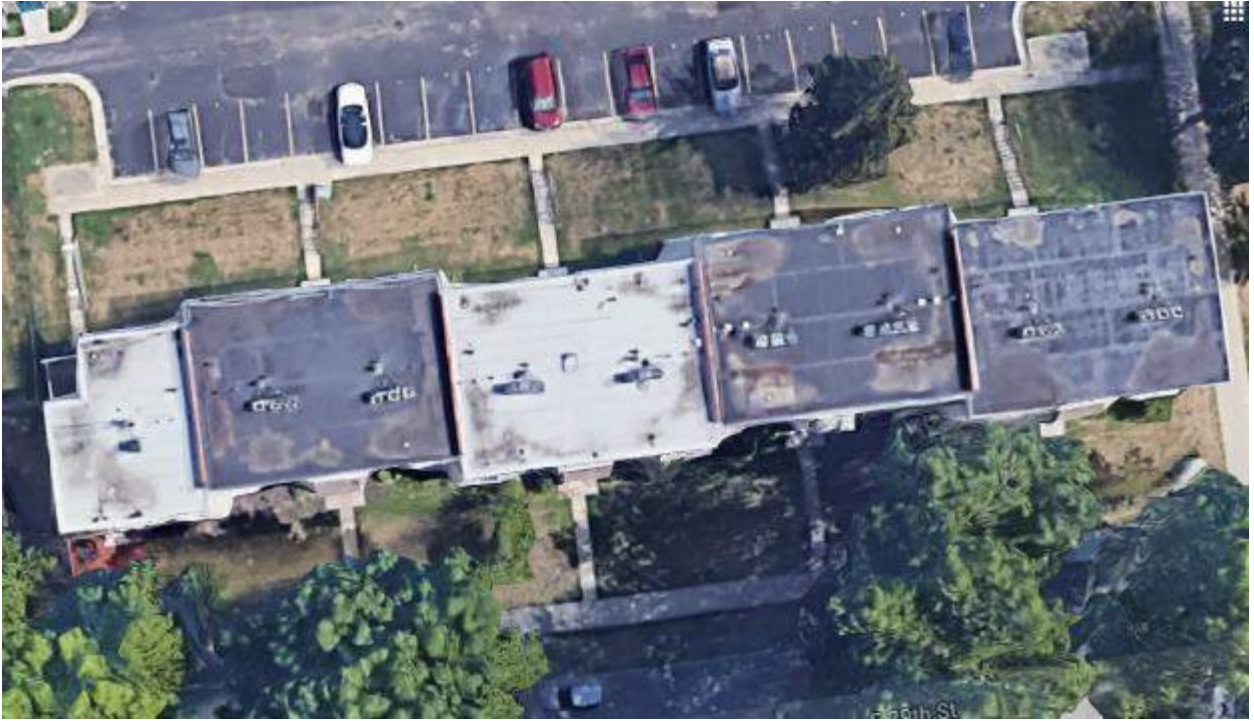
## ROOF DETERIORATION

2702 E 29<sup>th</sup> Street

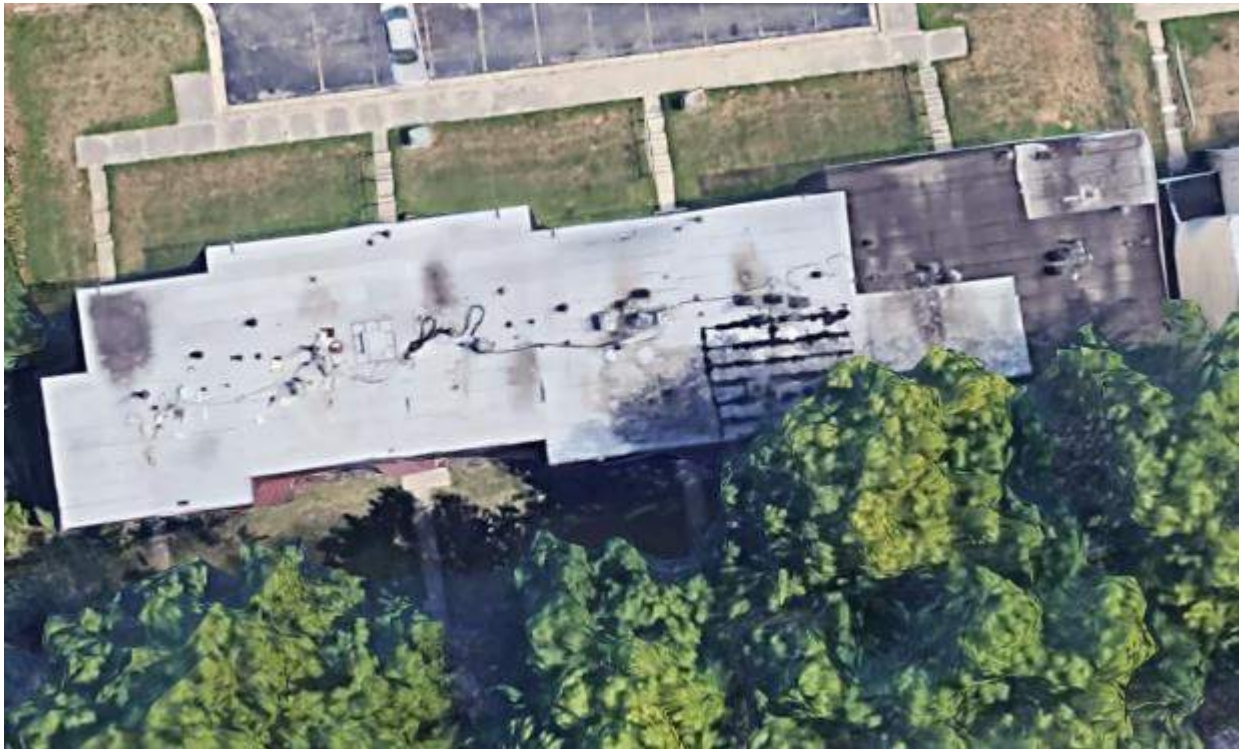
2644 E 29<sup>th</sup> Street

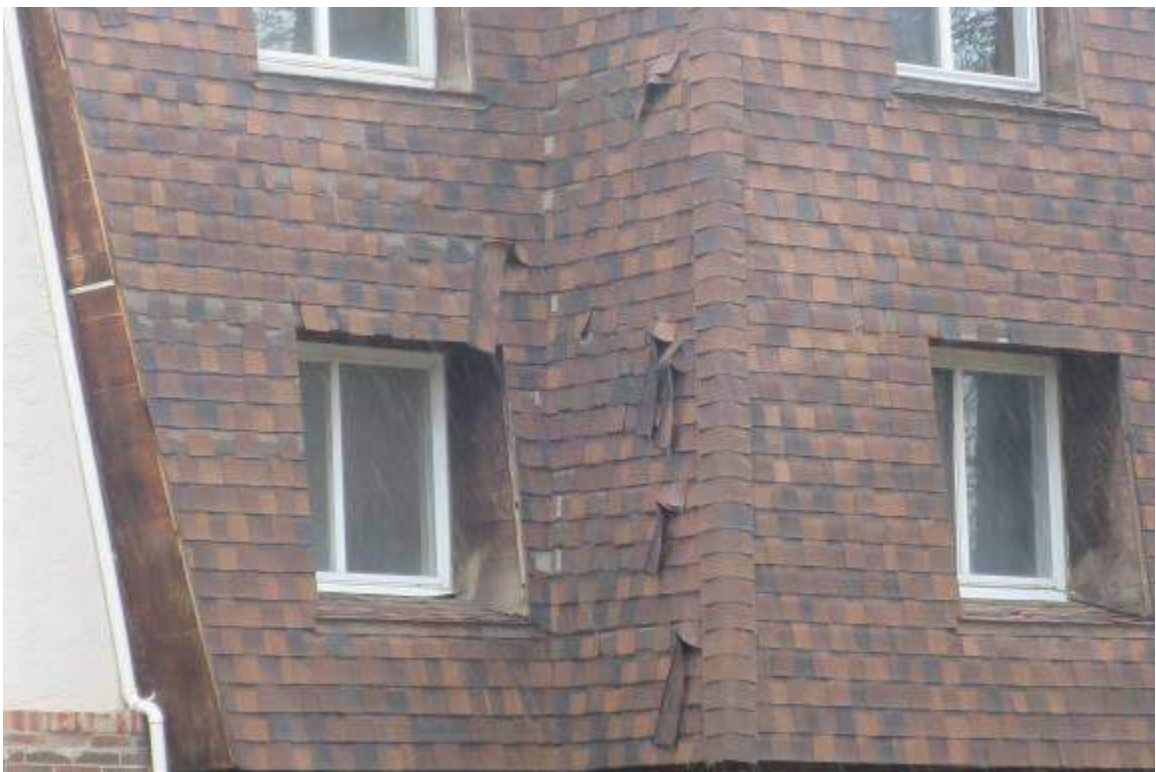
**EXTERIOR WALL DETERIORATION – 2644 E 29<sup>TH</sup> STREET**

The North Elevation

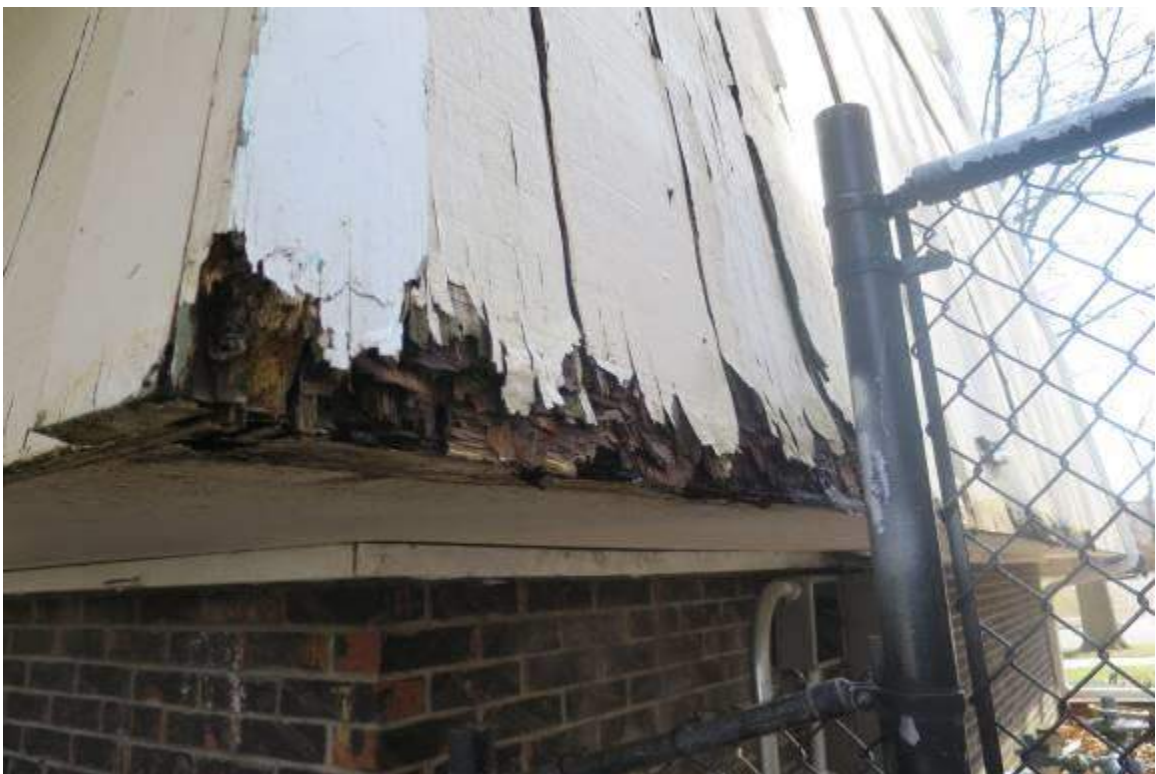
**EXTERIOR WALL DETERIORATION – 2702 E 29<sup>TH</sup> STREET**

The South Elevation

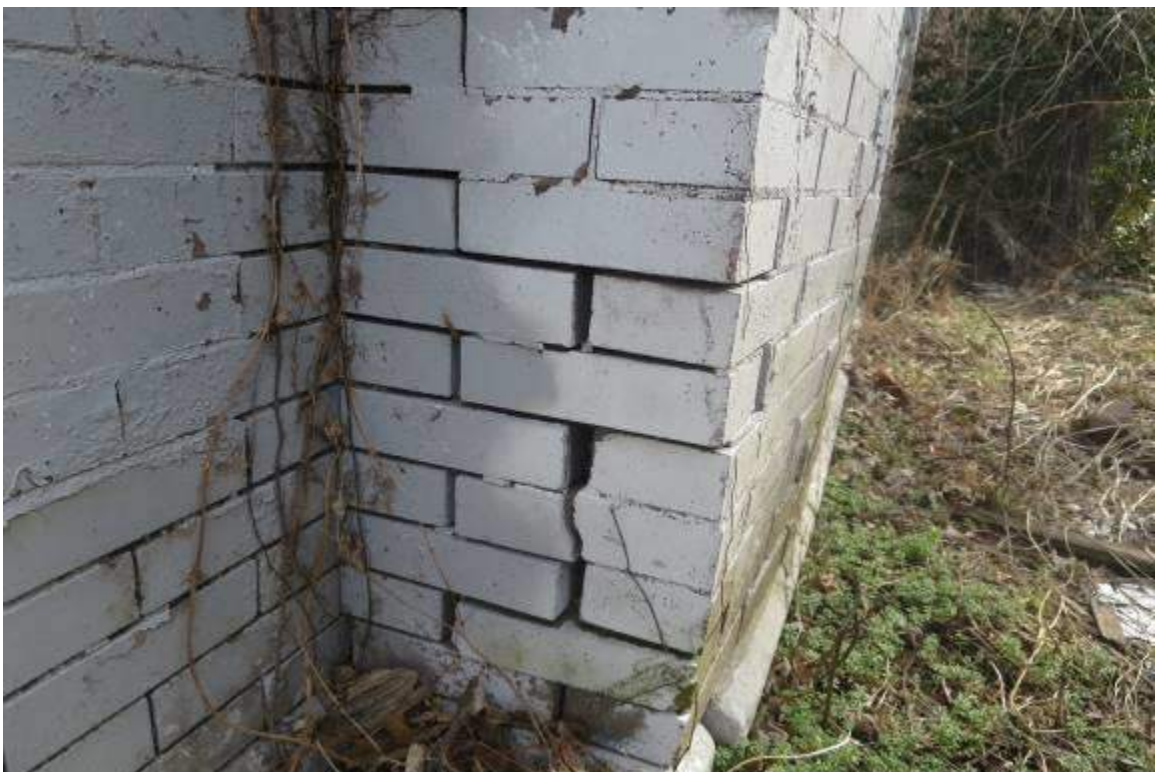
## EXTERIOR WALL DETERIORATION – 2651 VICTOR STREET

East Elevation

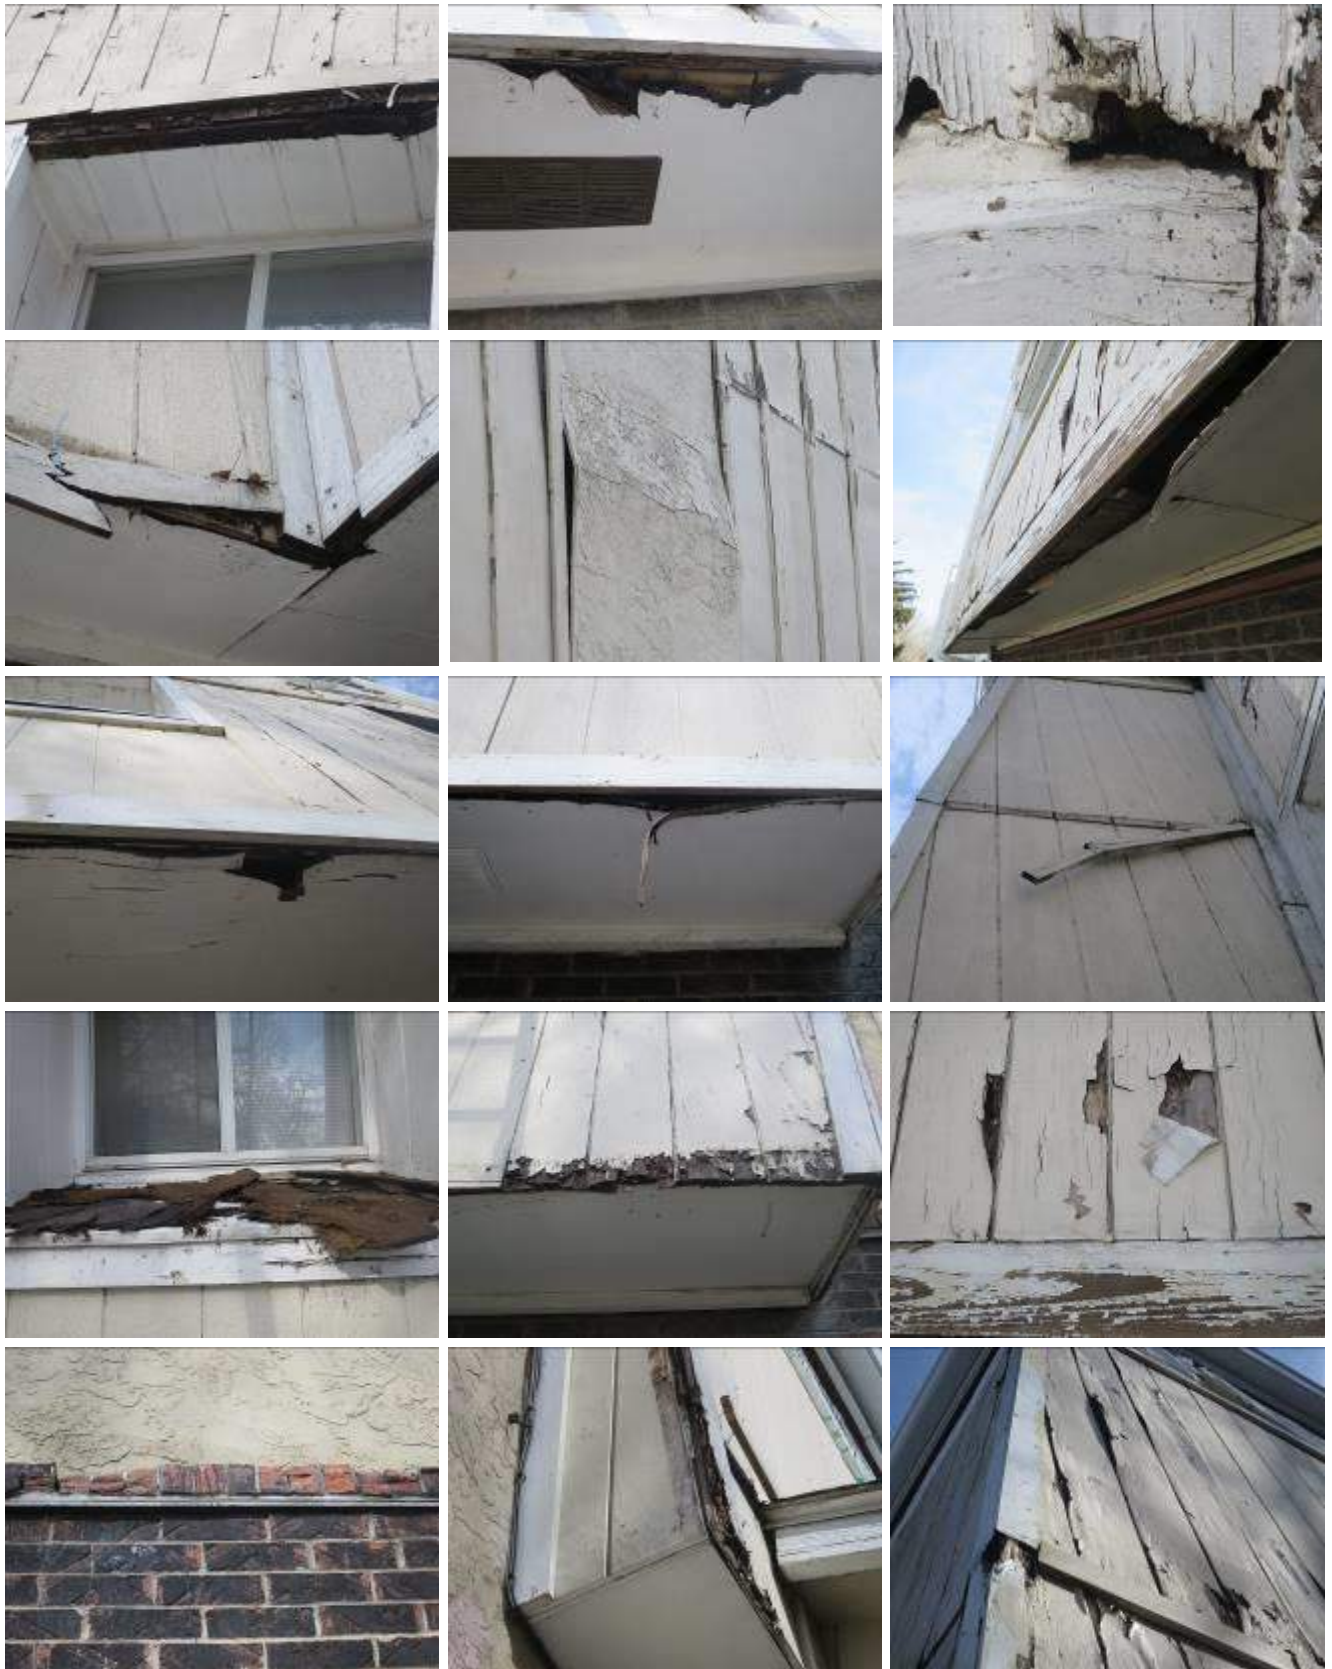
EXTERIOR WALL DETERIORATION – 2702 E 29<sup>TH</sup> STREET

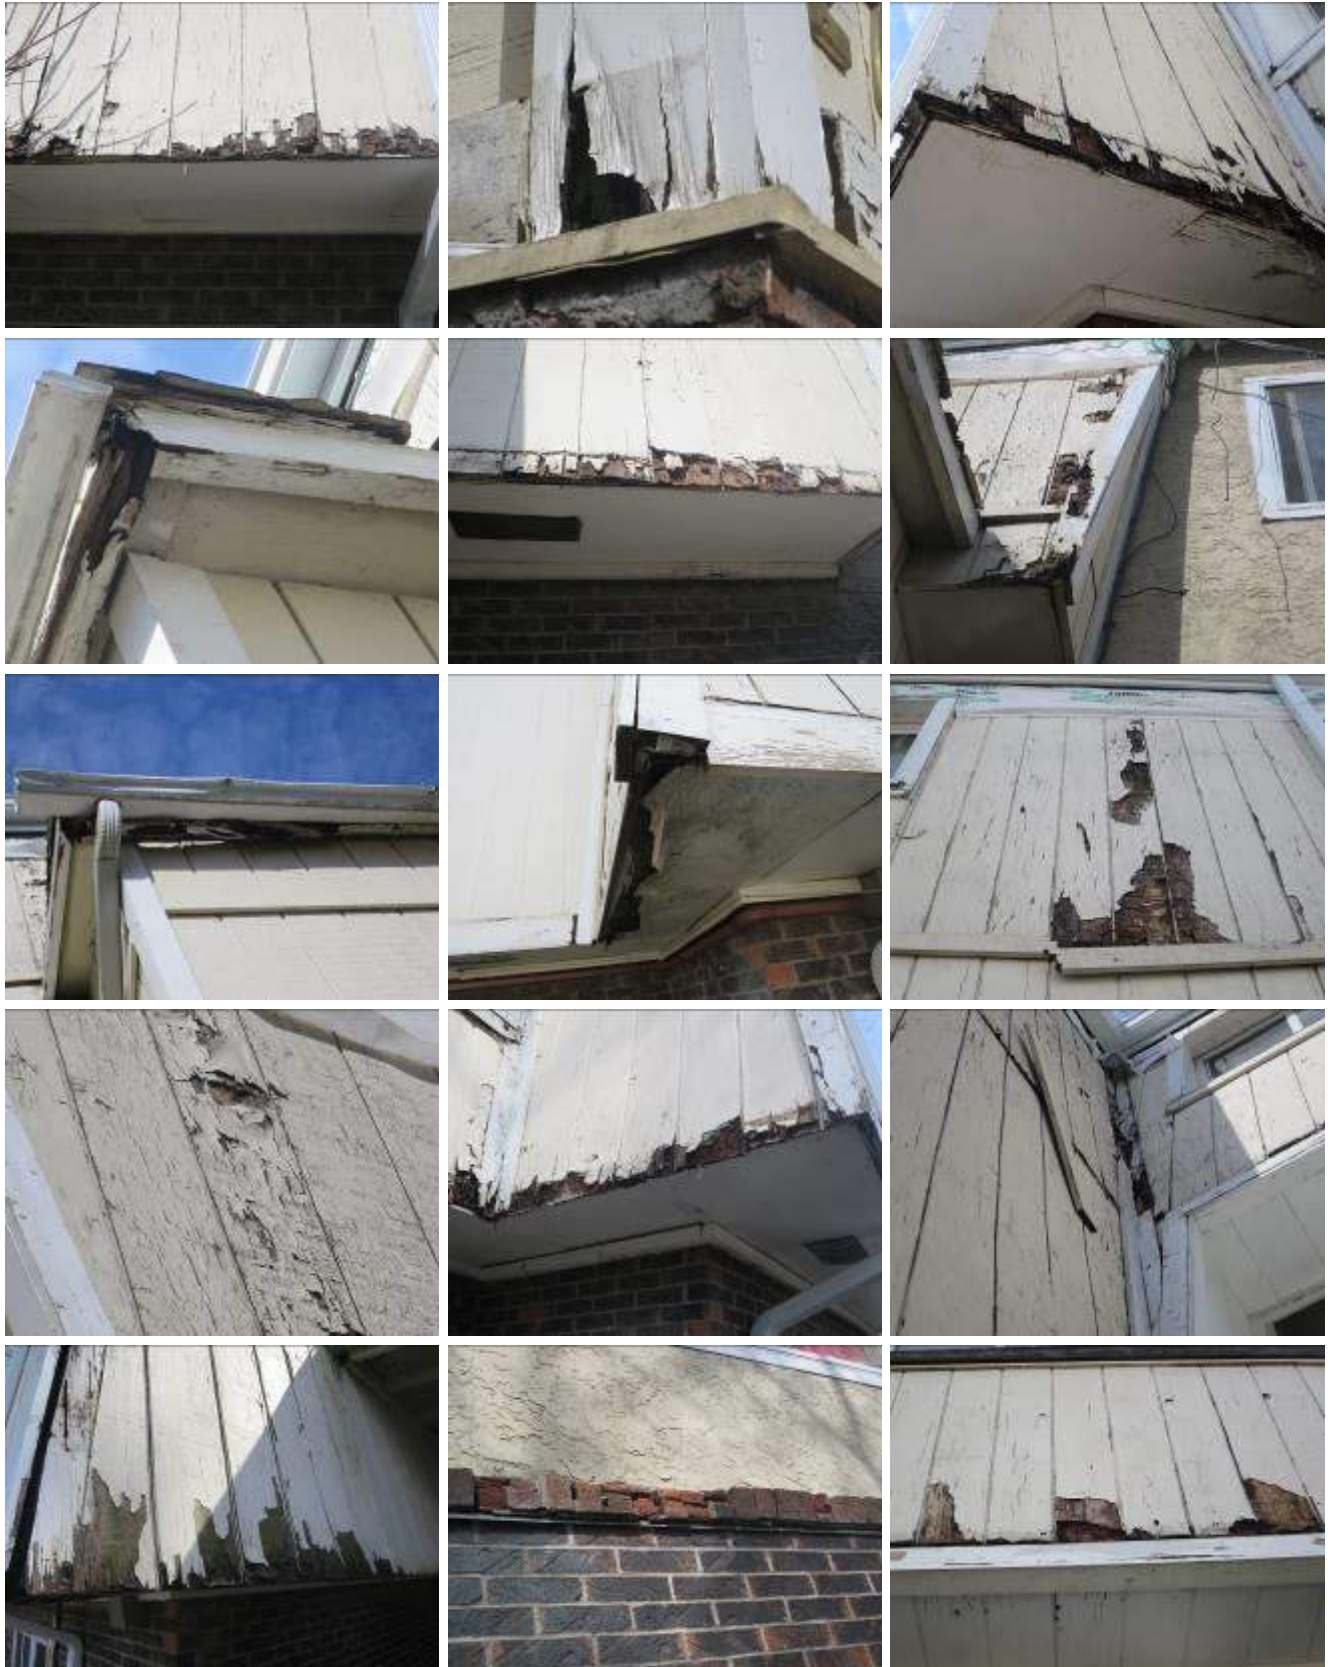
**EXTERIOR WALL DETERIORATION – 2702 E 29<sup>TH</sup> STREET**

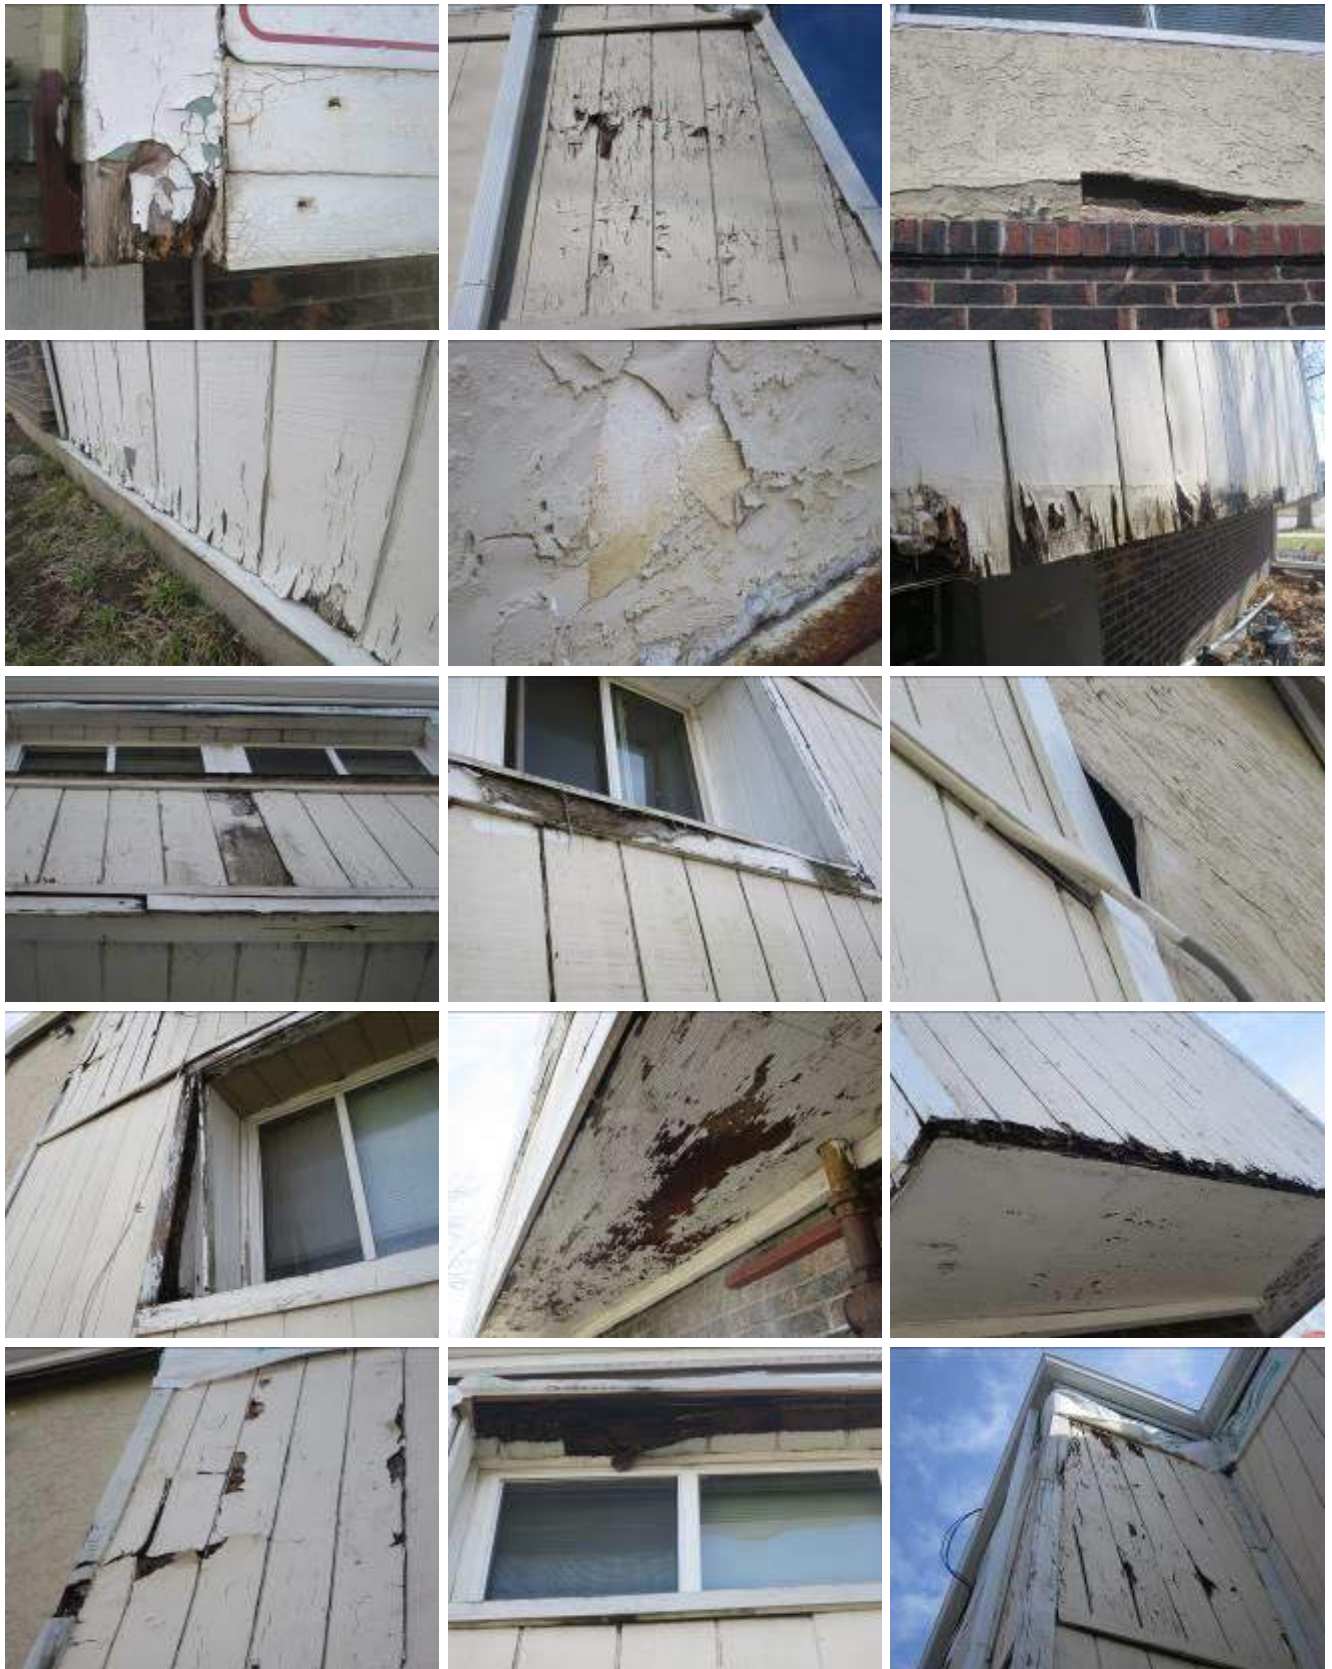
EXTERIOR WALL DETERIORATION – 2702 E 29<sup>TH</sup> STREET

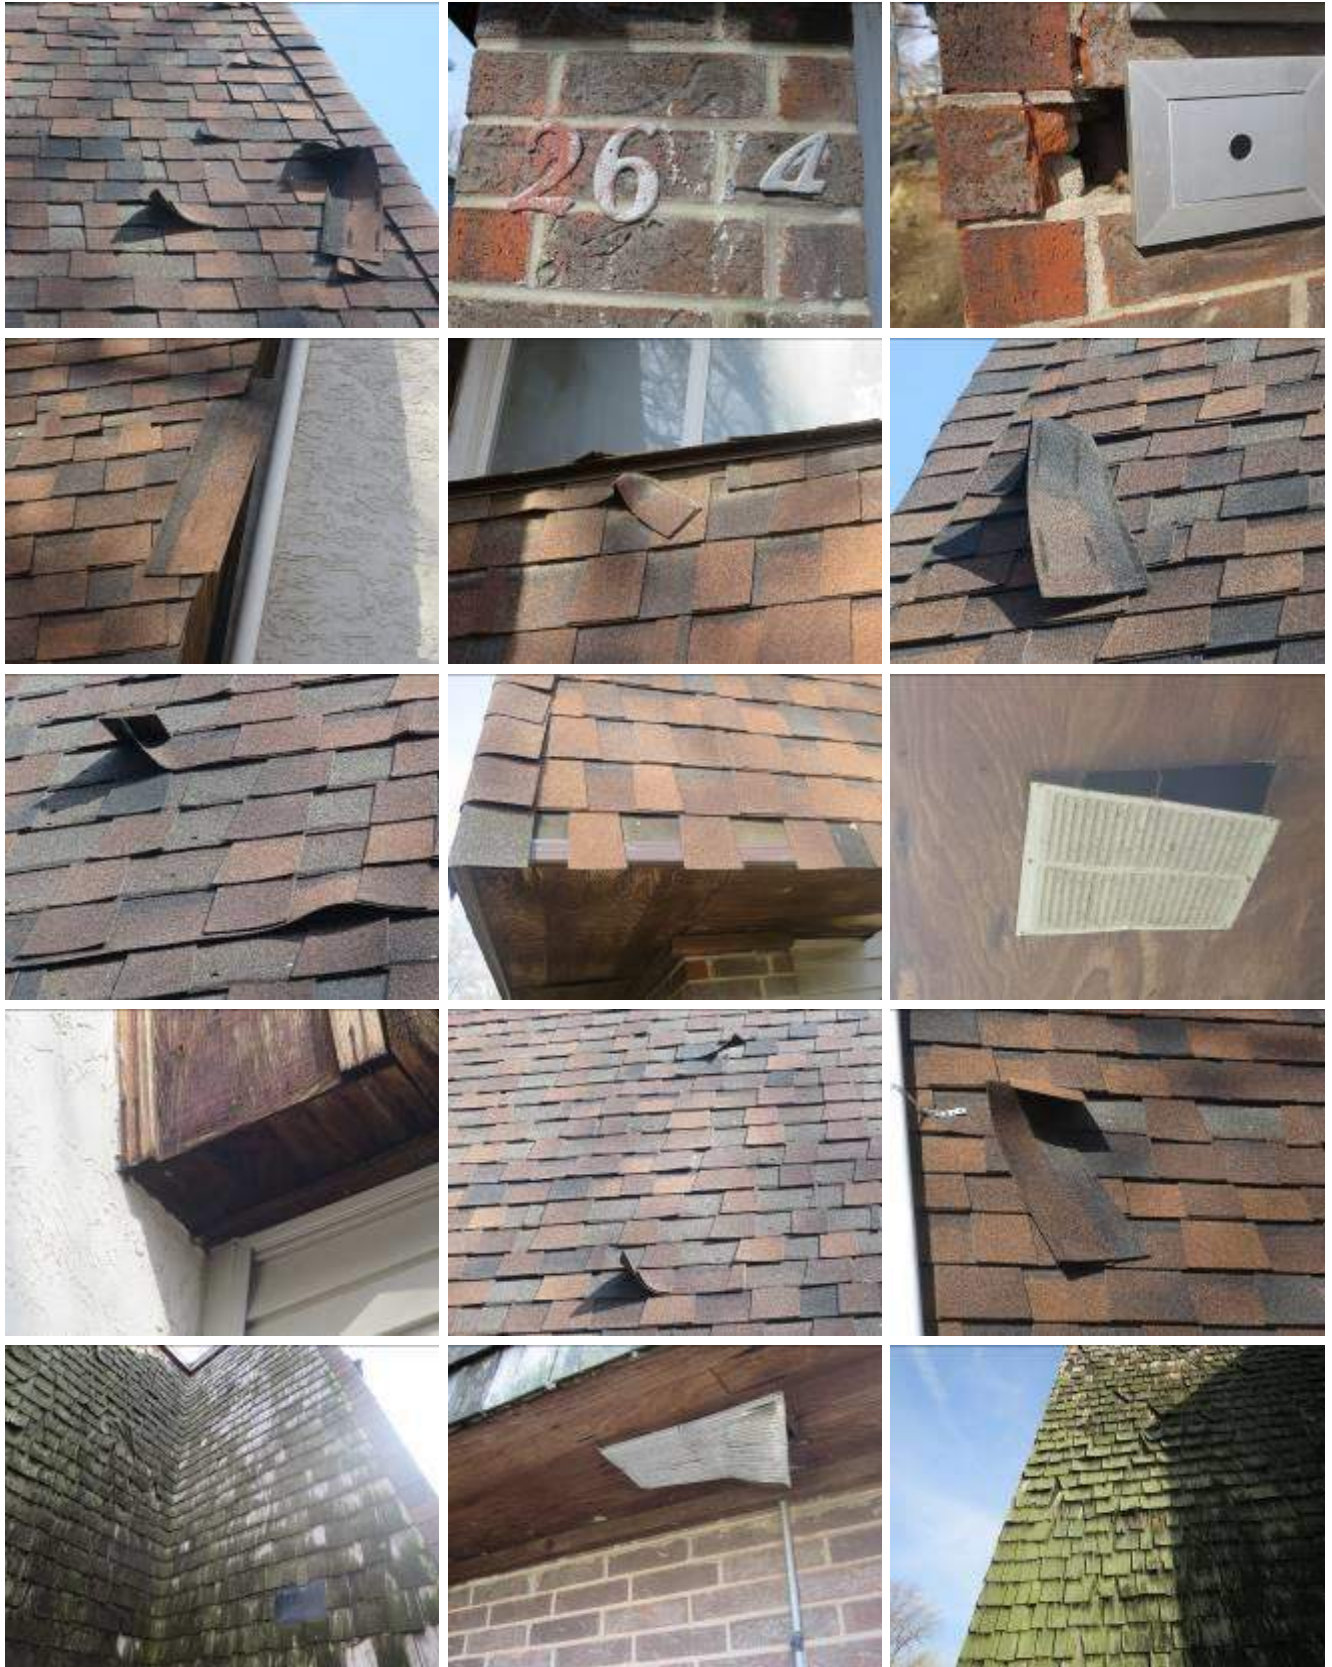
EXTERIOR WALL DETERIORATION – 2644 E 29<sup>TH</sup> STREET

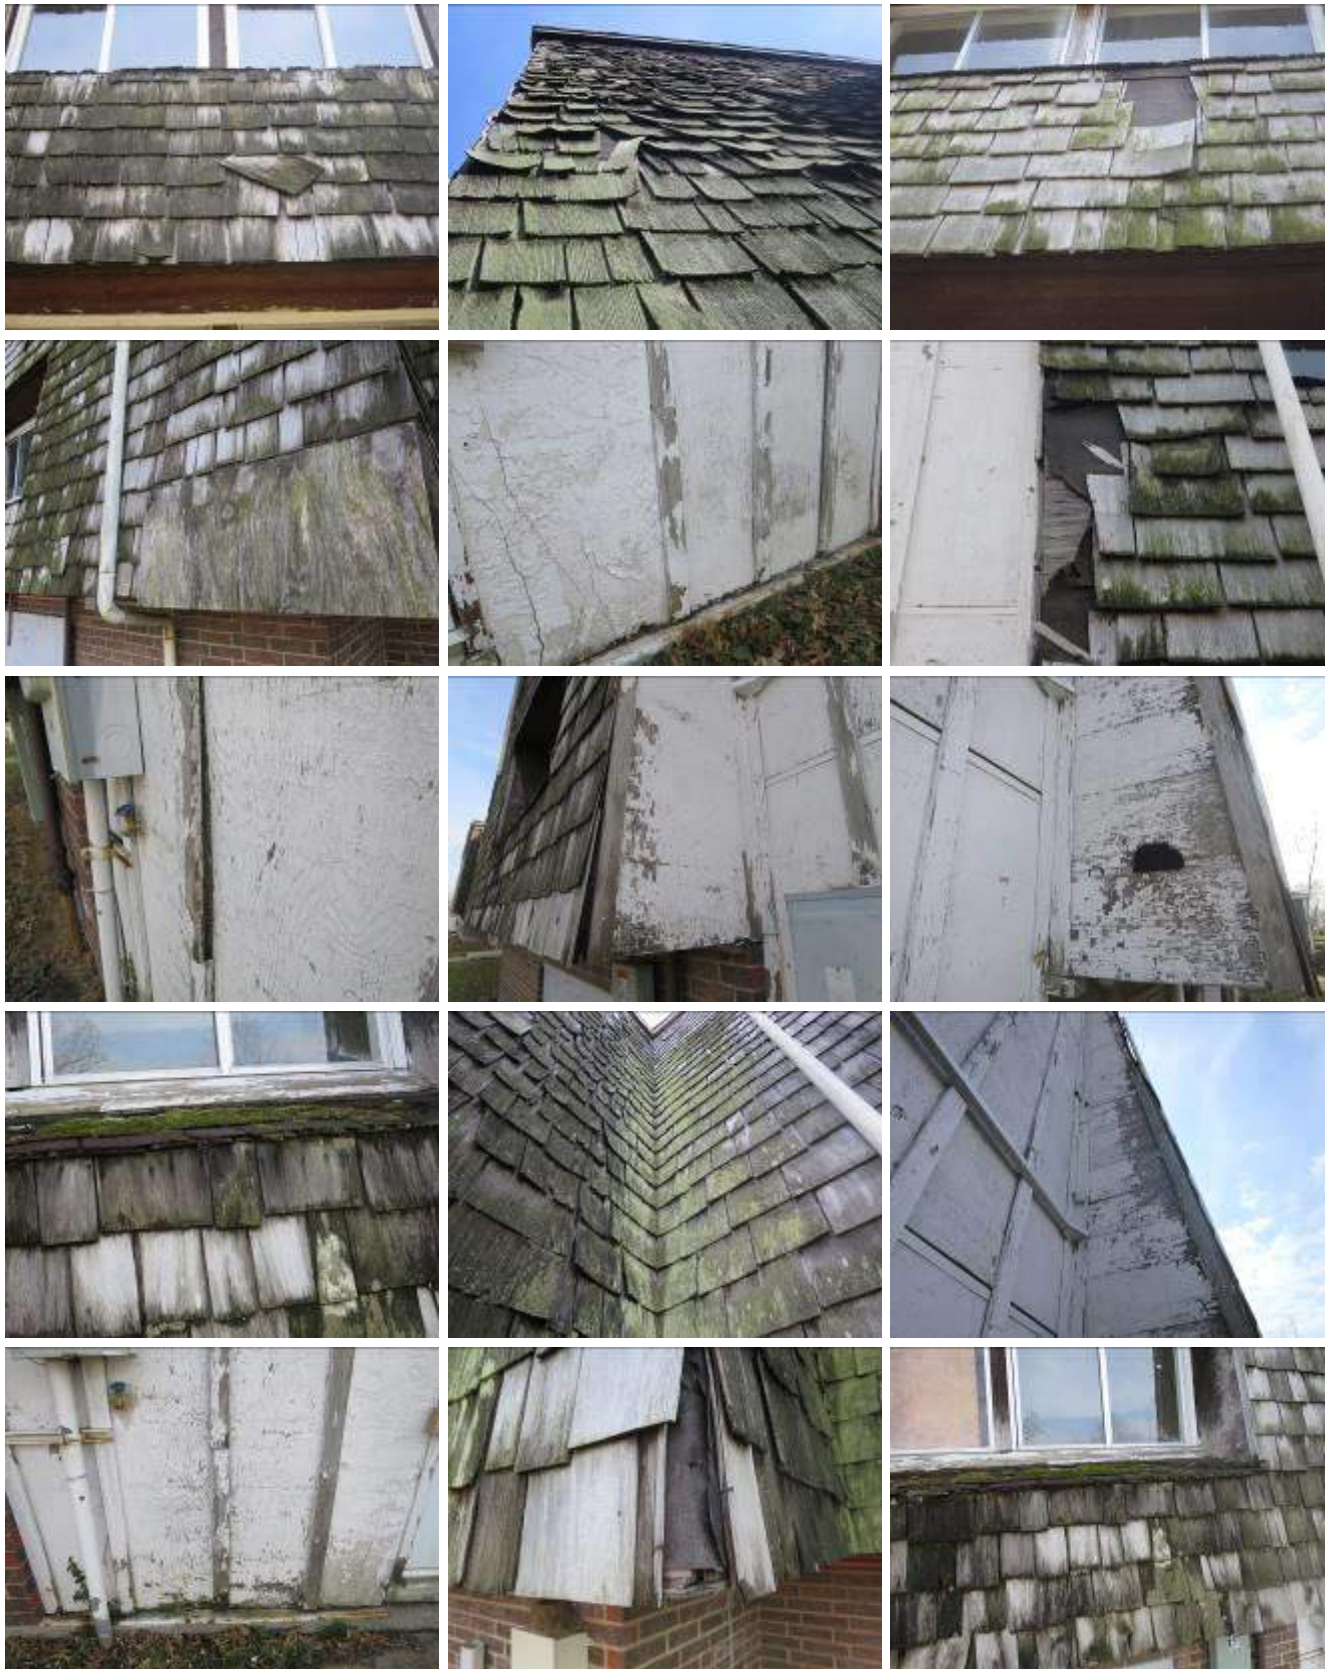
EXTERIOR WALL DETERIORATION – 2644 E 29<sup>TH</sup> STREET

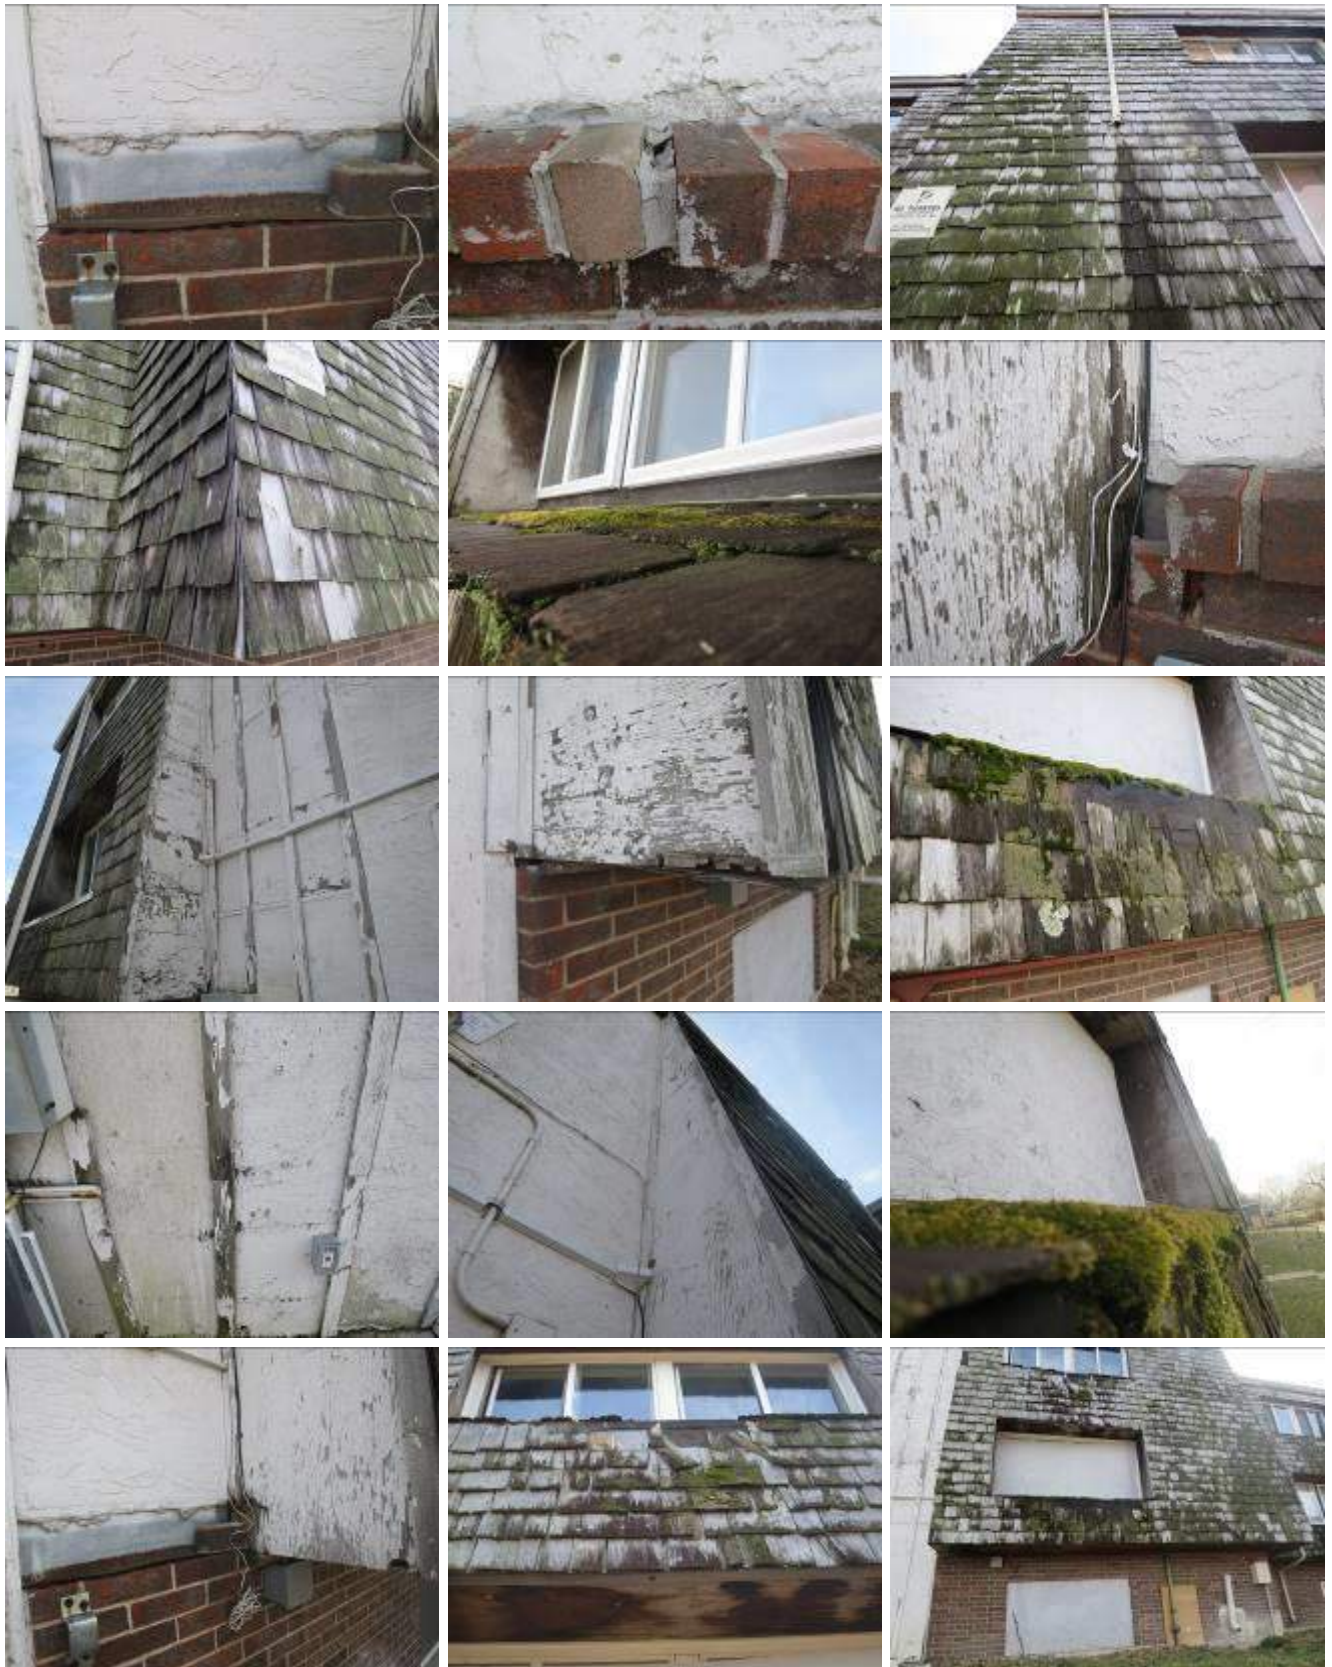
EXTERIOR WALL DETERIORATION – 2644 E 29<sup>TH</sup> STREET

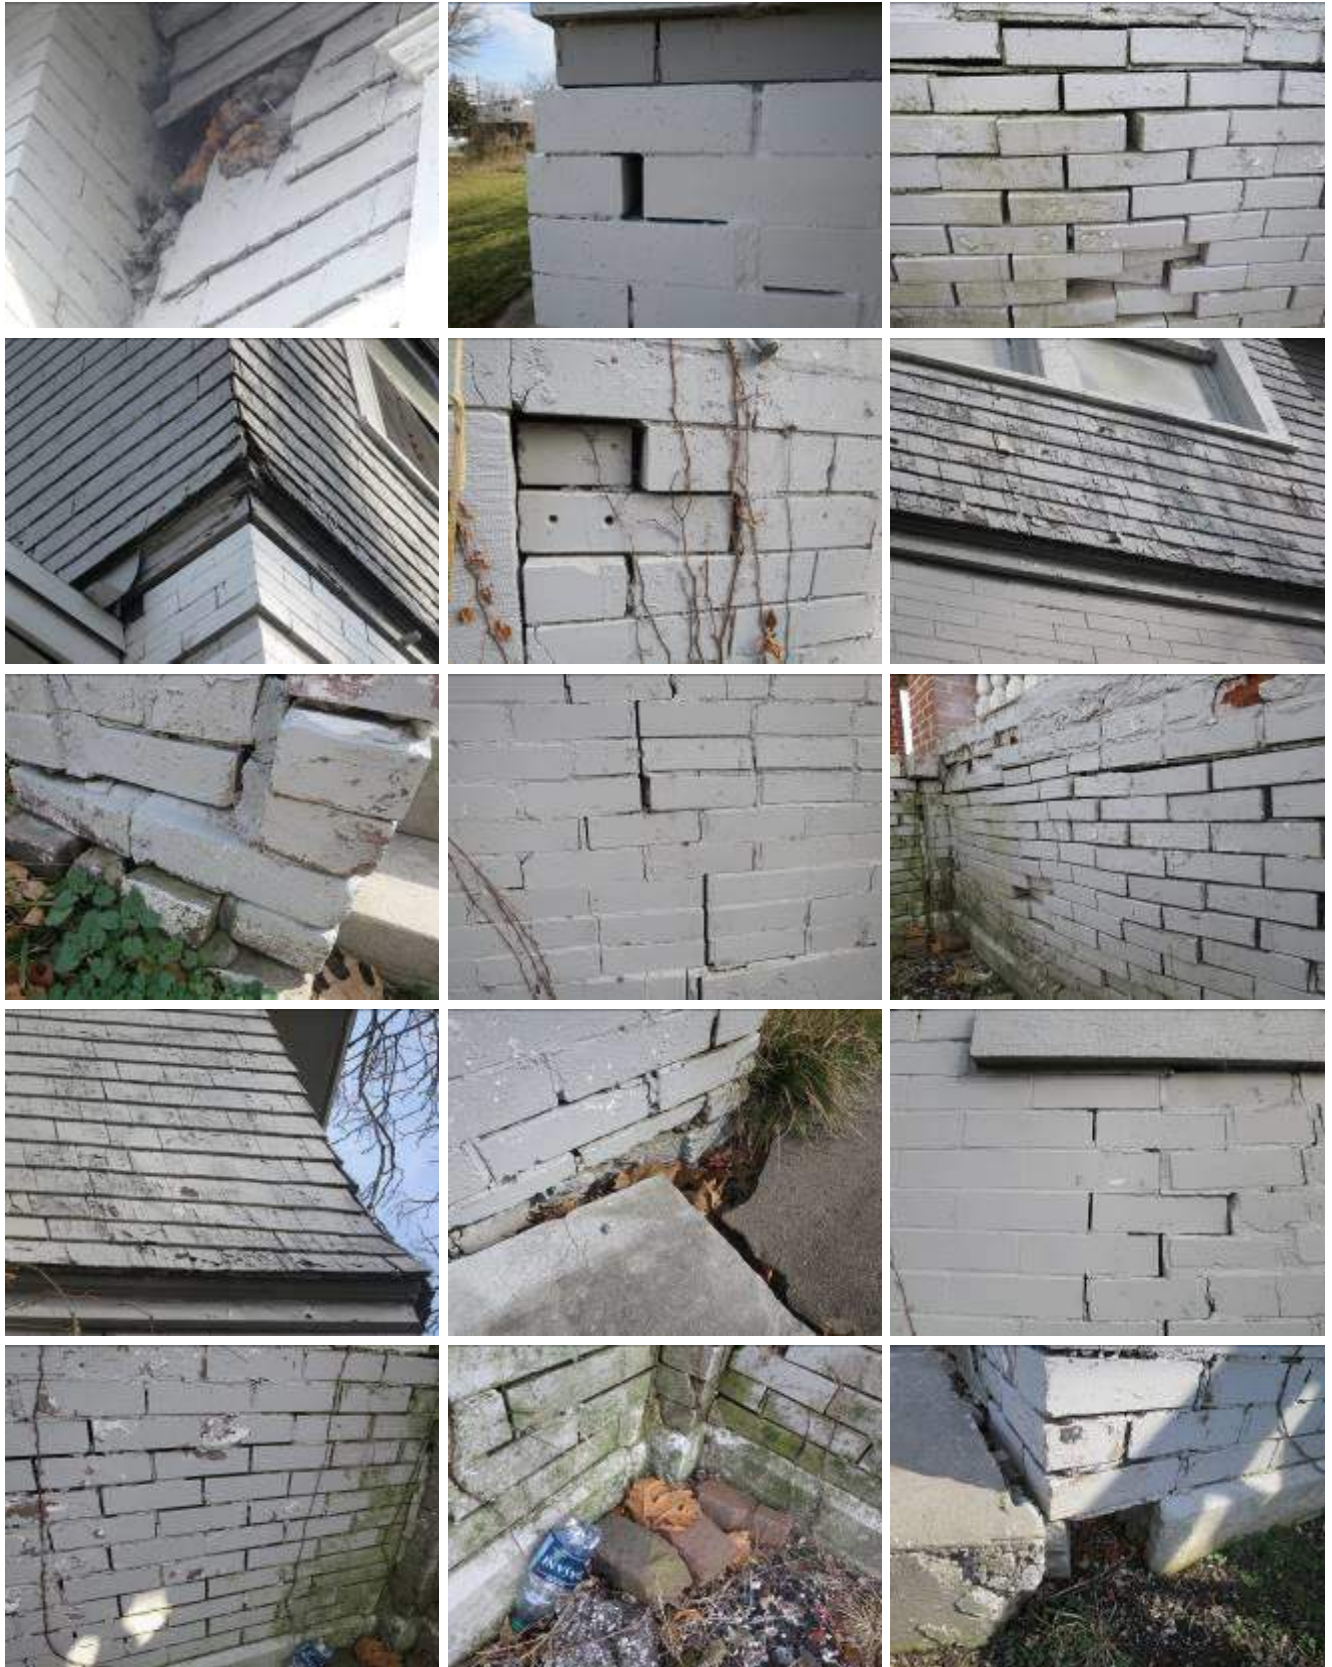
**EXTERIOR WALL DETERIORATION – 2651 VICTOR STREET**
