# QUALIFICATION ANALYSIS

29<sup>TH</sup> & BENTON PIEA STUDY AREA  
NWQ BENTON BOULEVARD & E 29<sup>TH</sup> STREET  
KANSAS CITY, MISSOURI

APRIL 3, 2020  
RECORD NO. 1730

BELKE APPRAISAL & CONSULTING SERVICES, INC.

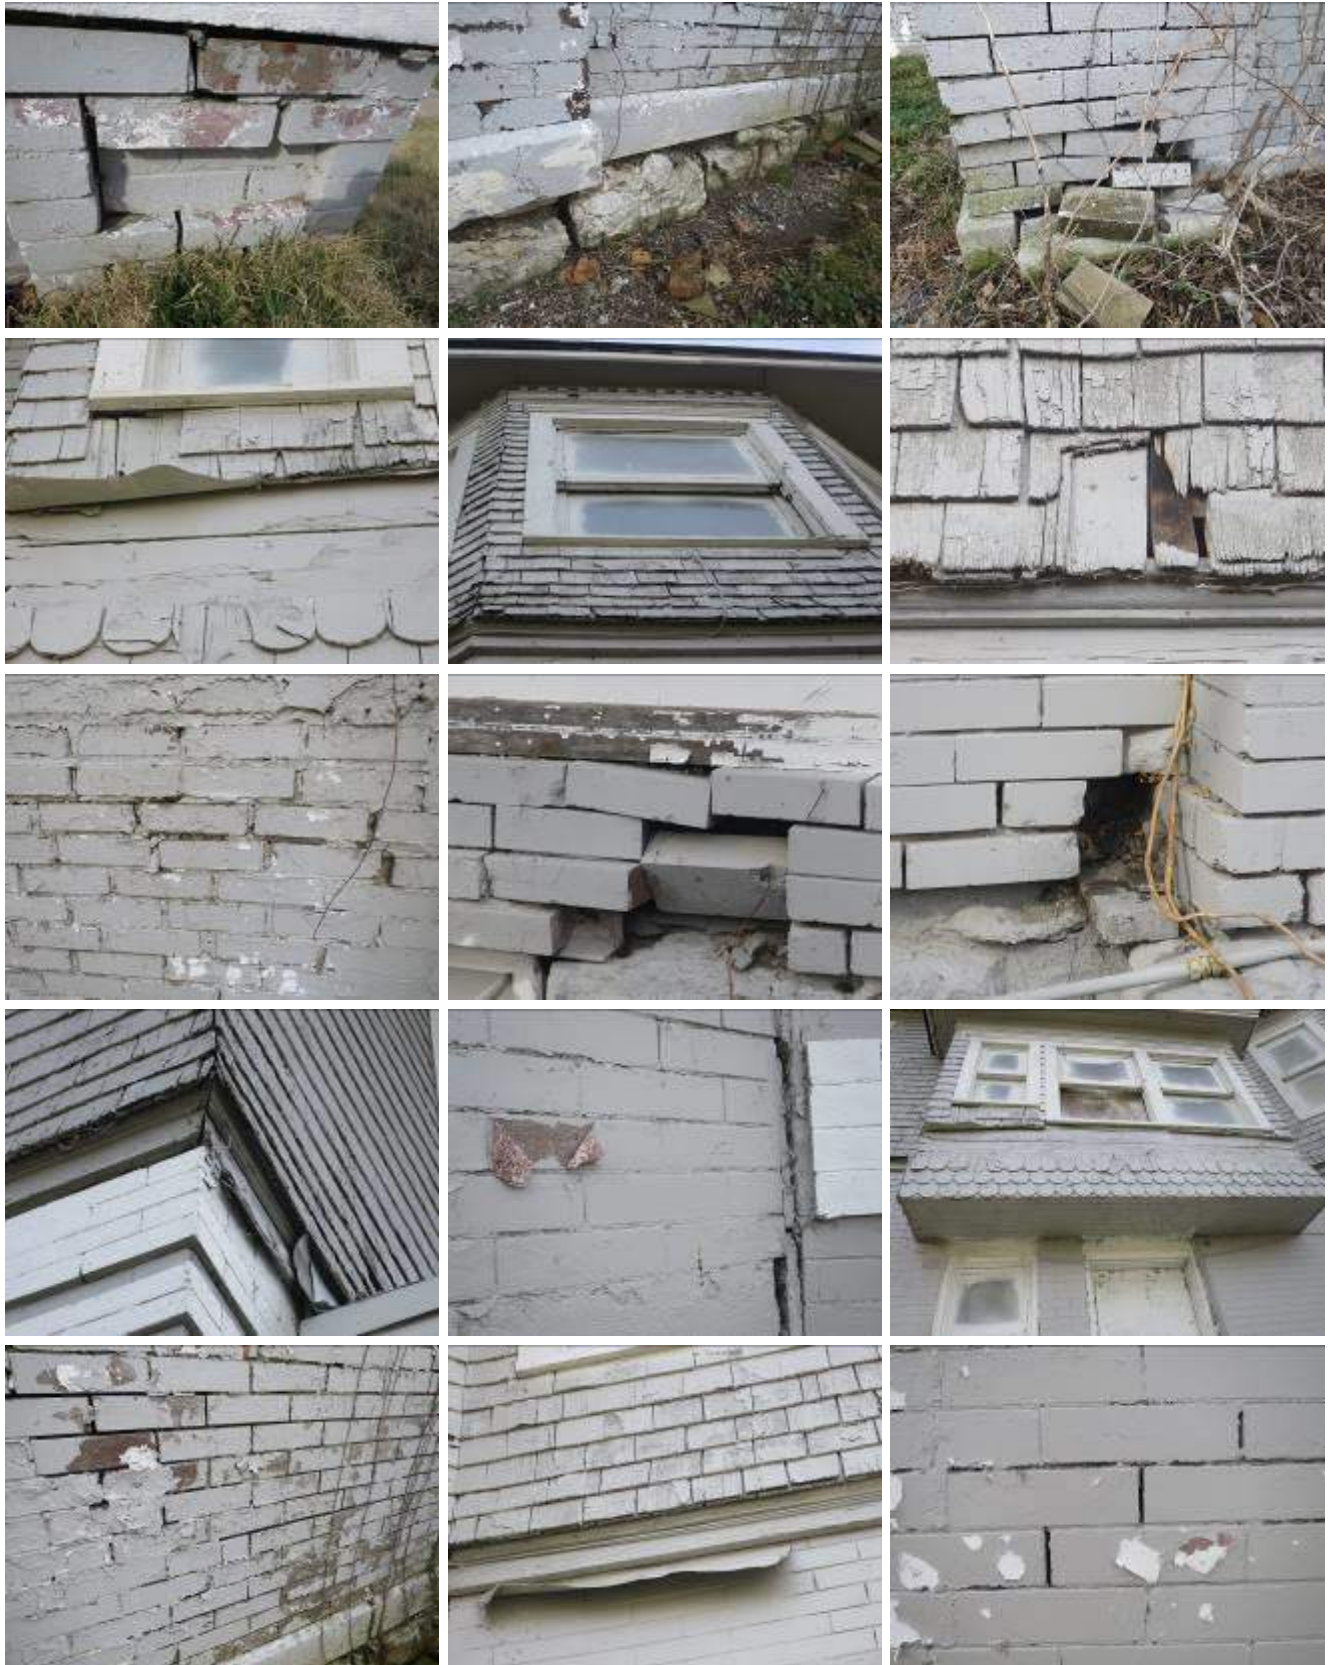
**EXTERIOR WALL DETERIORATION – 2651 VICTOR STREET**

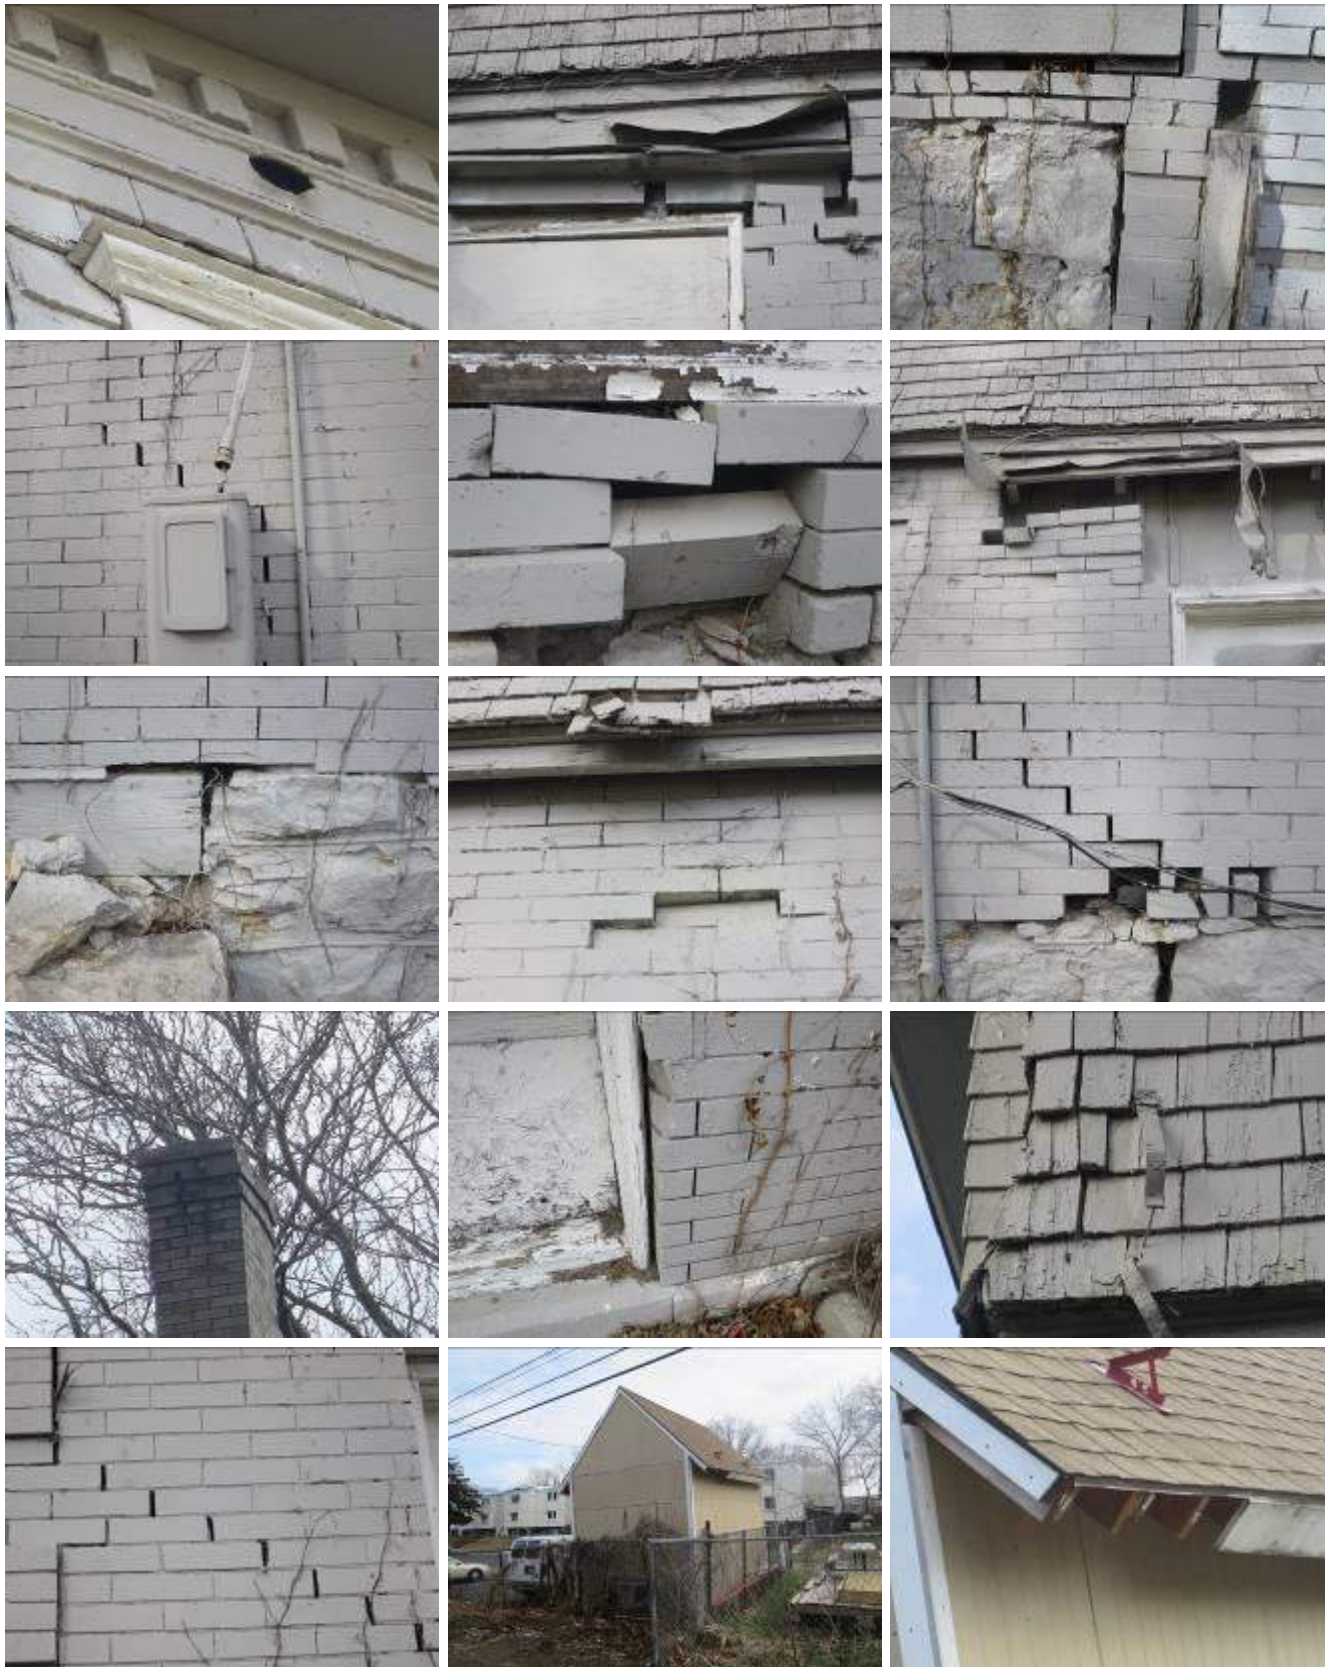
**EXTERIOR WALL DETERIORATION – 2651 VICTOR STREET**

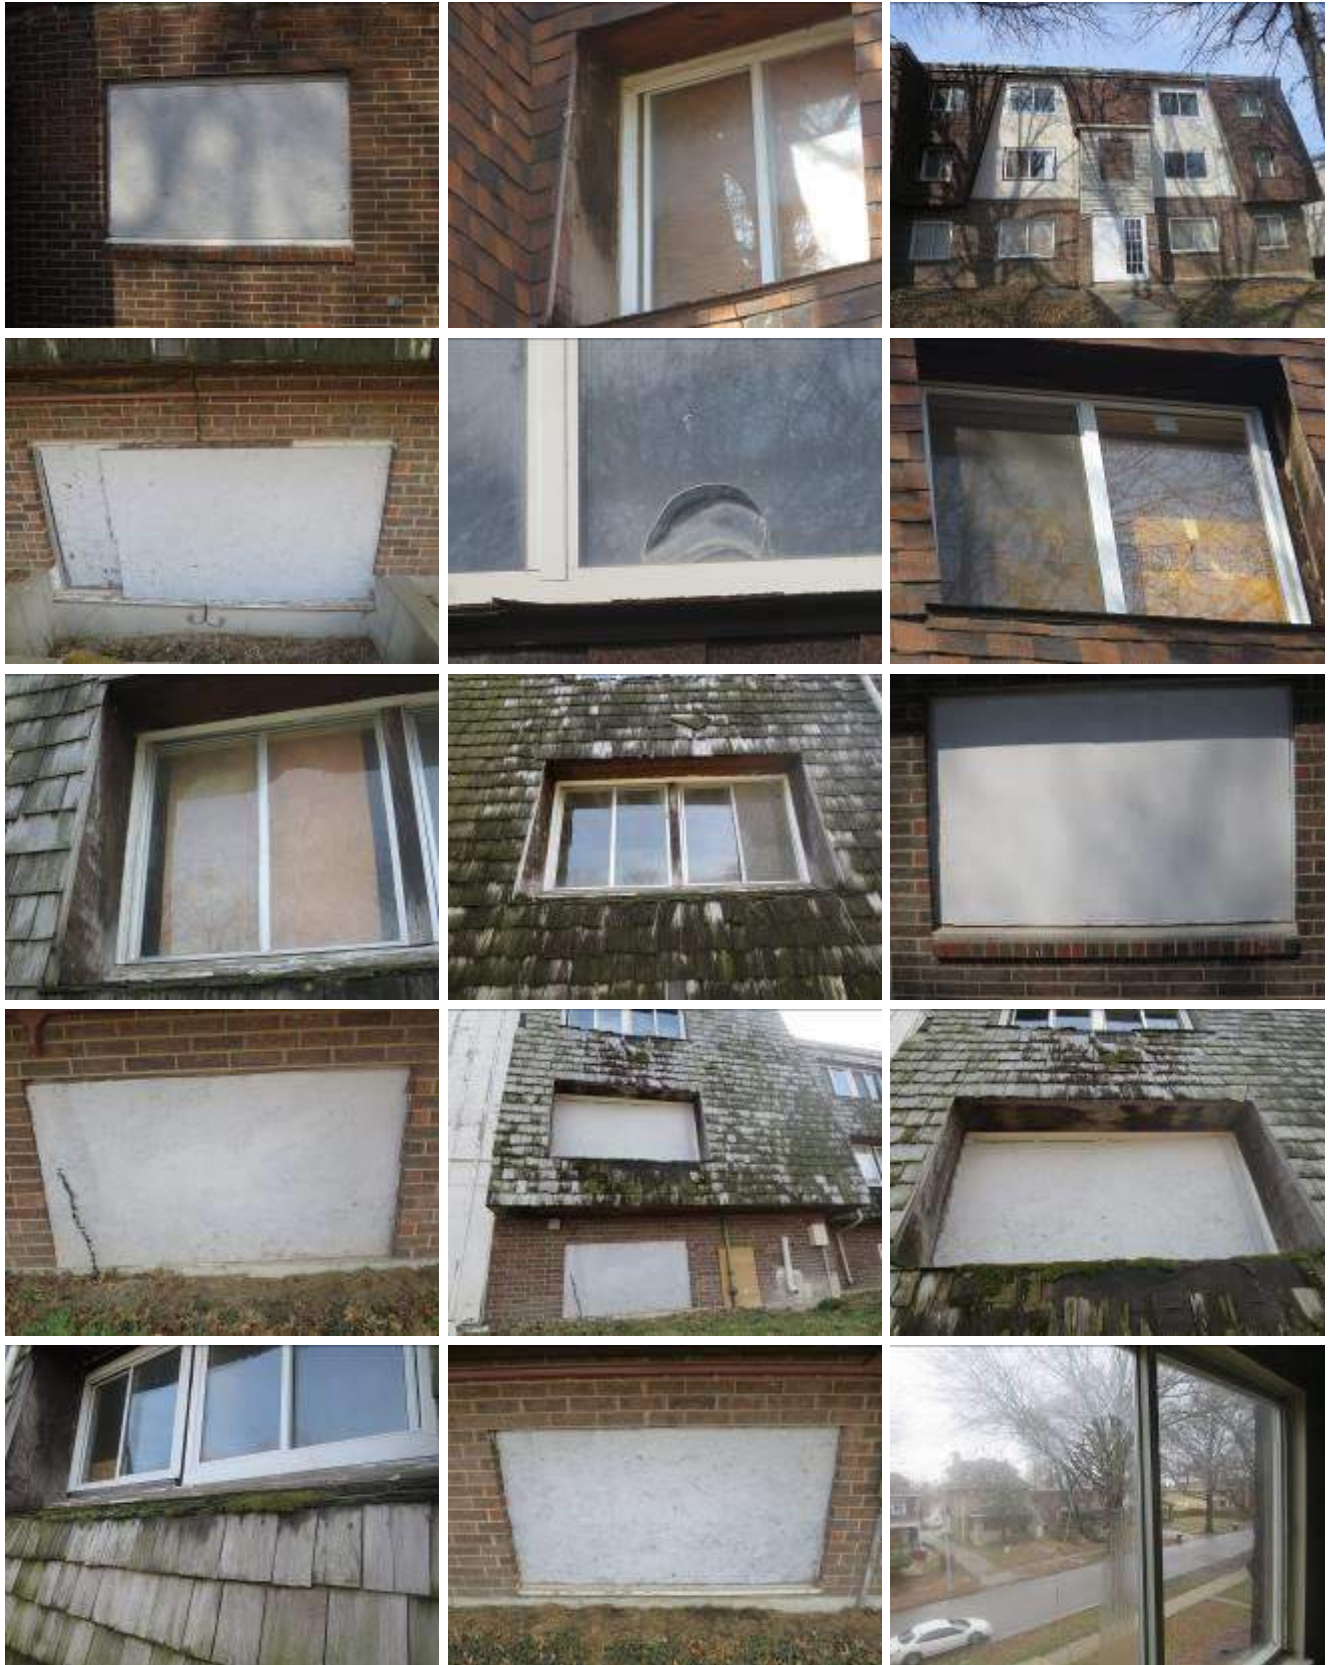
WINDOW DETERIORATION – 2644 E 29<sup>TH</sup> STREET

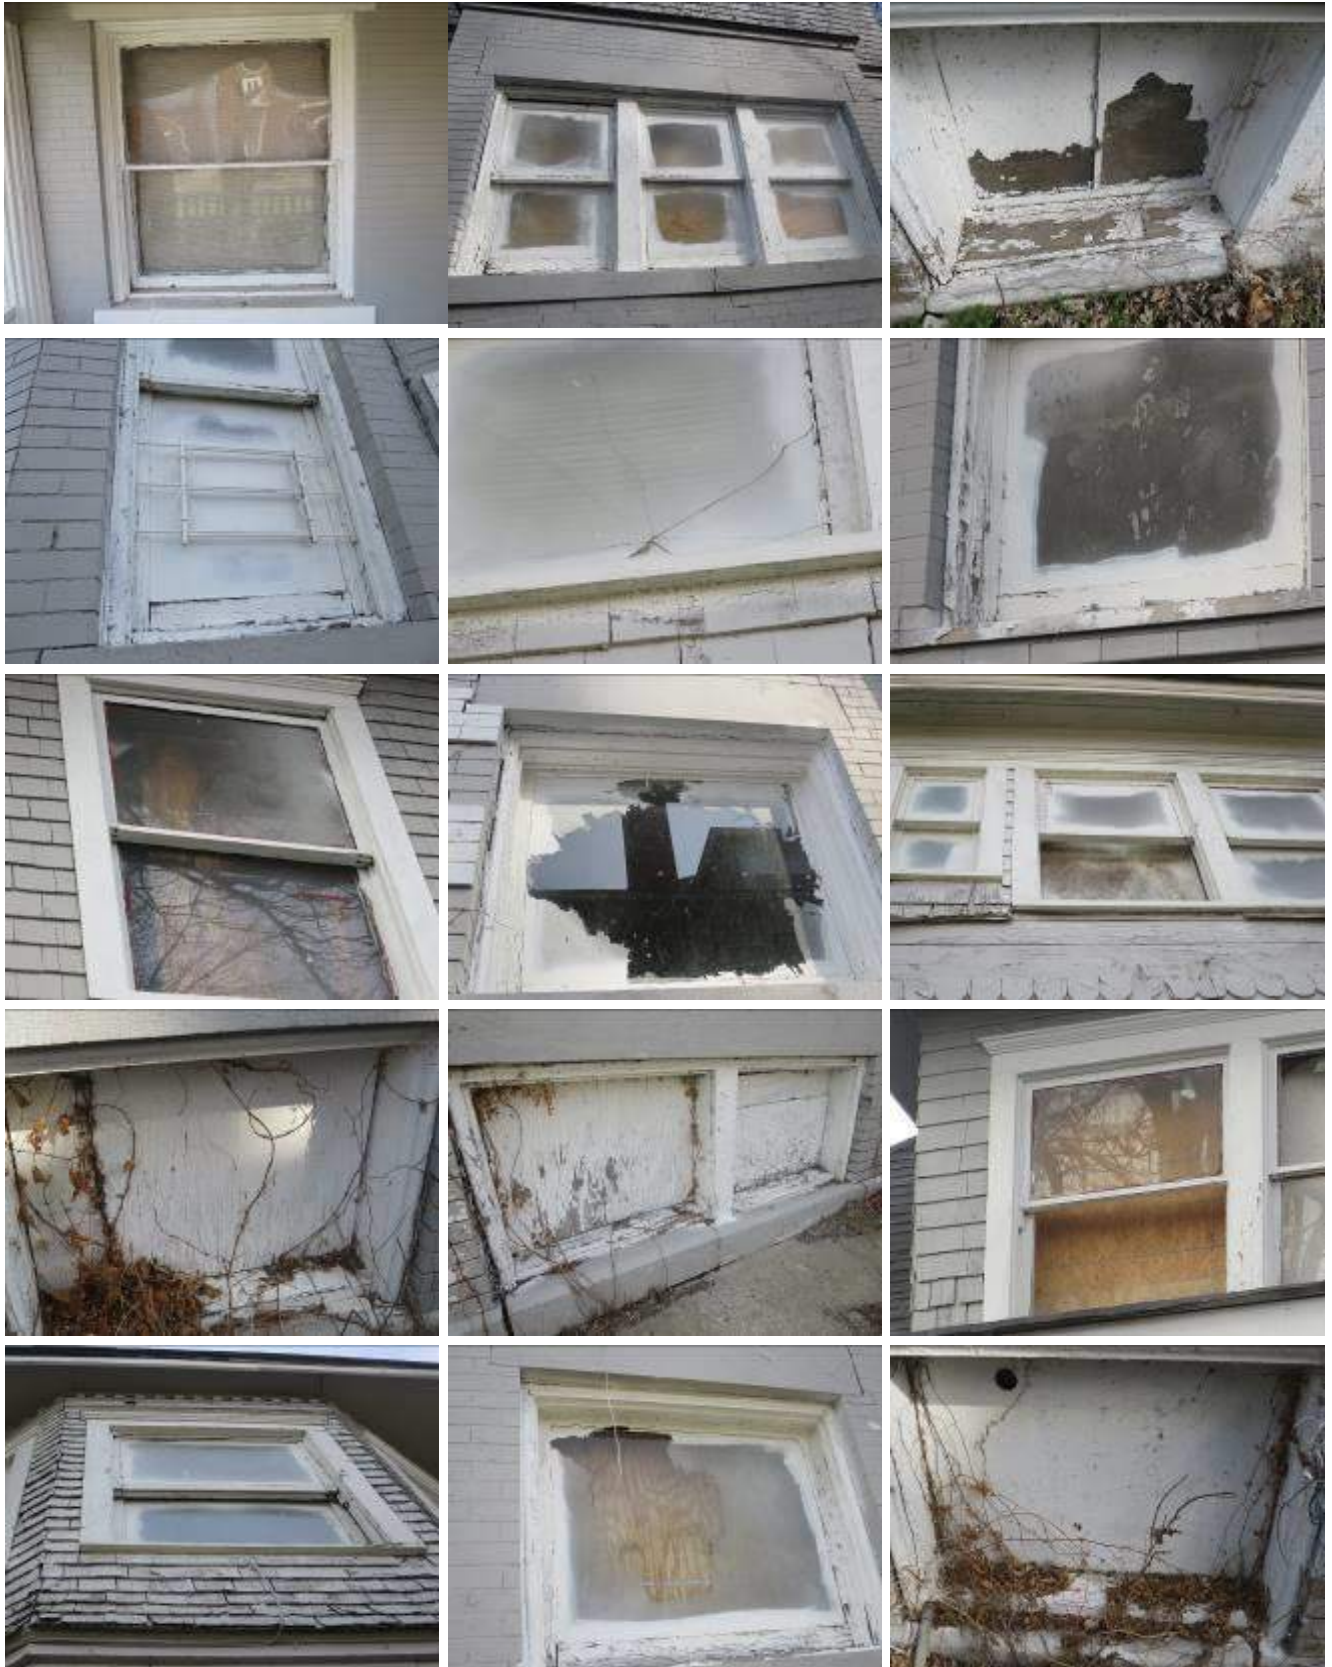
**WINDOW DETERIORATION – 2651 VICTOR STREET**

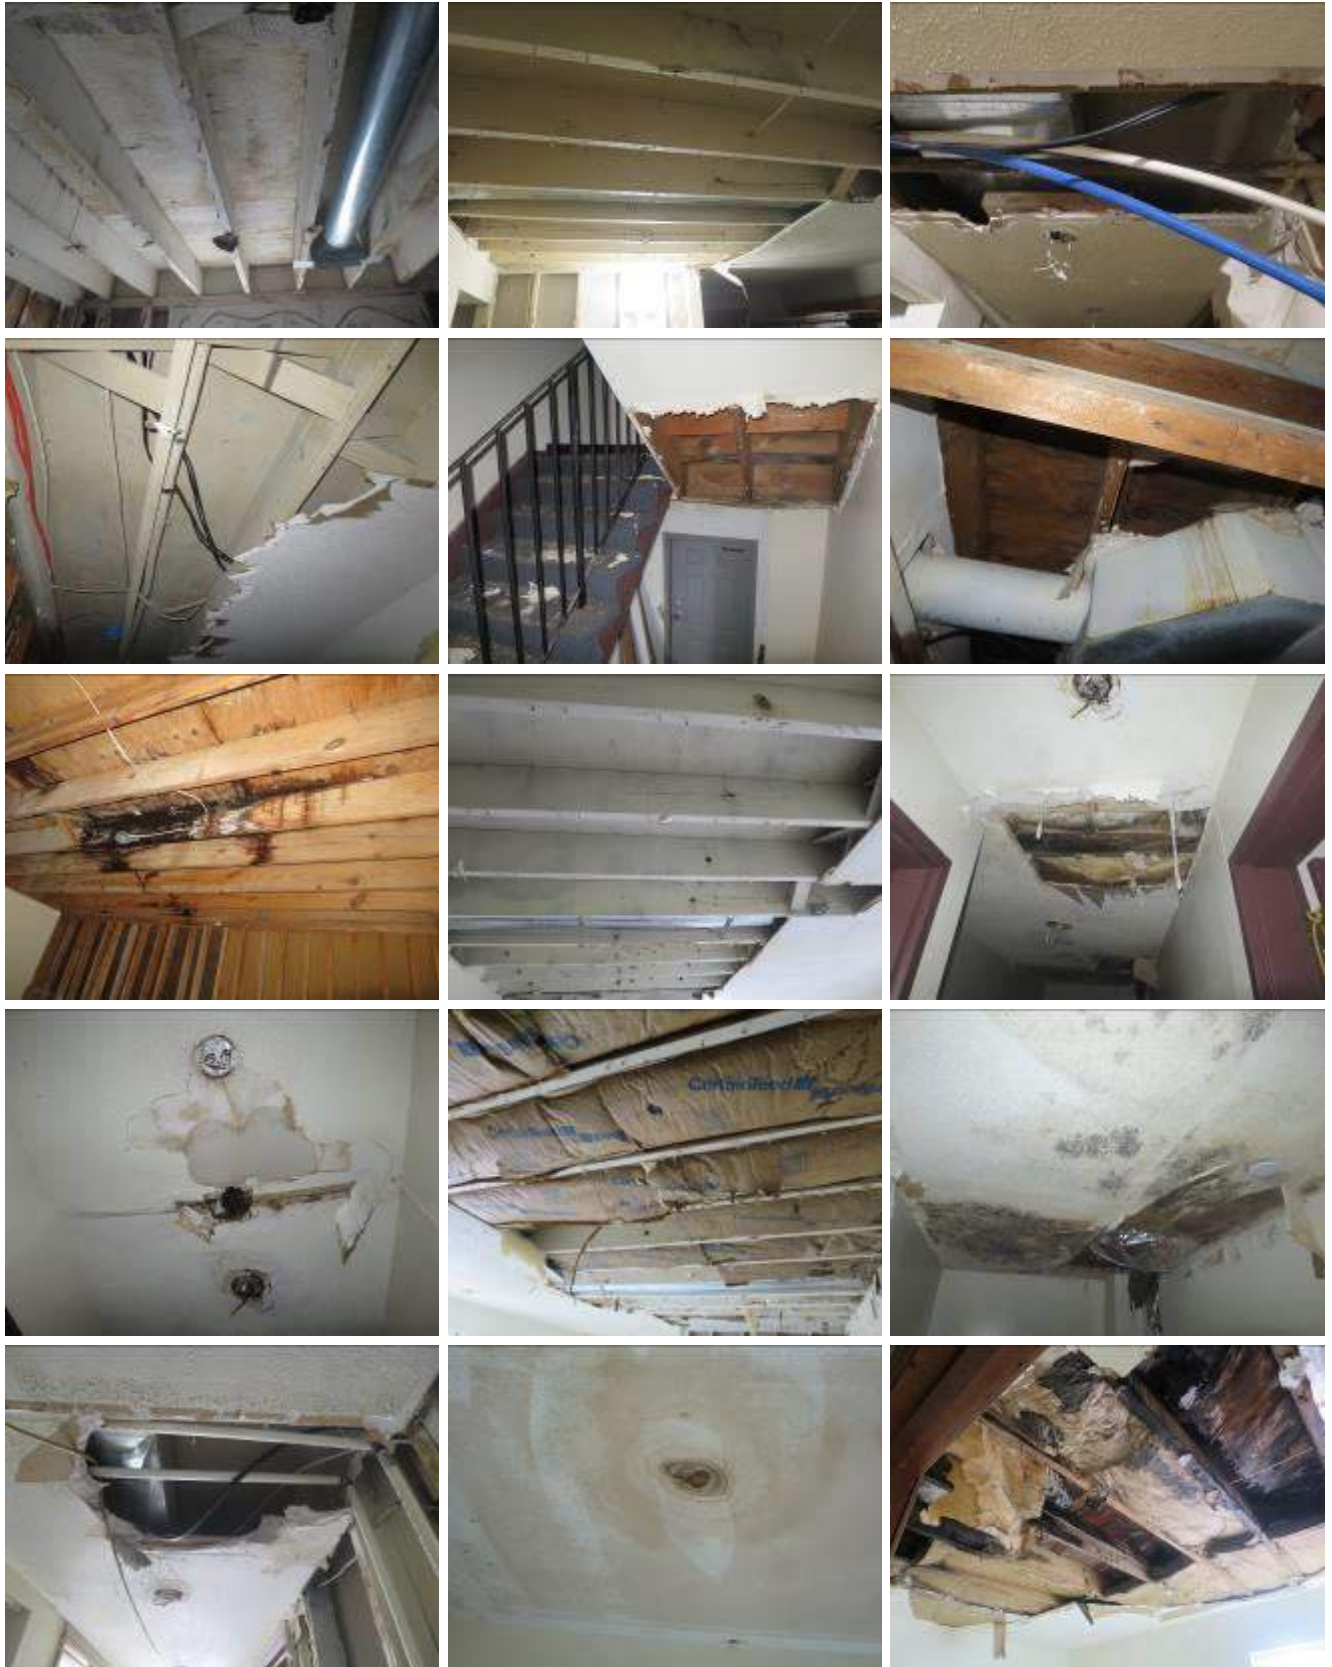
**CEILING DETERIORATION – 2644 E 29<sup>TH</sup> STREET**

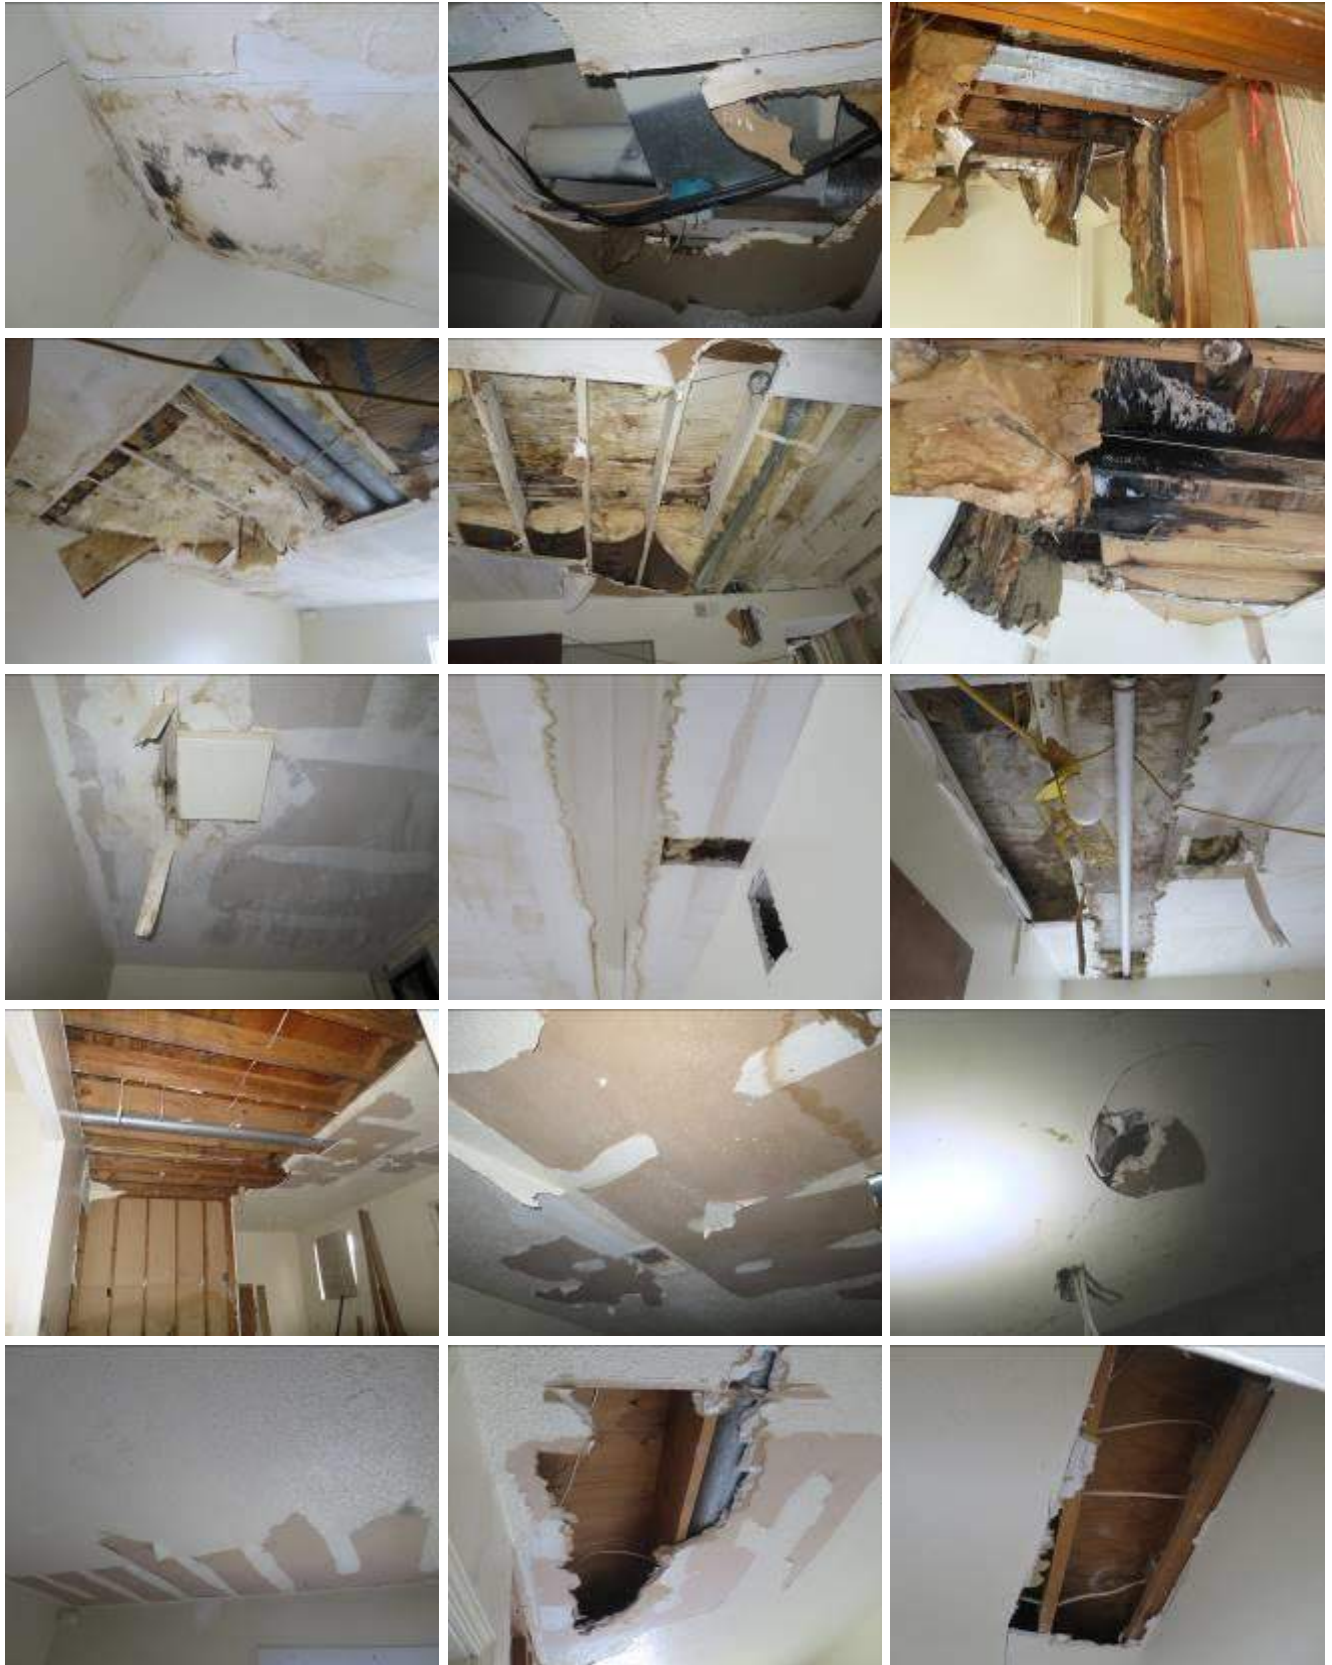
**CEILING DETERIORATION – 2644 E 29<sup>TH</sup> STREET**

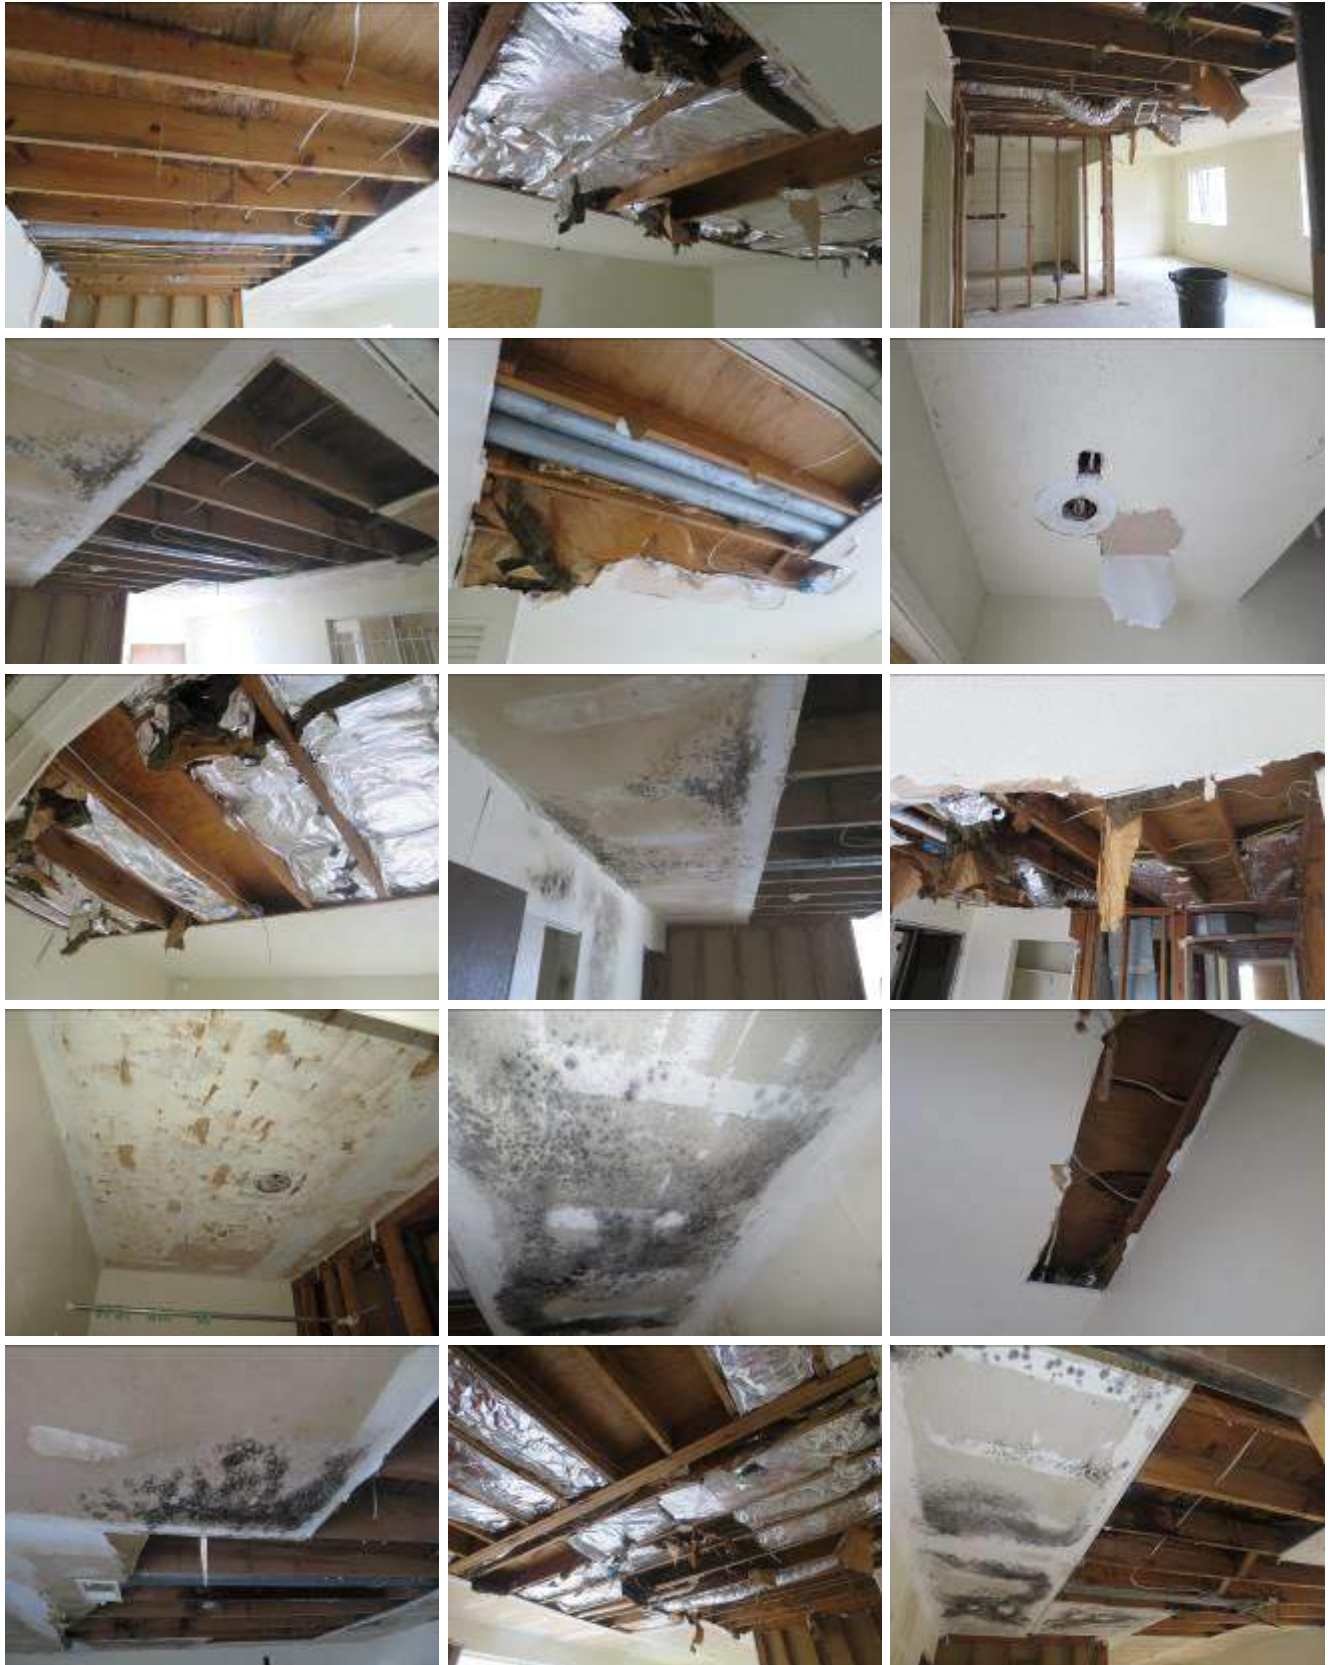
**CEILING DETERIORATION – 2644 E 29<sup>TH</sup> STREET**

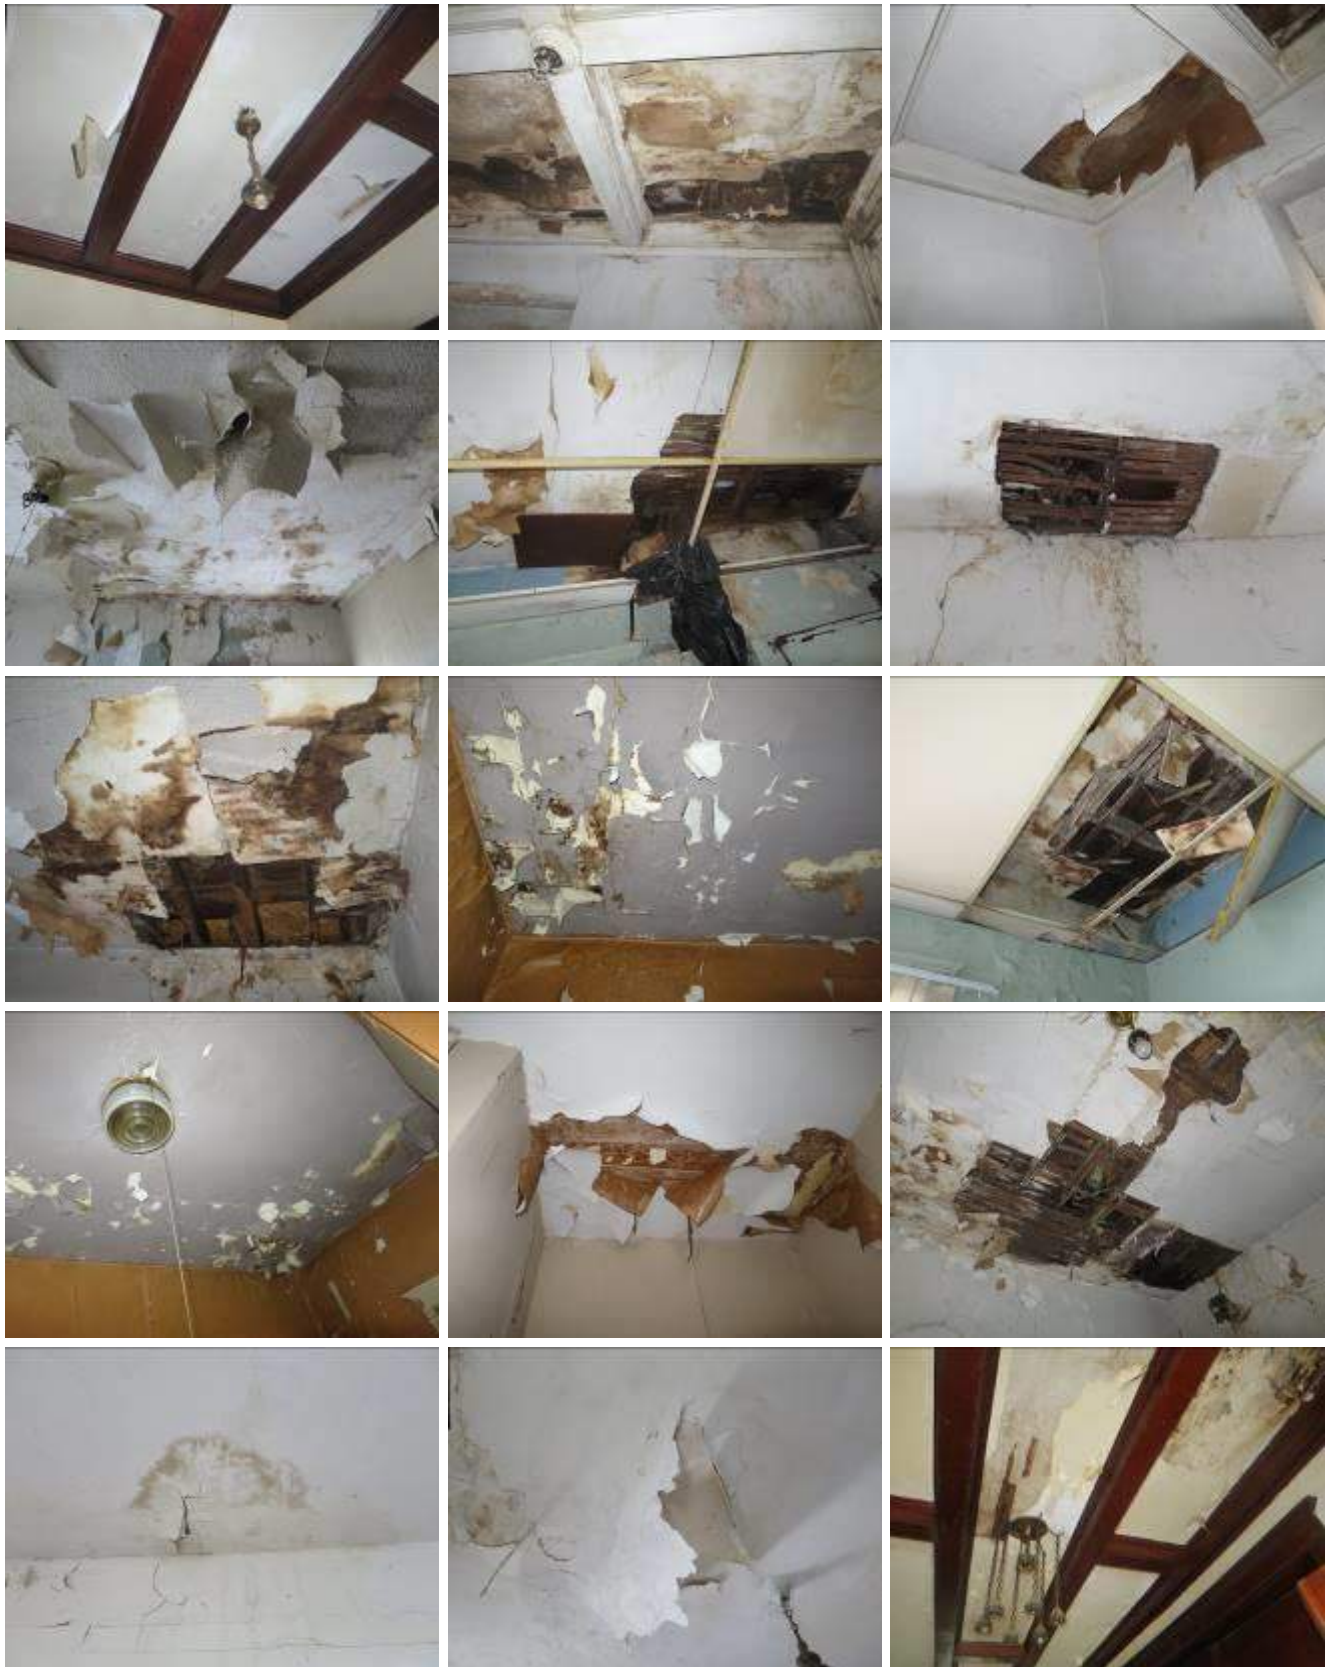
**CEILING DETERIORATION – 2651 VICTOR STREET**

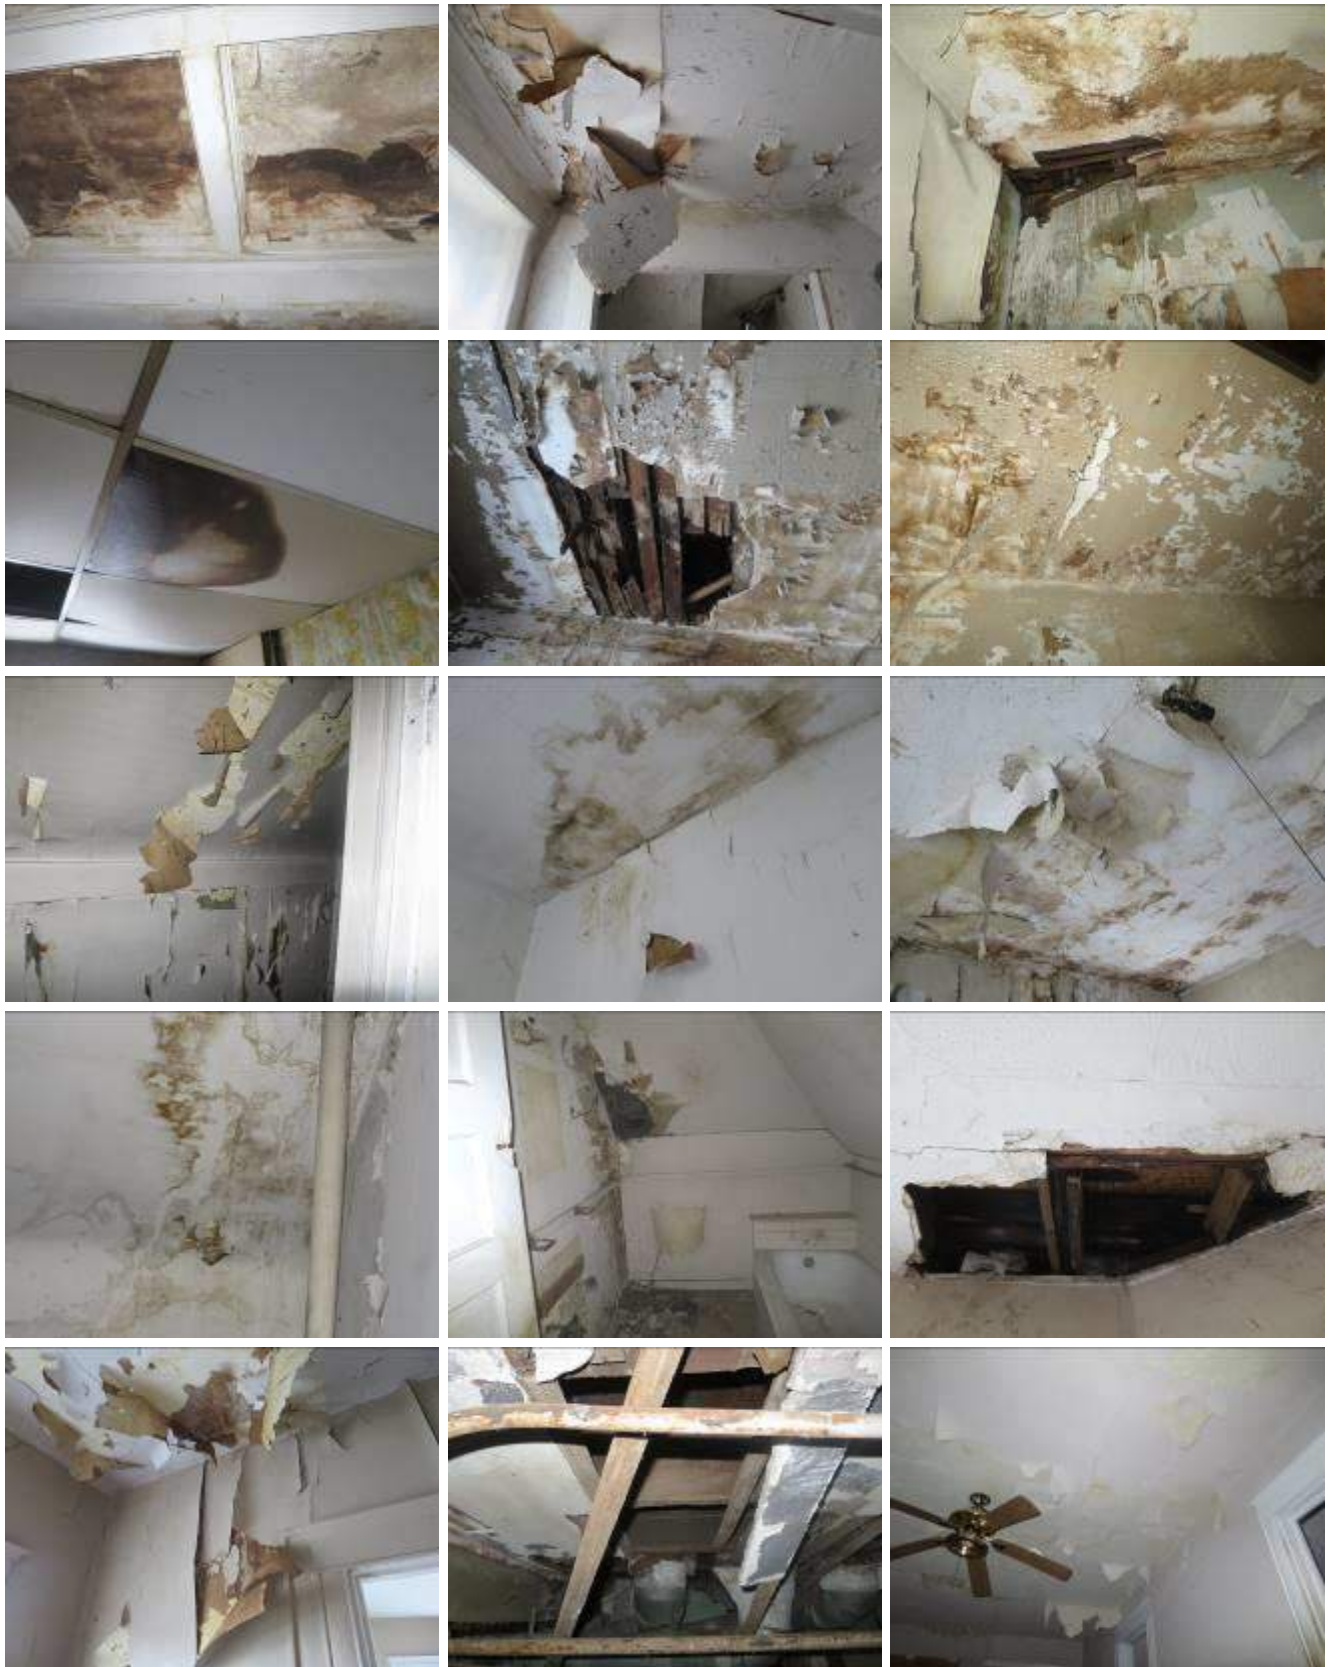
**CEILING DETERIORATION – 2651 VICTOR STREET**

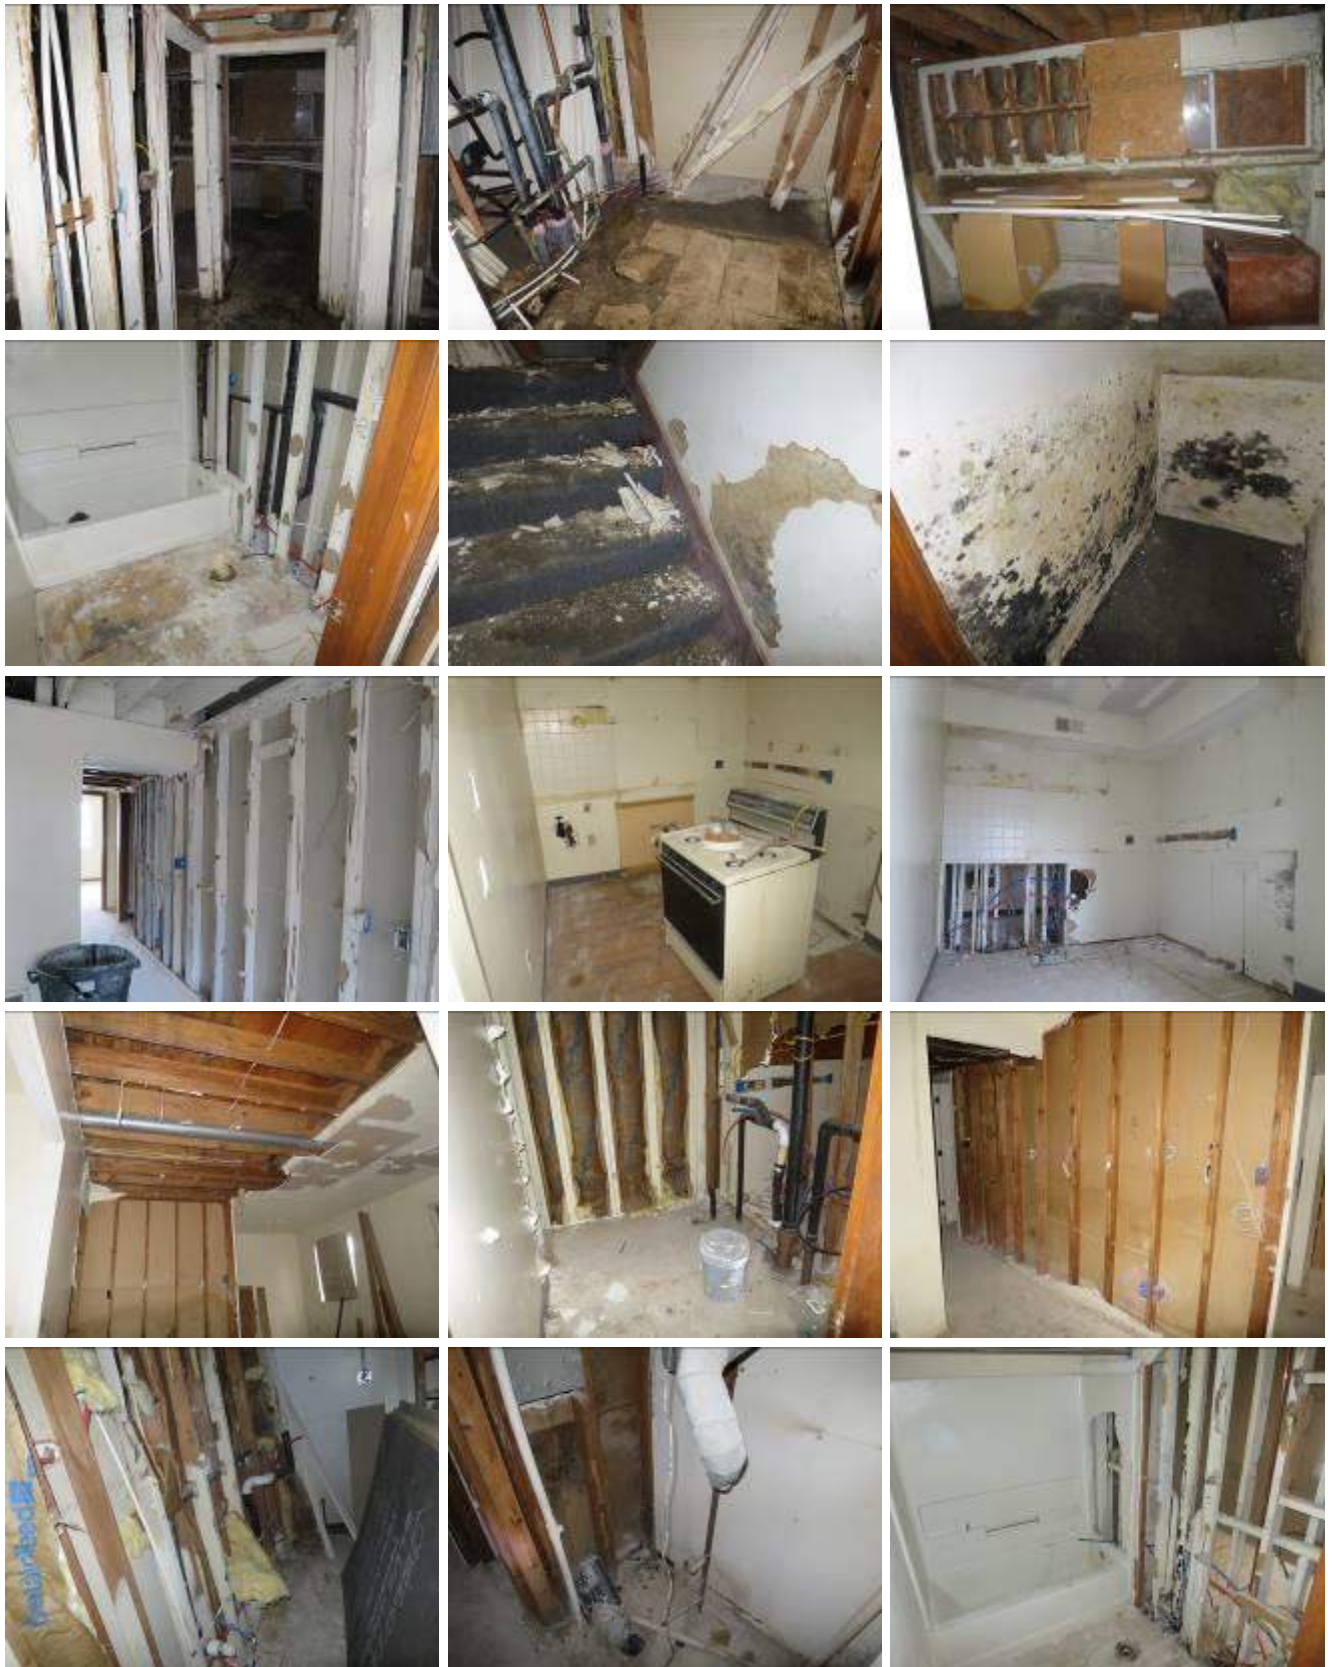
INTERIOR WALL DETERIORATION – 2644 E 29<sup>TH</sup> STREET
