# QUALIFICATION ANALYSIS

29<sup>TH</sup> & BENTON PIEA STUDY AREA  
NWQ BENTON BOULEVARD & E 29<sup>TH</sup> STREET  
KANSAS CITY, MISSOURI

APRIL 3, 2020  
RECORD NO. 1730

BELKE APPRAISAL & CONSULTING SERVICES, INC.

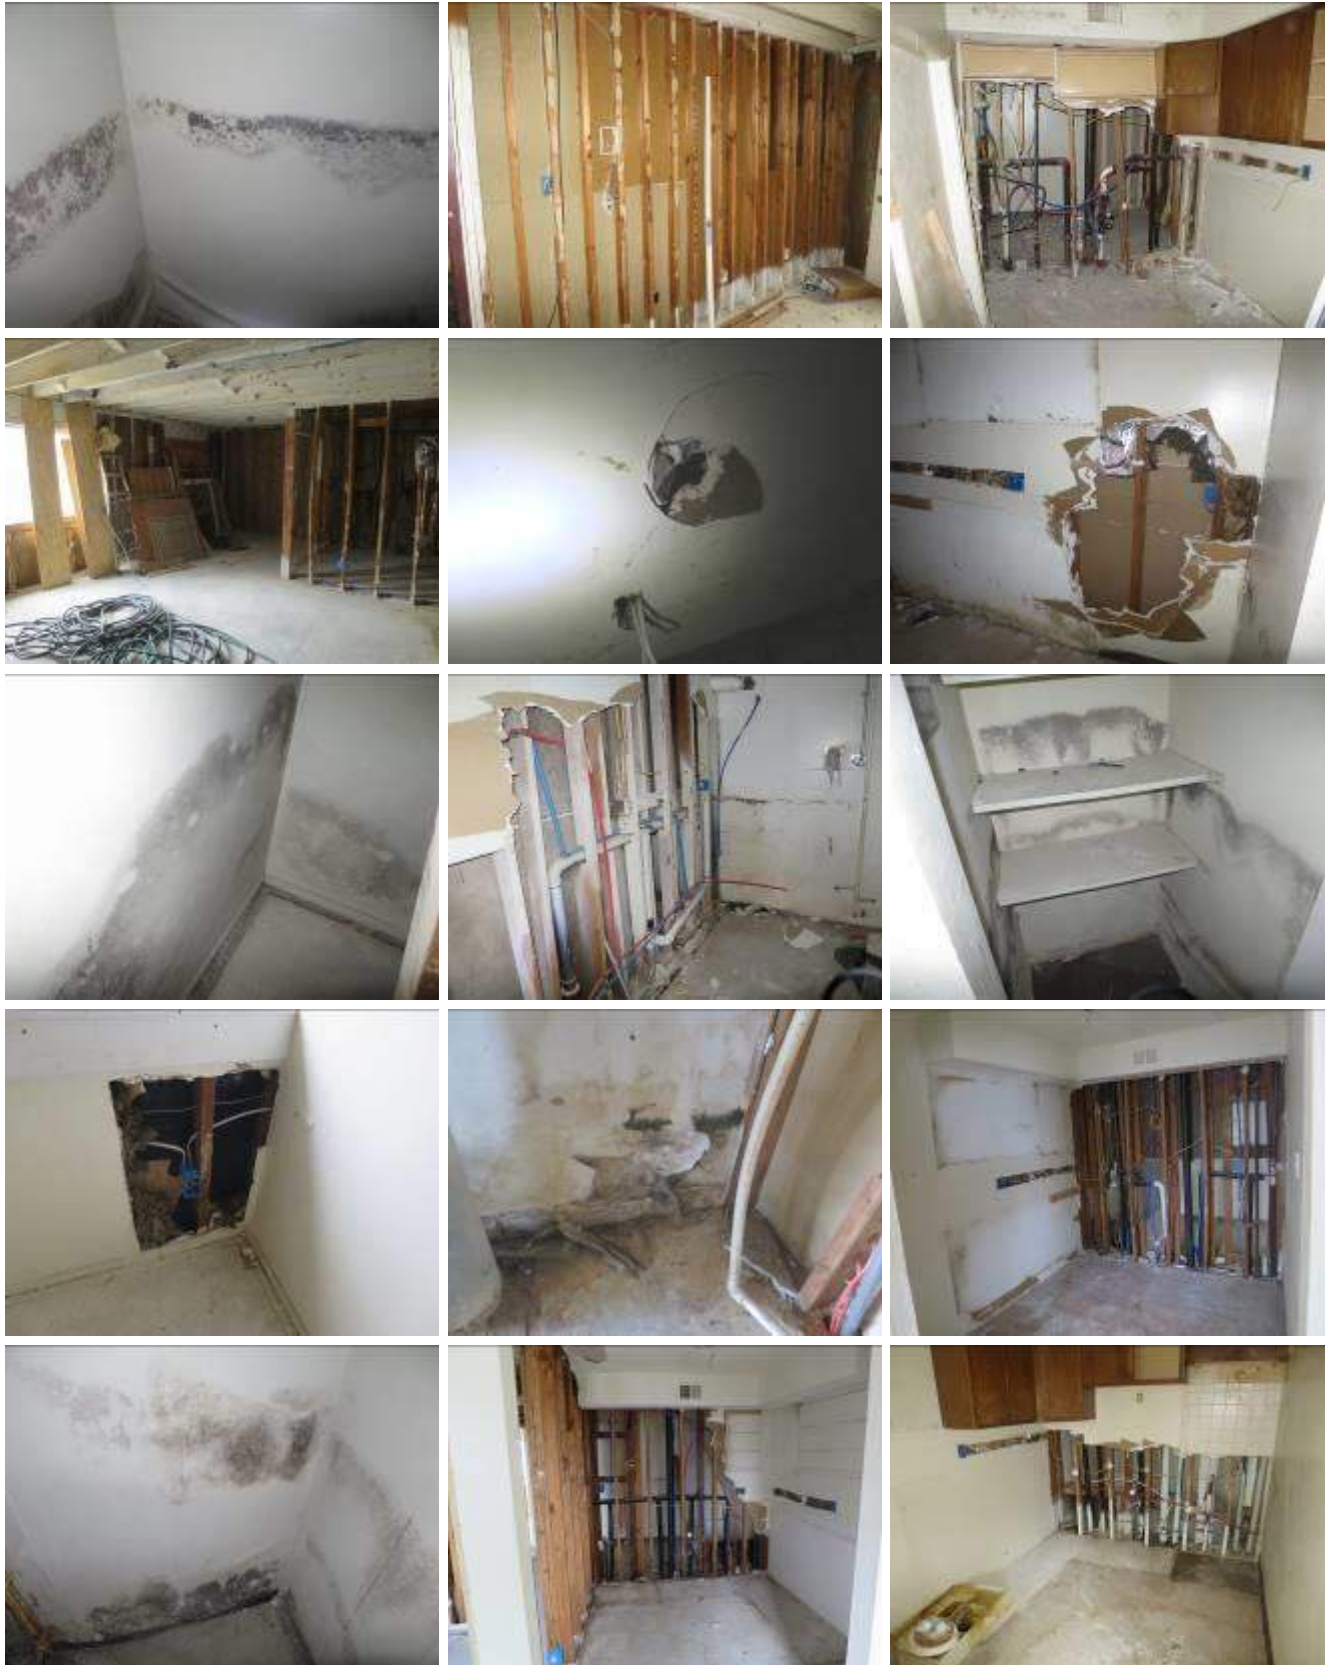
**INTERIOR WALL DETERIORATION – 2644 E 29<sup>TH</sup> STREET**

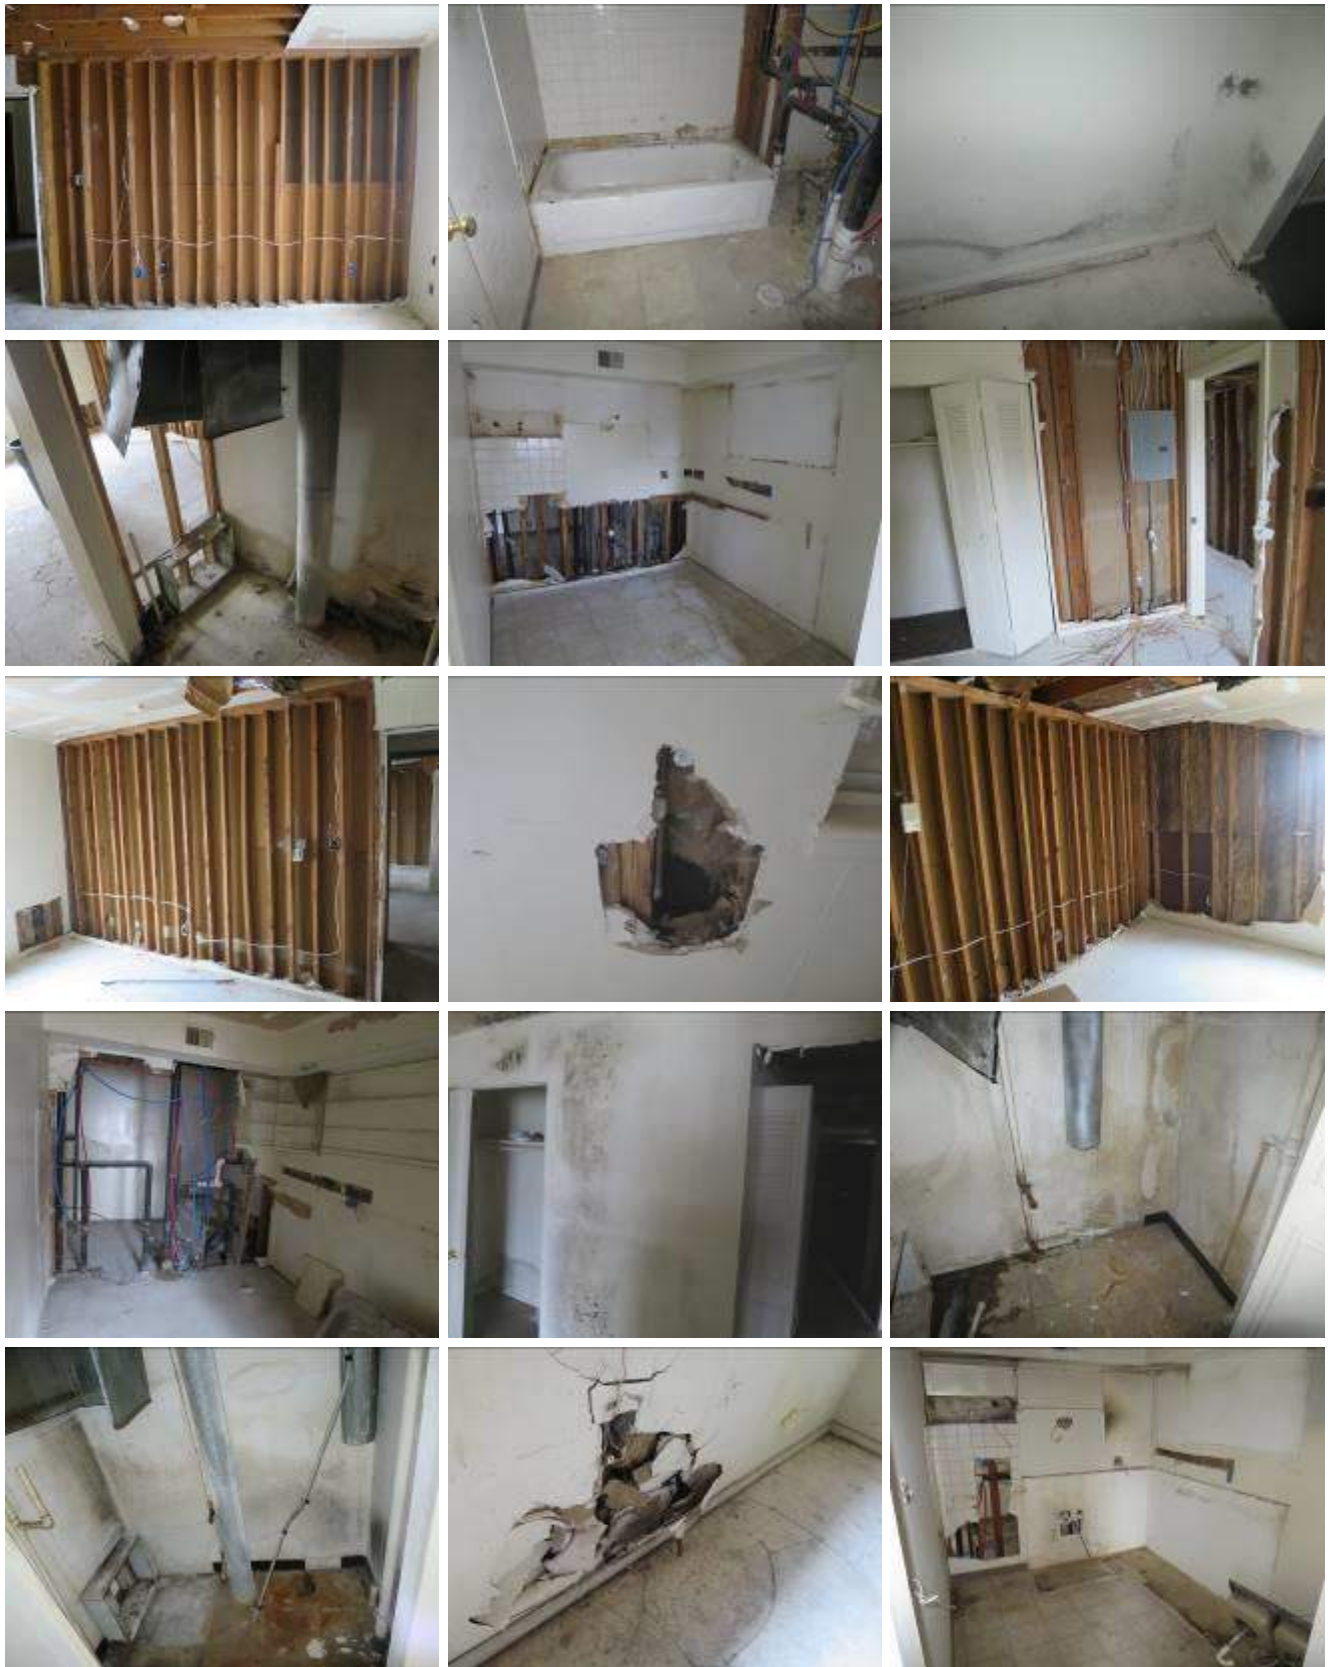
**INTERIOR WALL DETERIORATION – 2644 E 29<sup>TH</sup> STREET**

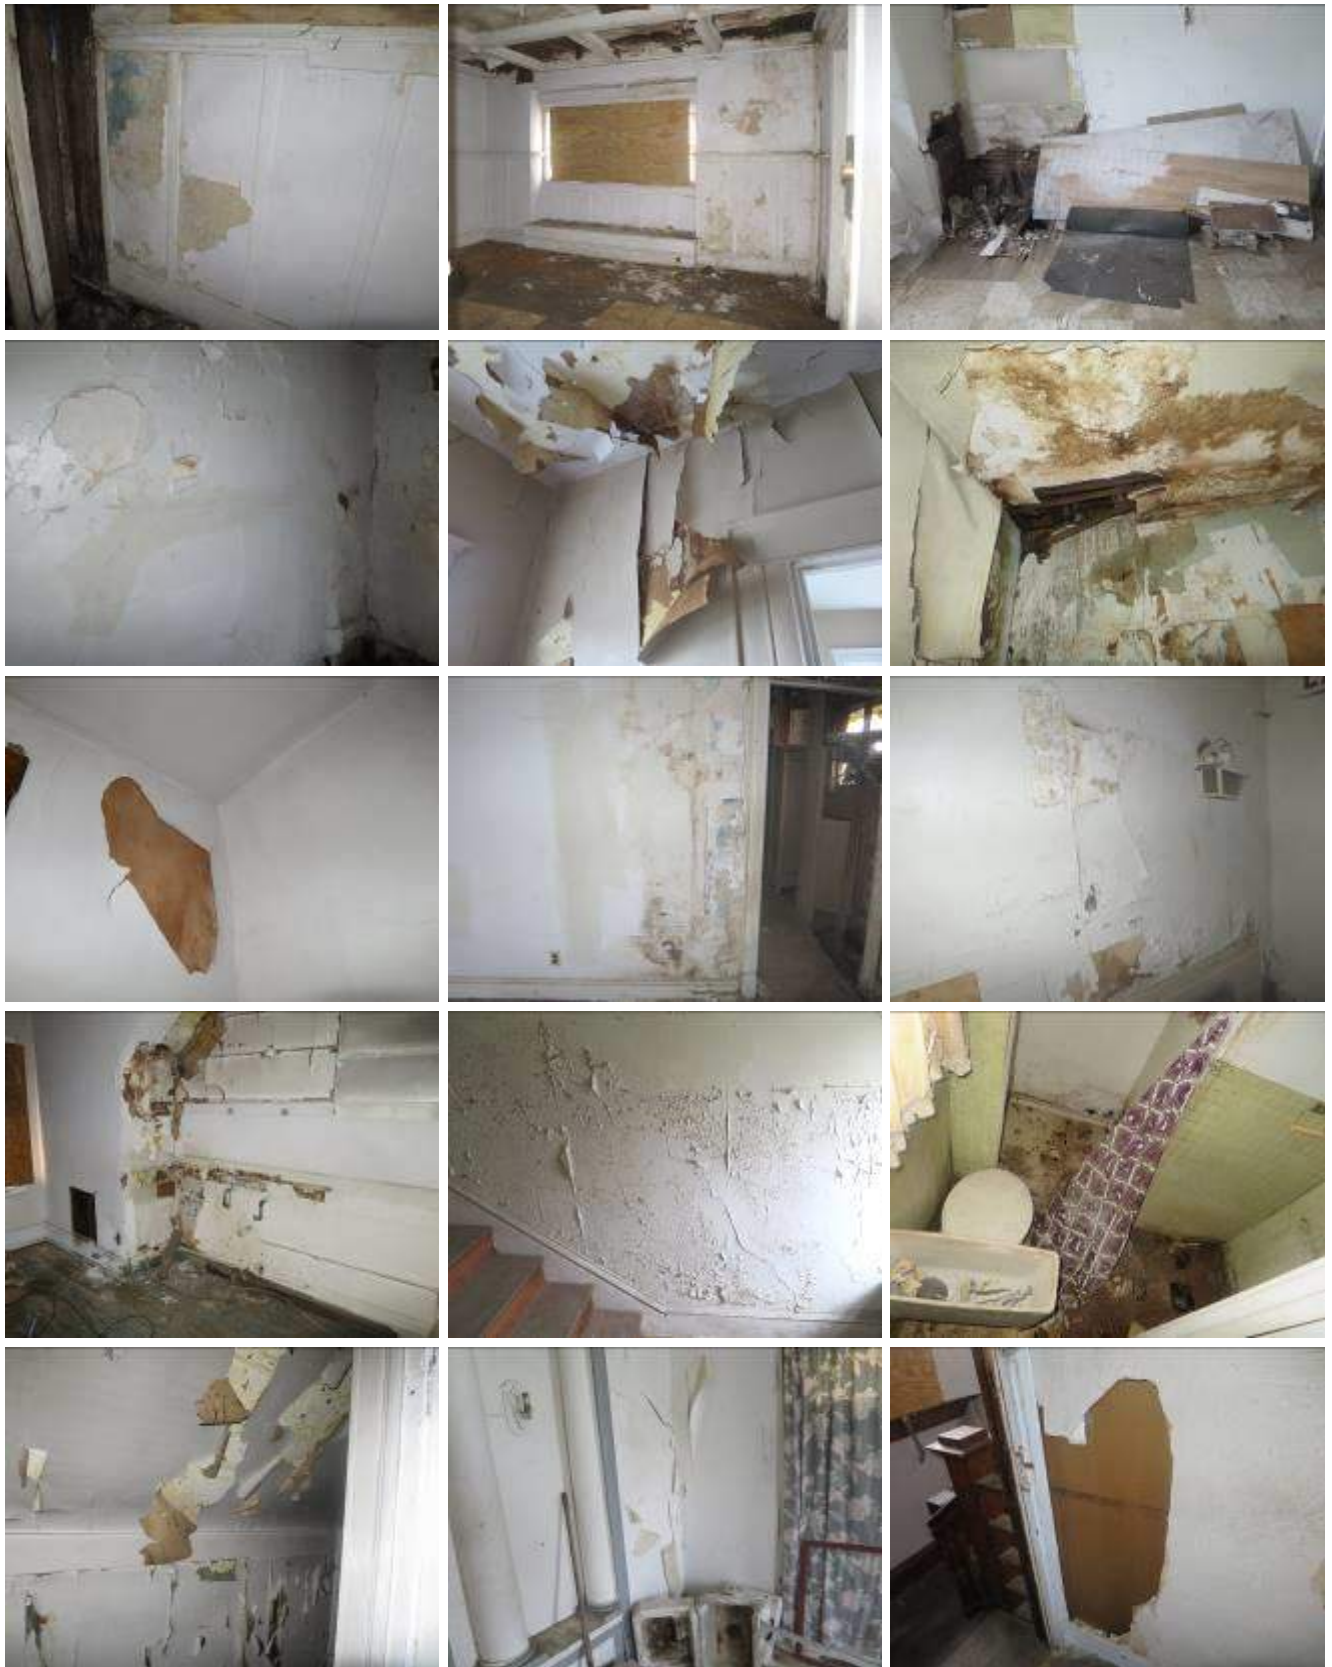
**INTERIOR WALL DETERIORATION – 2651 VICTOR STREET**

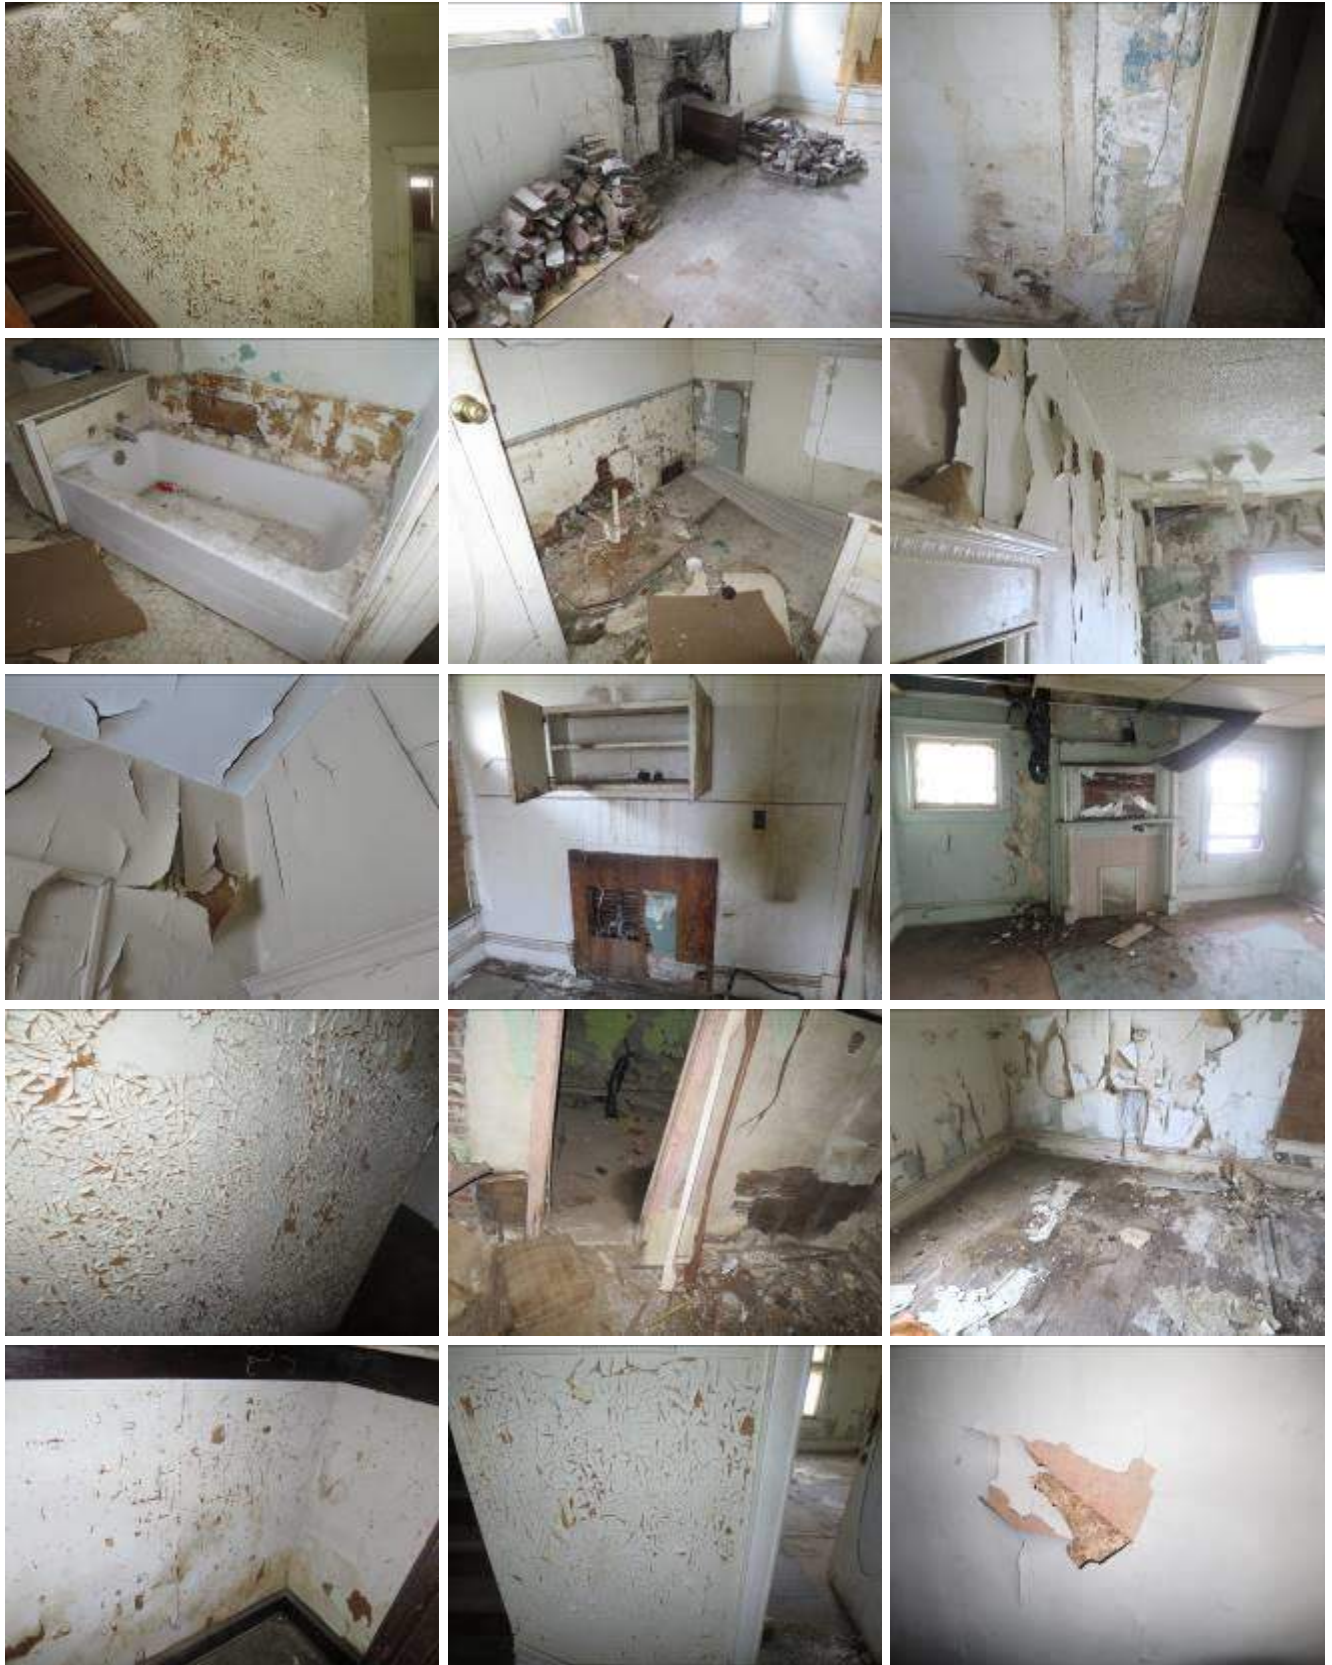
INTERIOR WALL DETERIORATION – 2651 VICTOR STREET

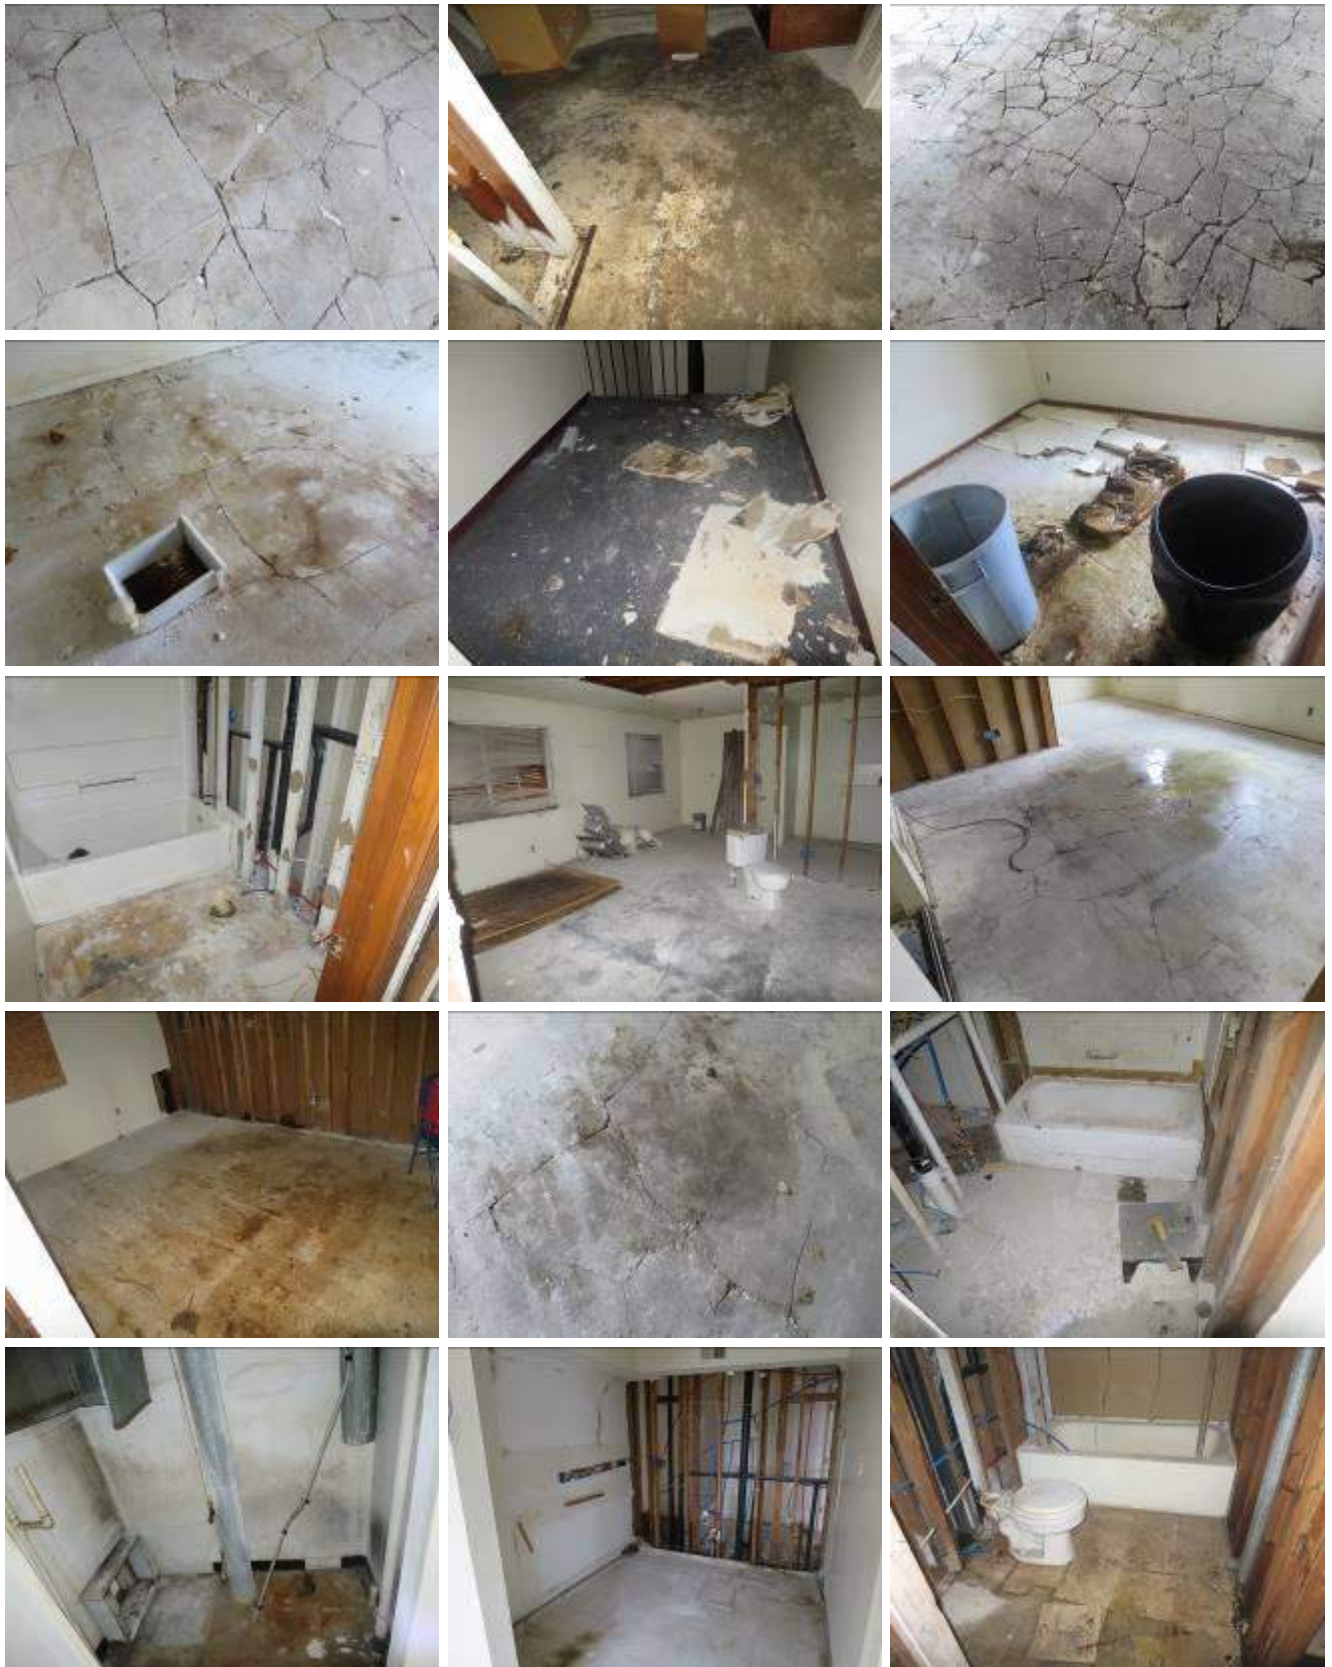
**FLOOR DETERIORATION – 2644 E 29<sup>TH</sup> STREET**

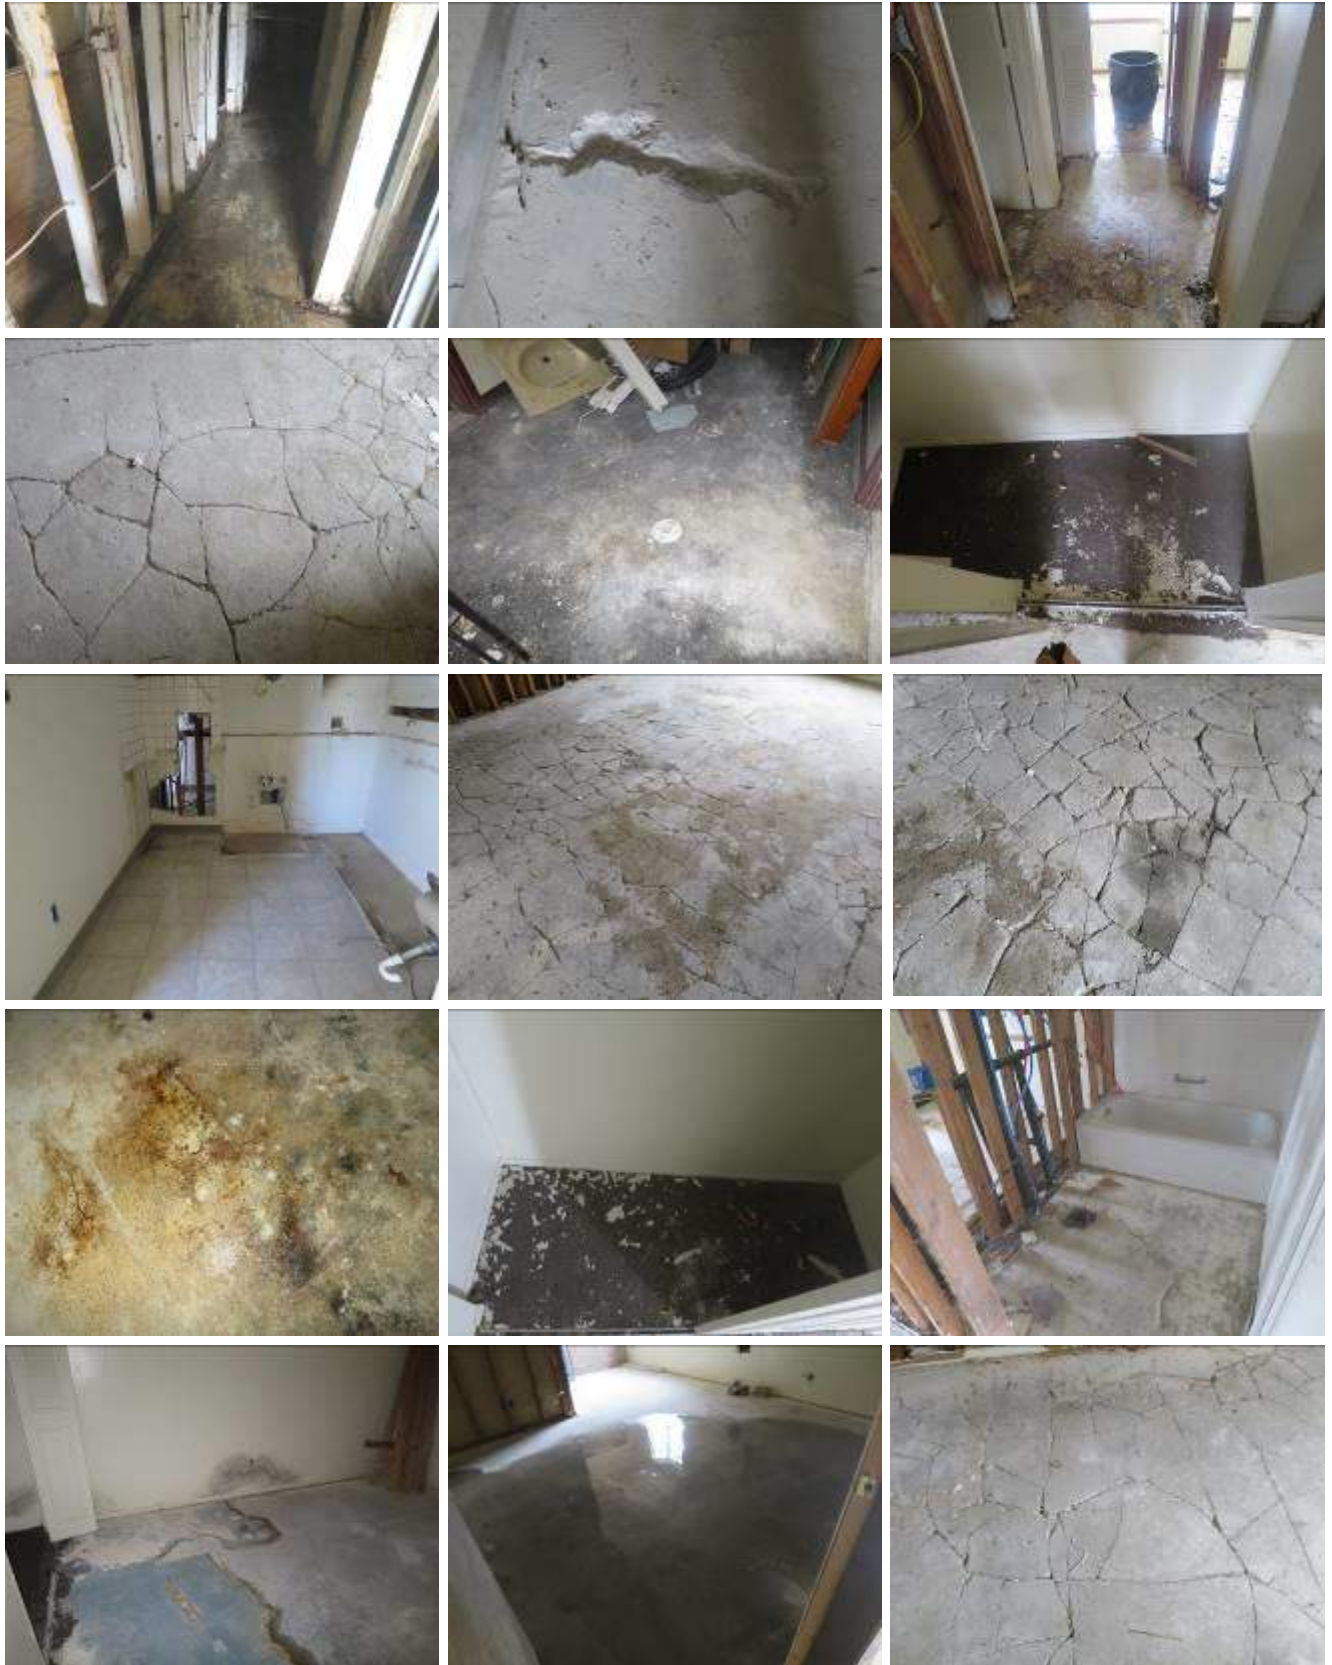
**FLOOR DETERIORATION – 2644 E 29<sup>TH</sup> STREET**

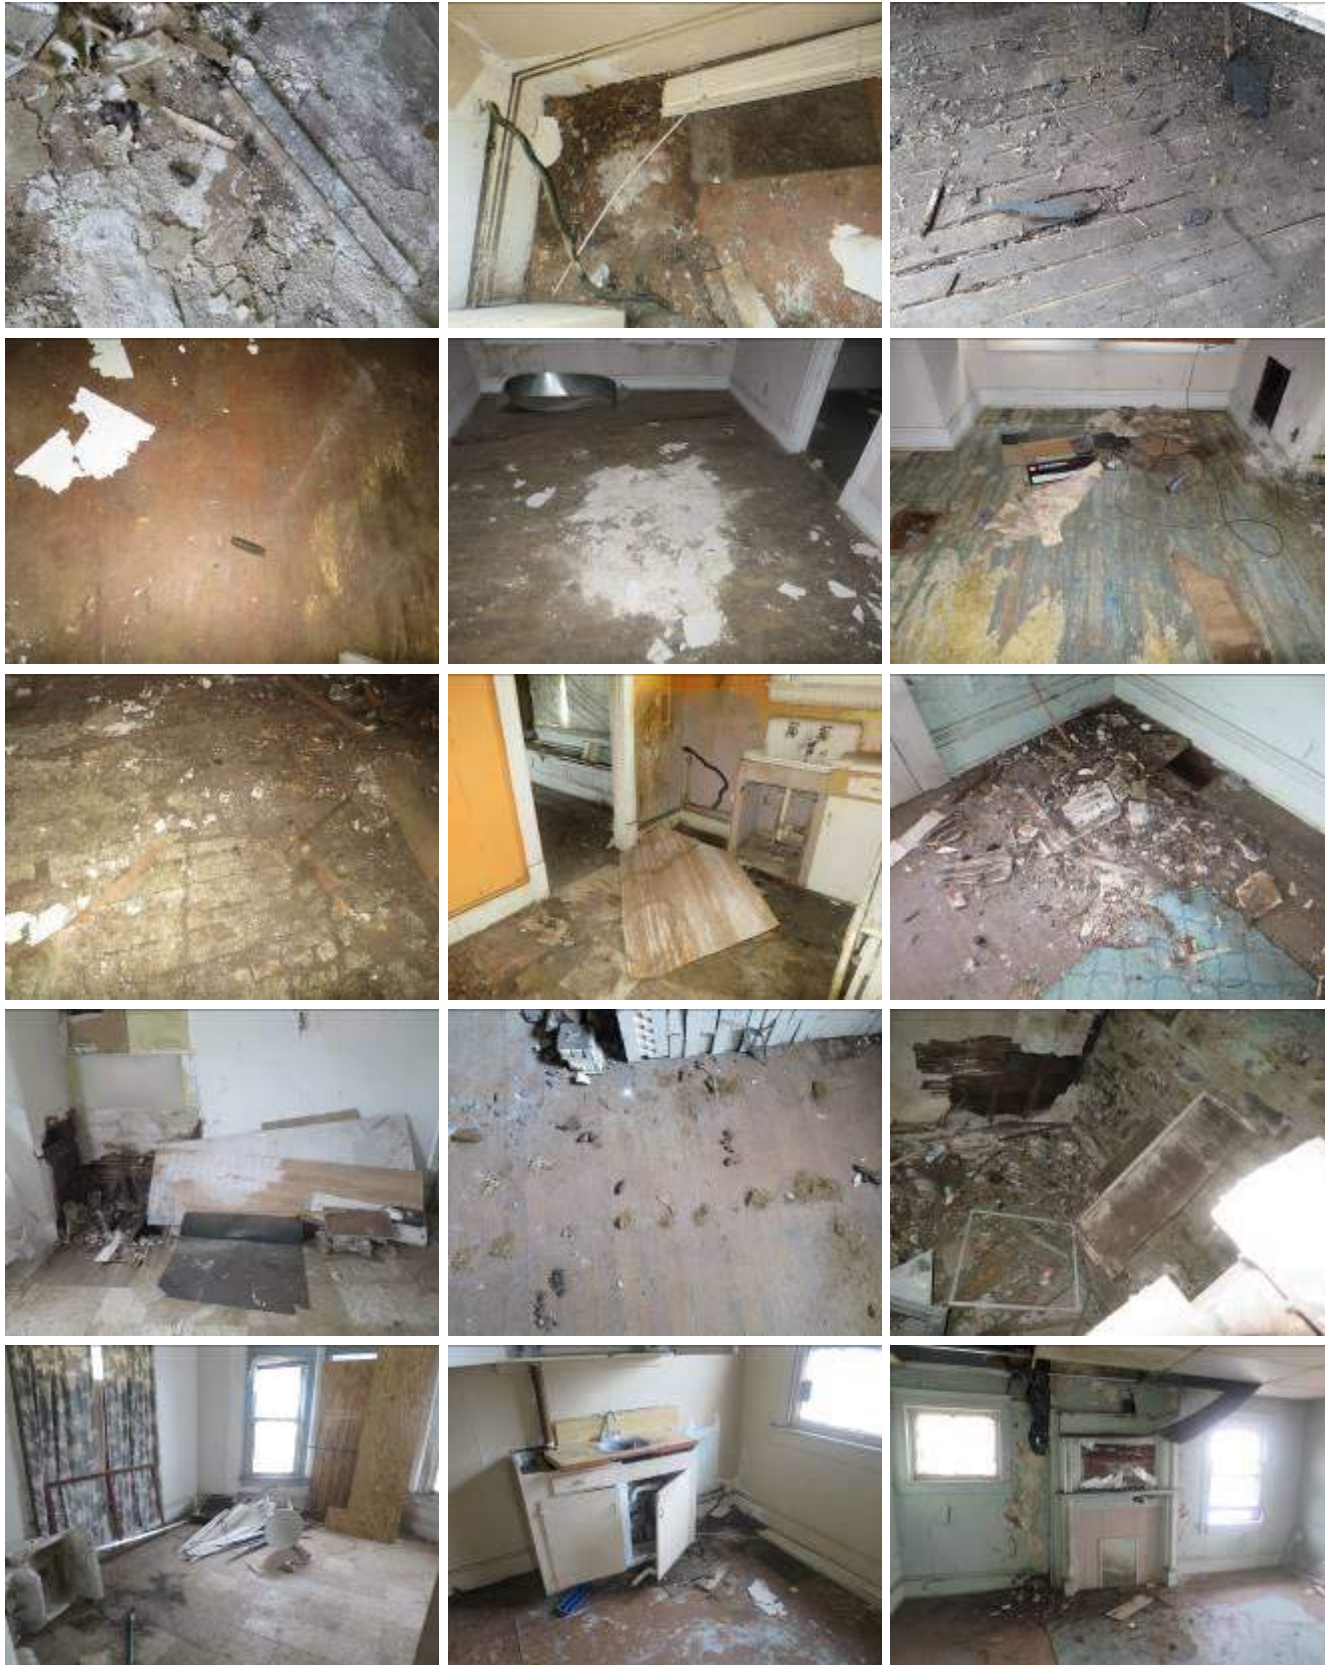
FLOOR DETERIORATION – 2651 VICTOR STREET

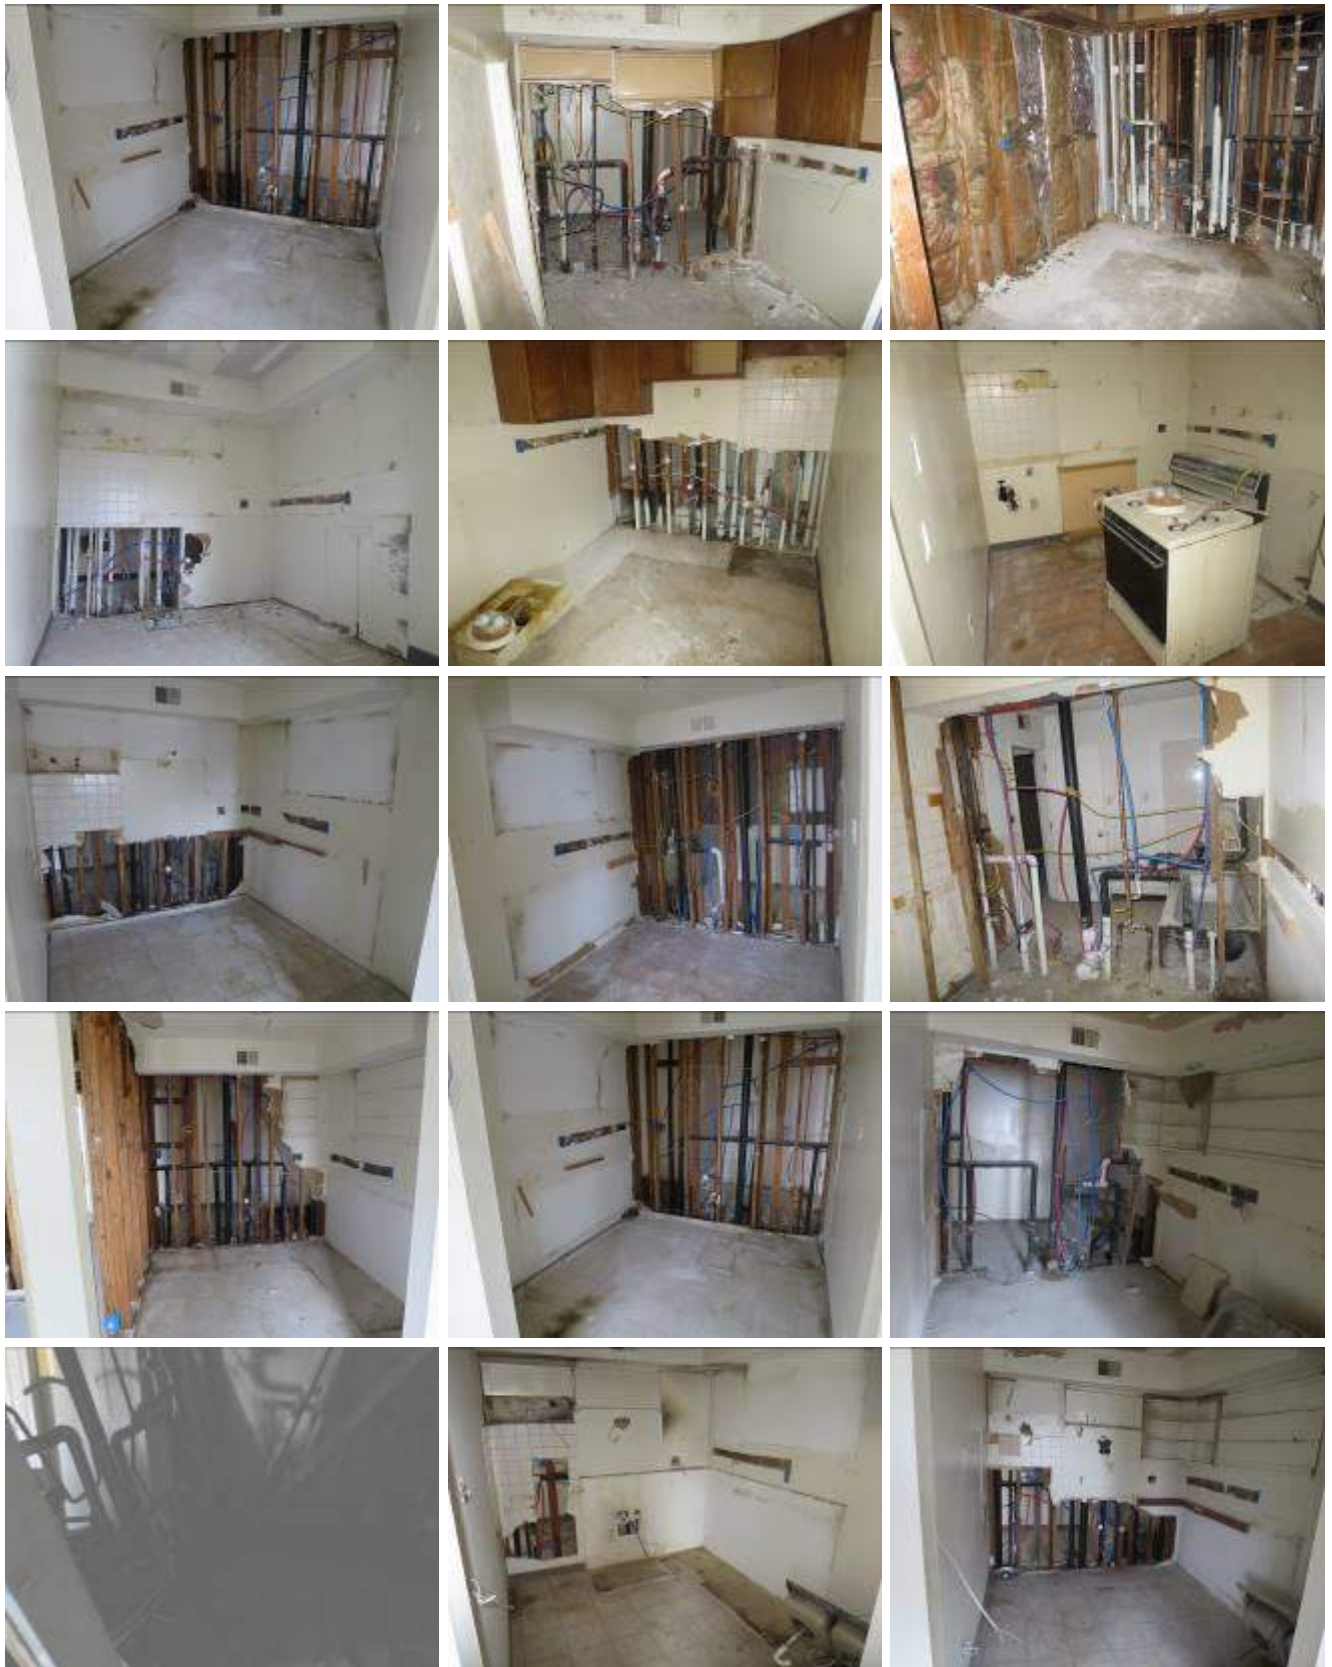
**KITCHEN DETERIORATION – 2644 E 29<sup>TH</sup> STREET**

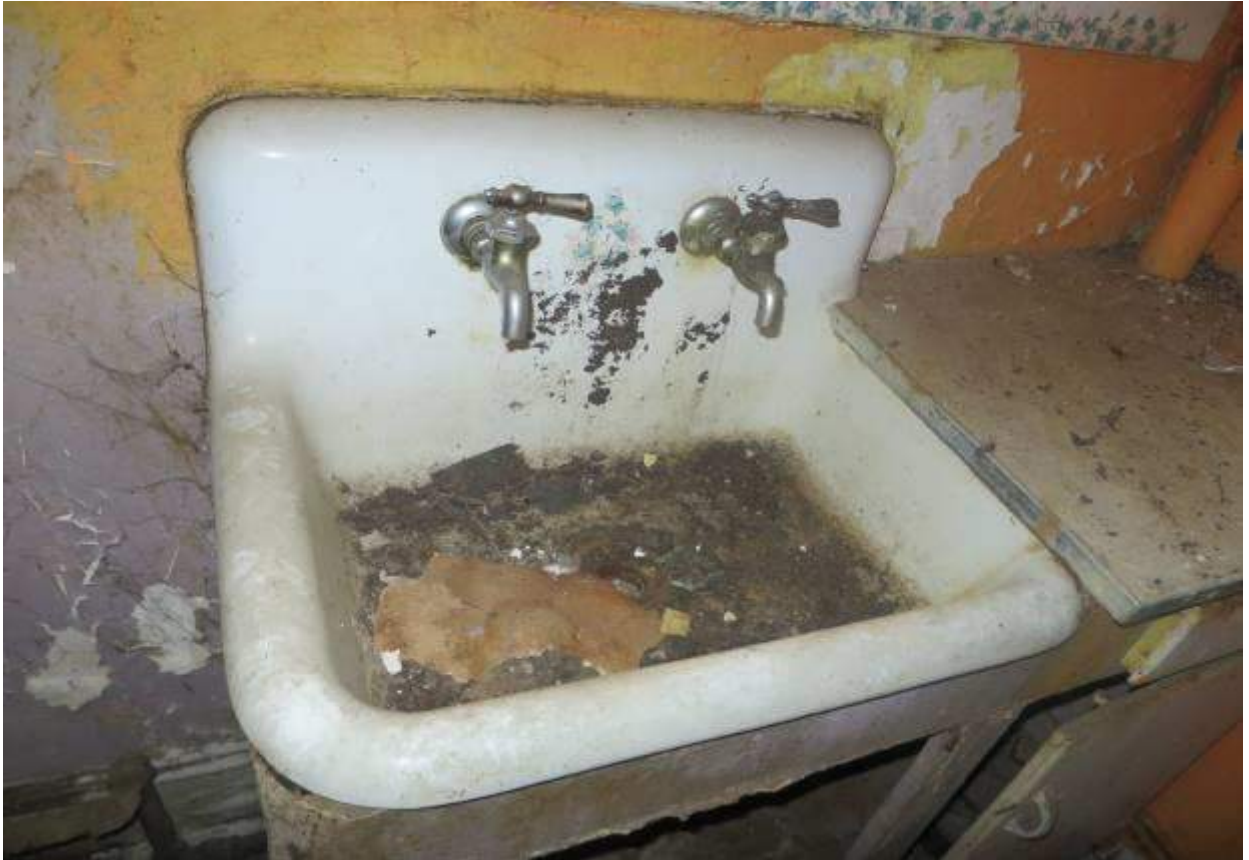
**KITCHEN DETERIORATION – 2651 VICTOR STREET**

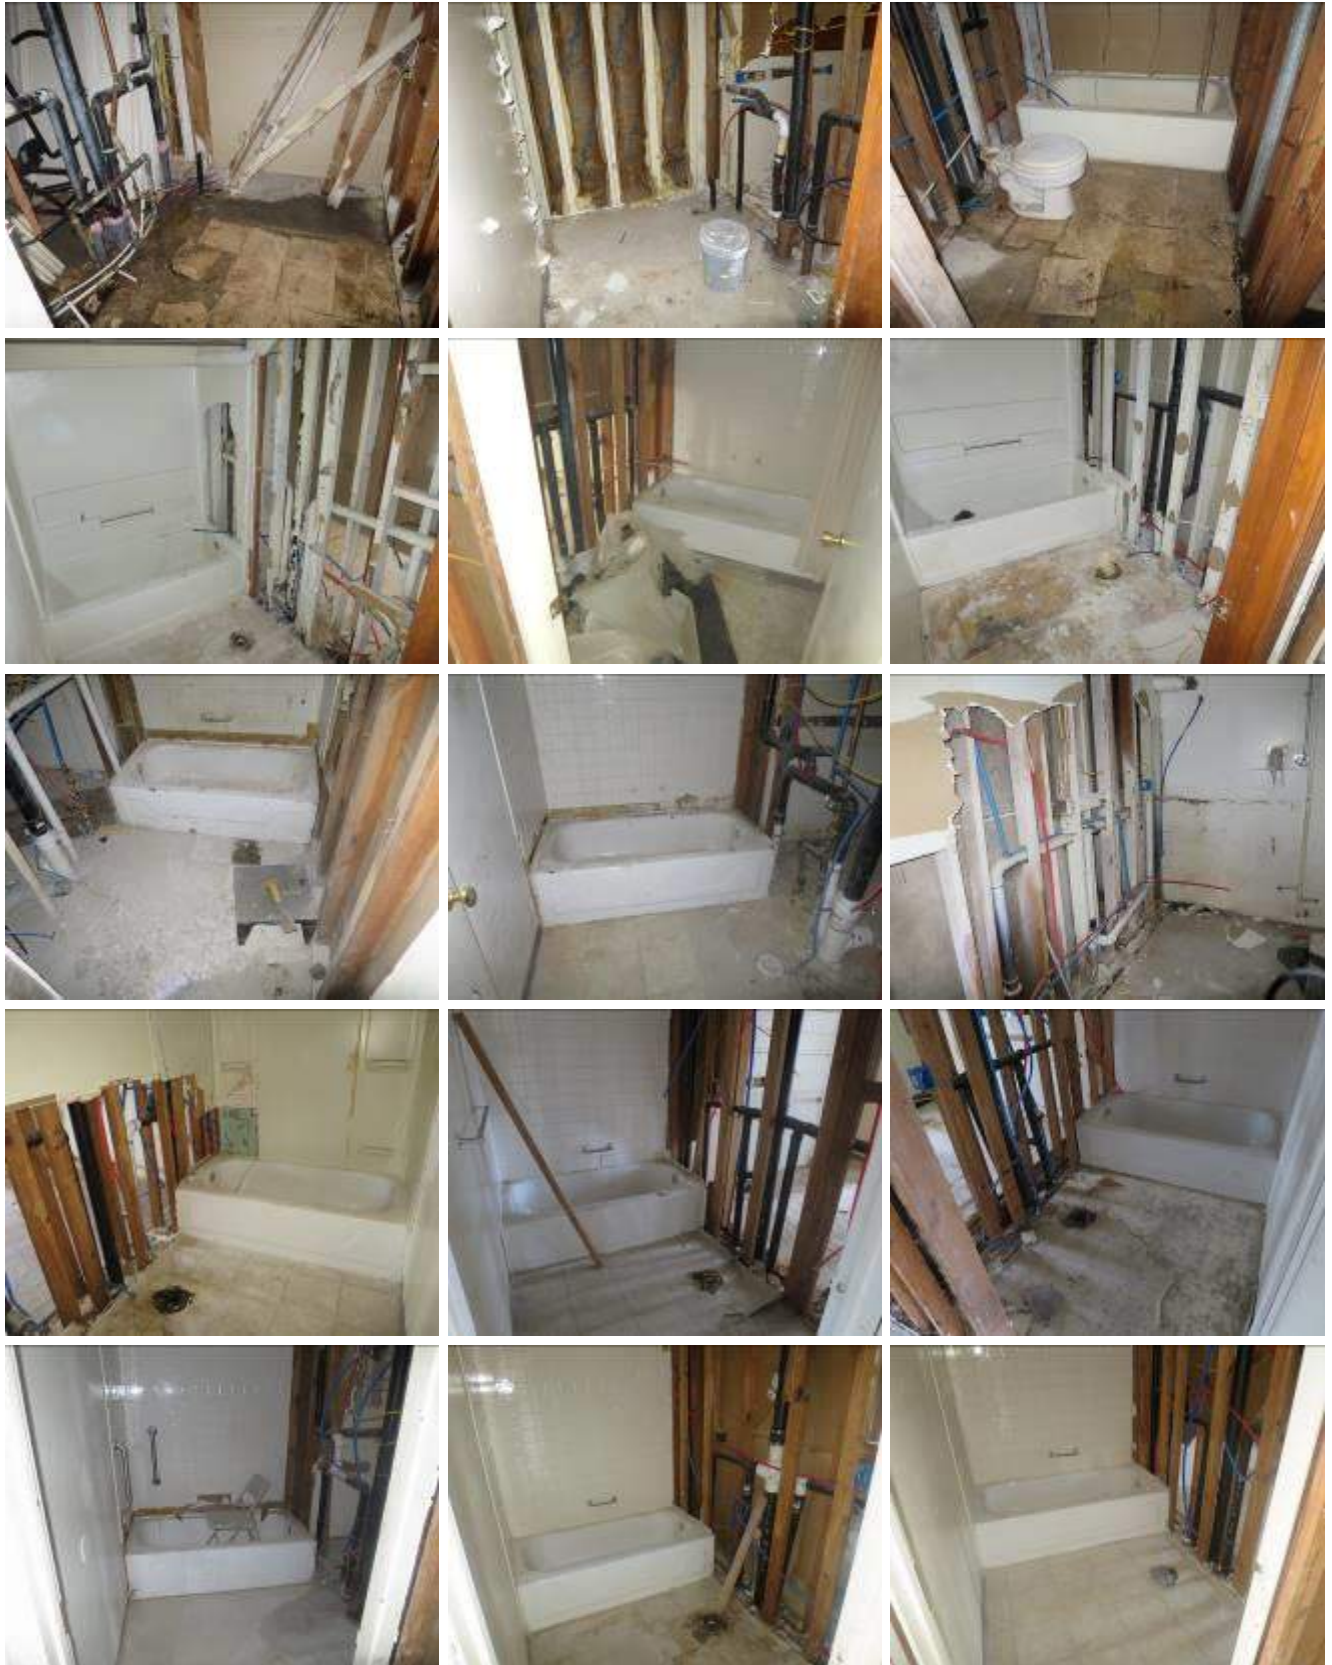
RESTROOM DETERIORATION – 2644 E 29<sup>TH</sup> STREET
