# QUALIFICATION ANALYSIS

29<sup>TH</sup> & BENTON PIEA STUDY AREA  
NWQ BENTON BOULEVARD & E 29<sup>TH</sup> STREET  
KANSAS CITY, MISSOURI

APRIL 3, 2020  
RECORD NO. 1730

BELKE APPRAISAL & CONSULTING SERVICES, INC.

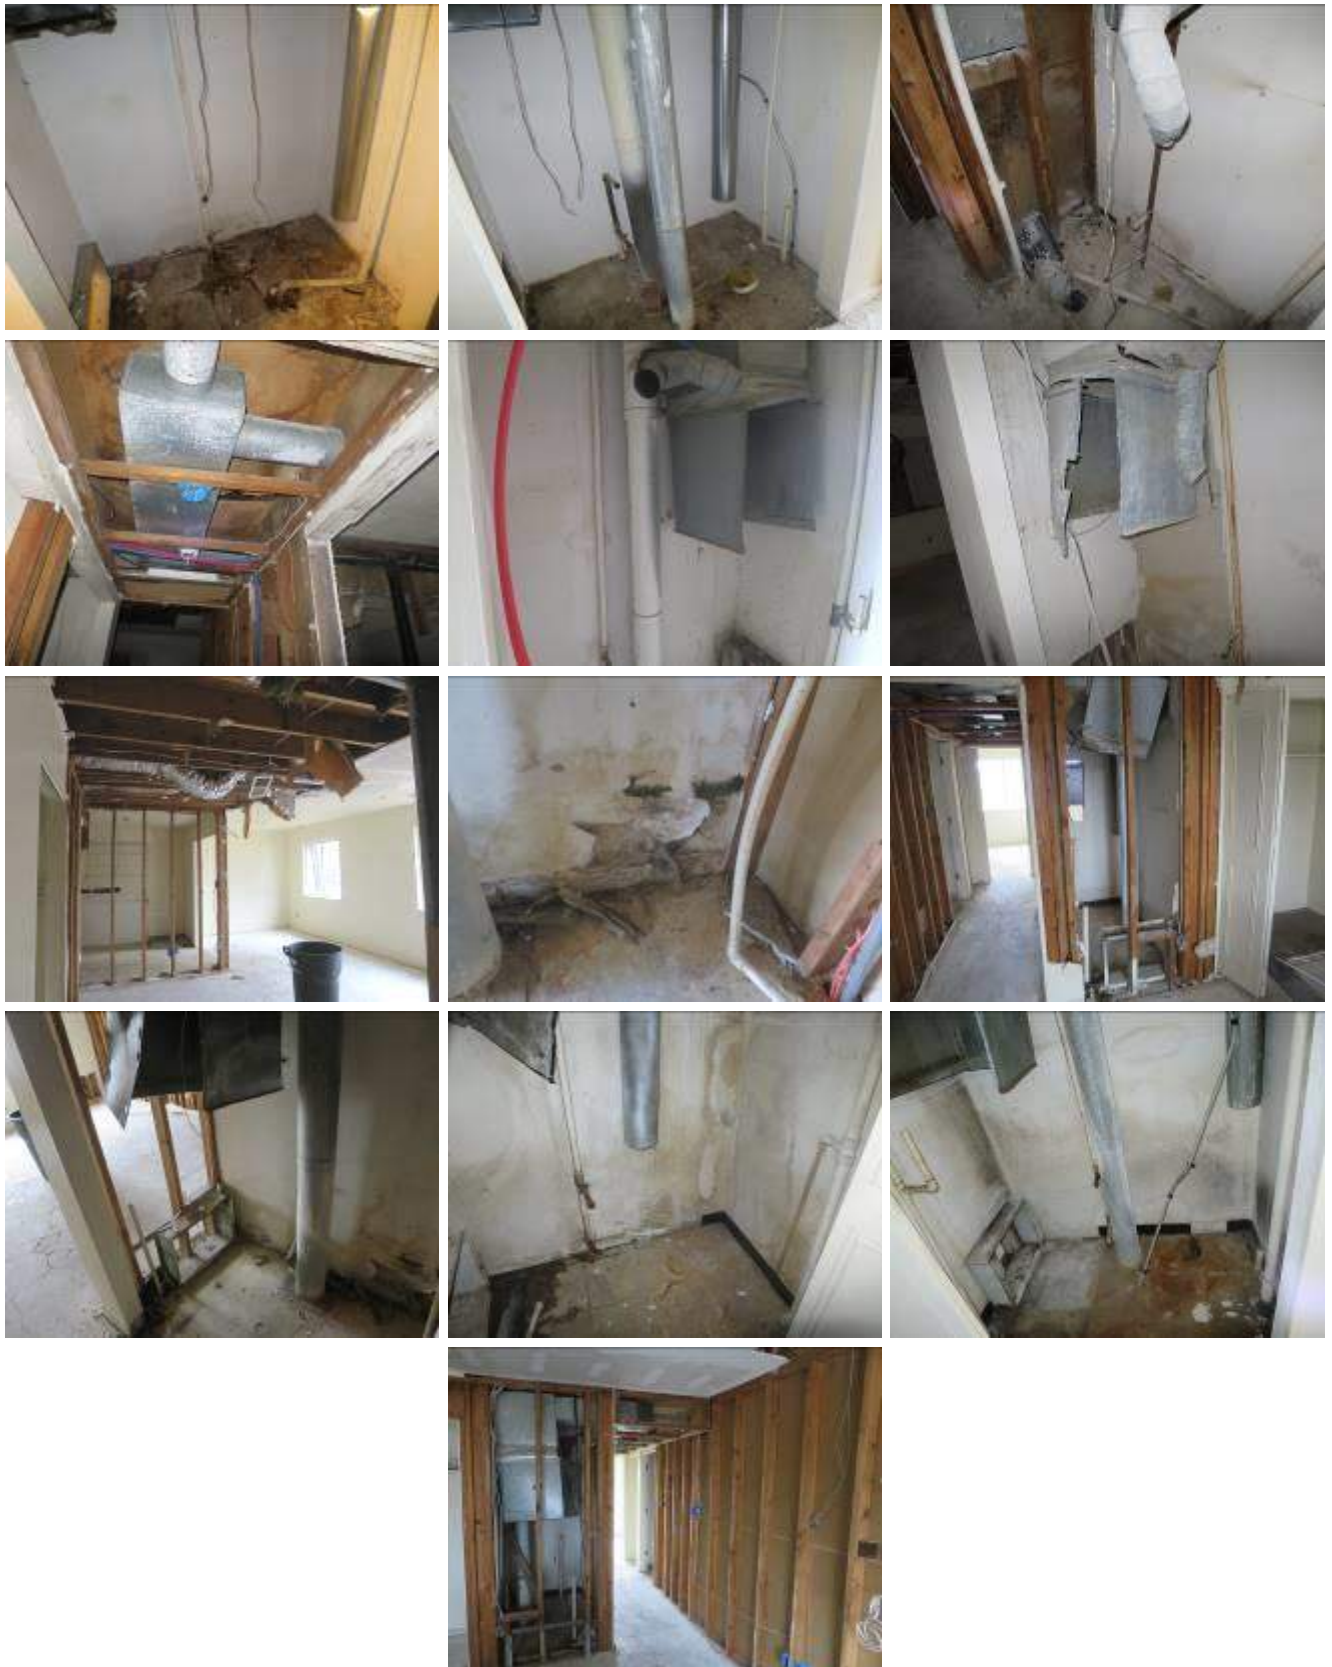
# HVAC DETERIORATION – 2644 E 29<sup>TH</sup> STREET

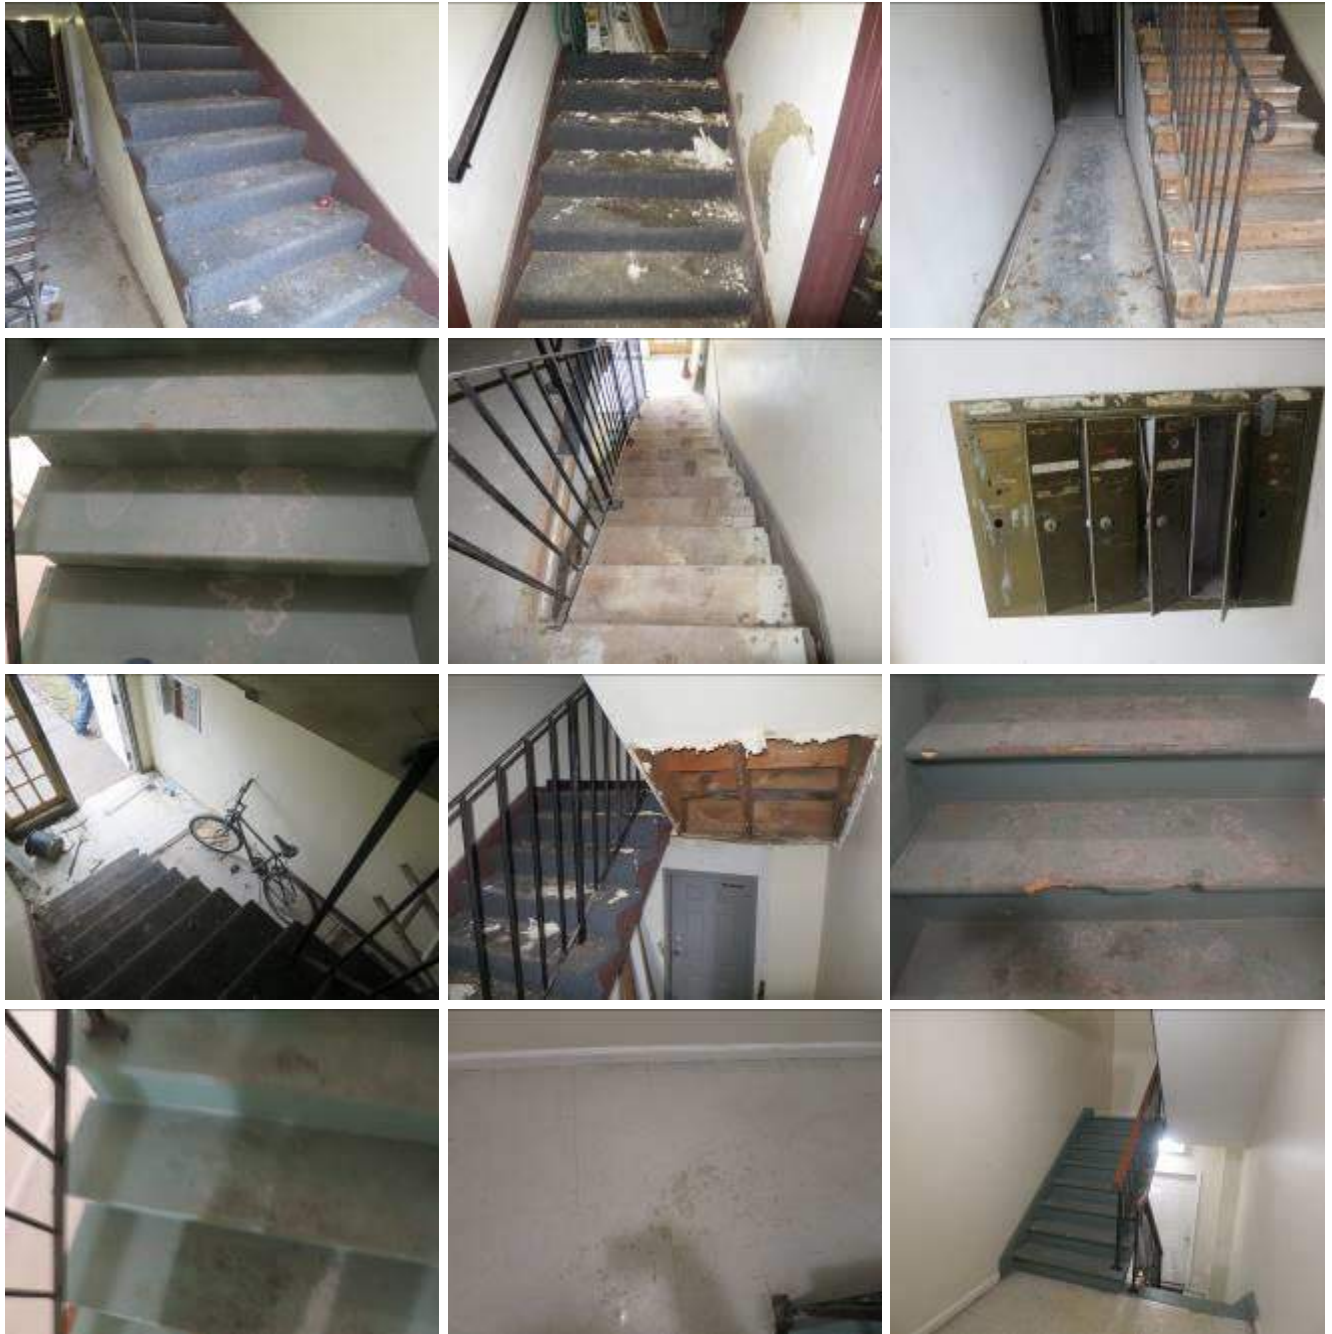
### HALLWAY & STAIRWAY DETERIORATION

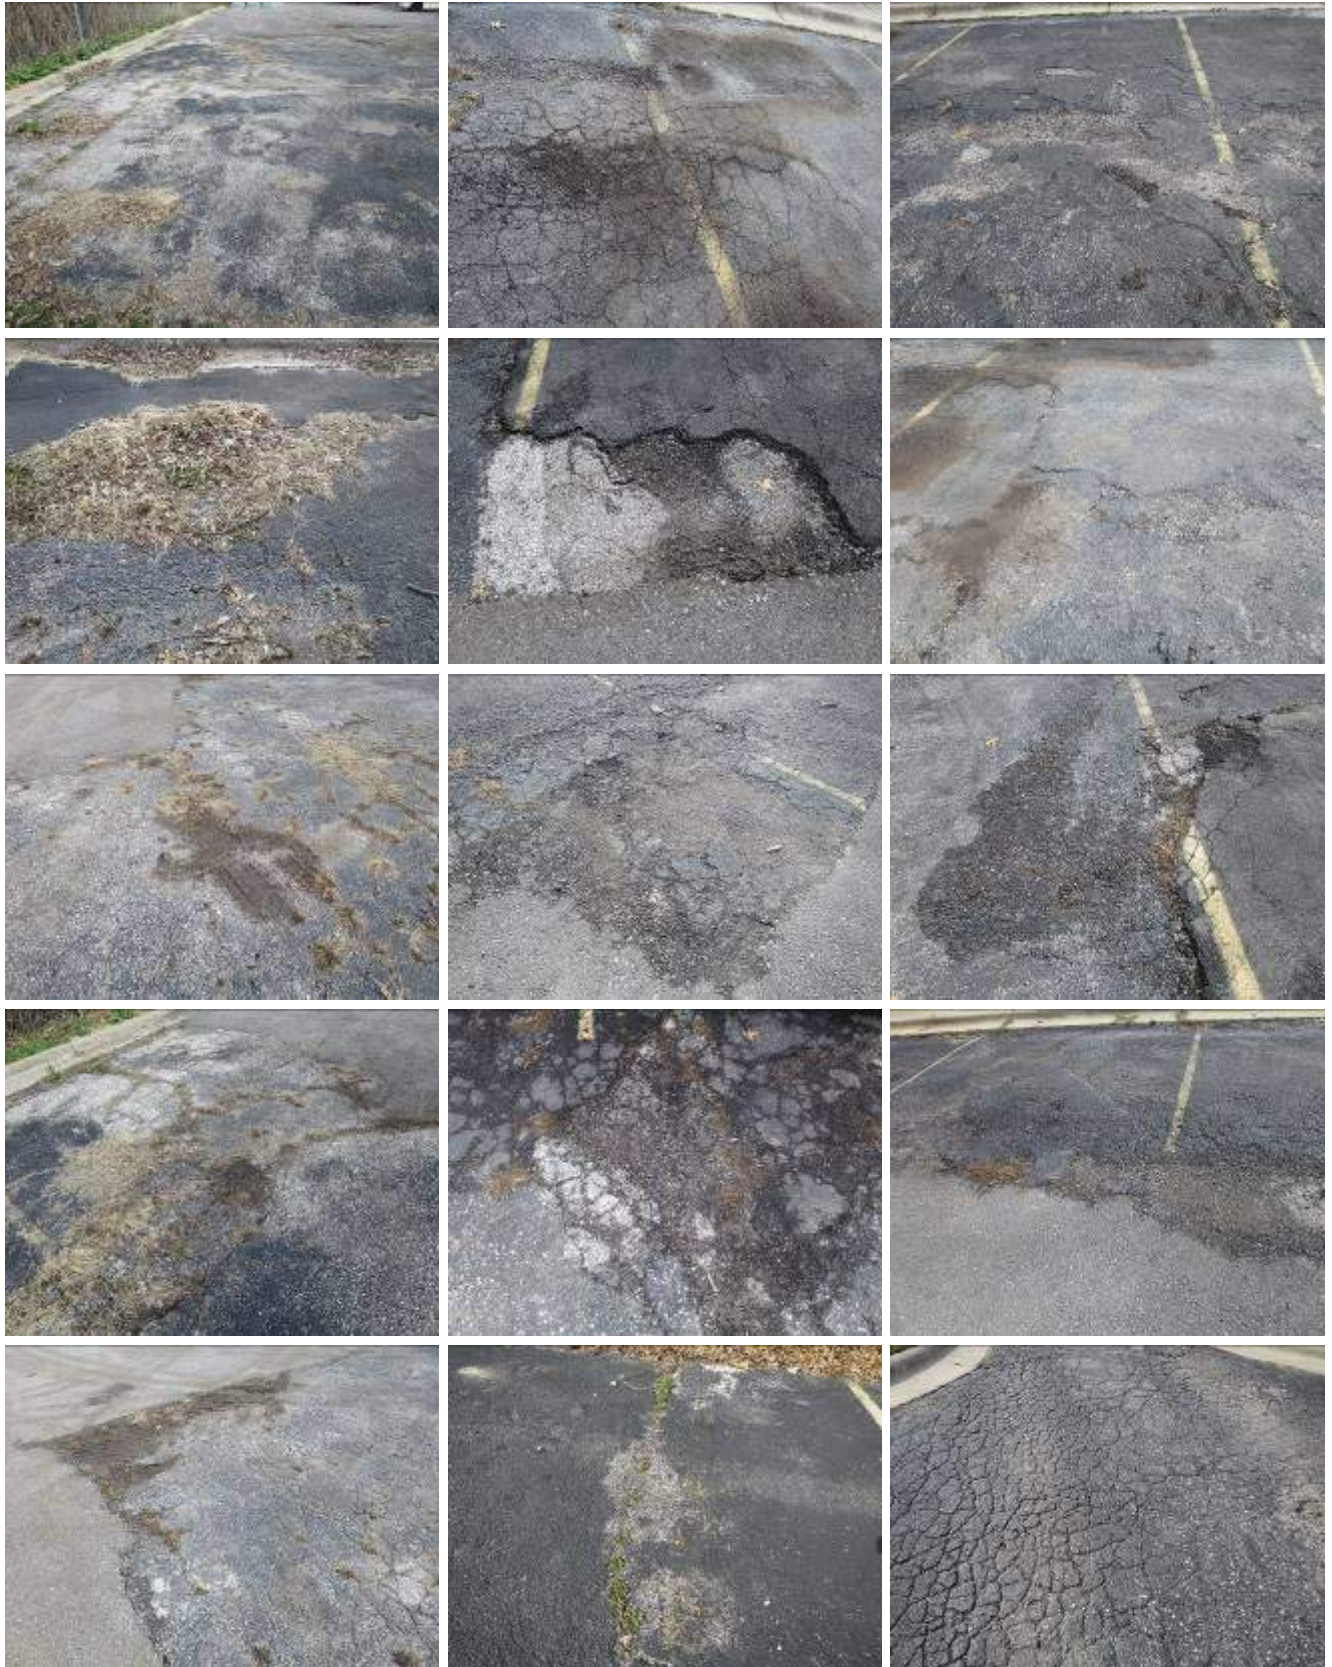
**DETERIORATION SITE IMPROVEMENTS – PARKING LOT**

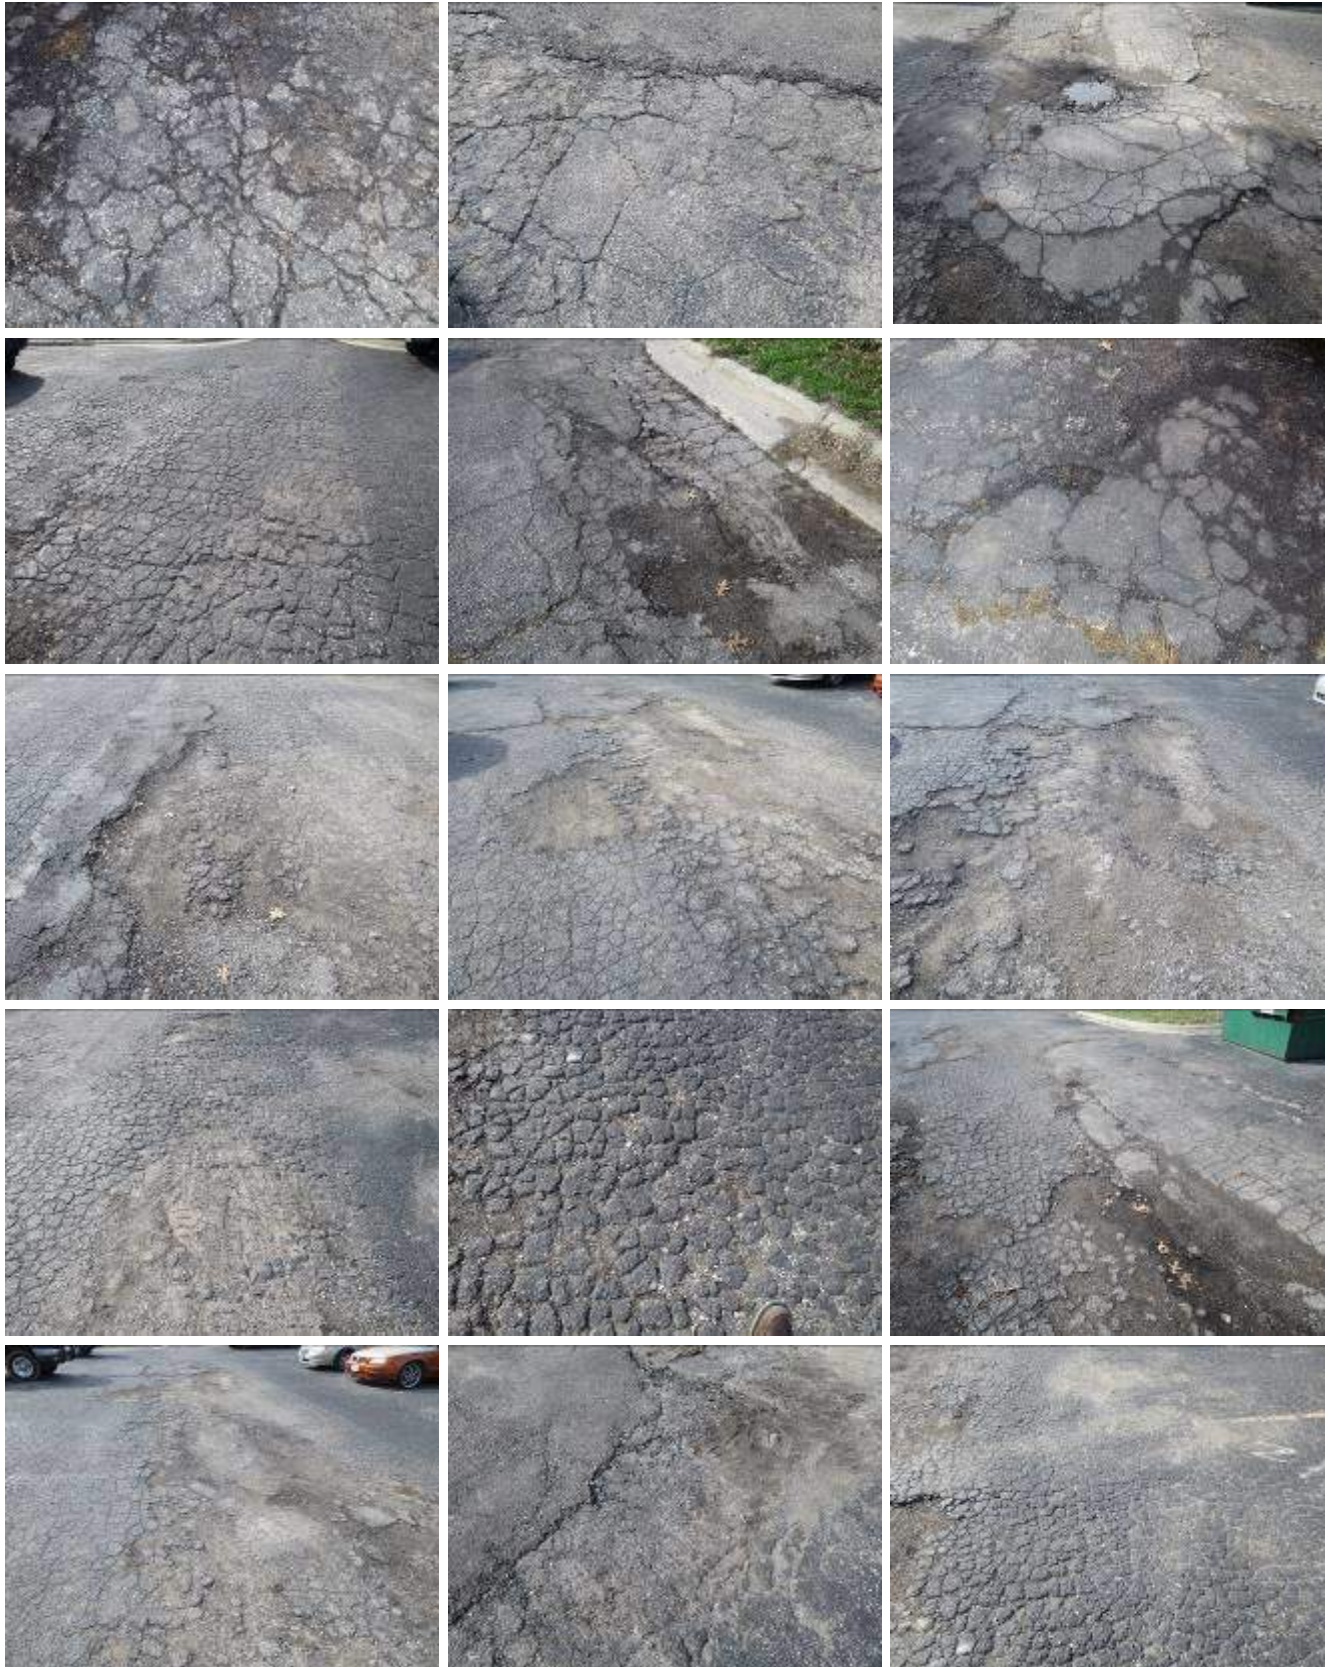
**DETERIORATION SITE IMPROVEMENTS – PARKING LOT**

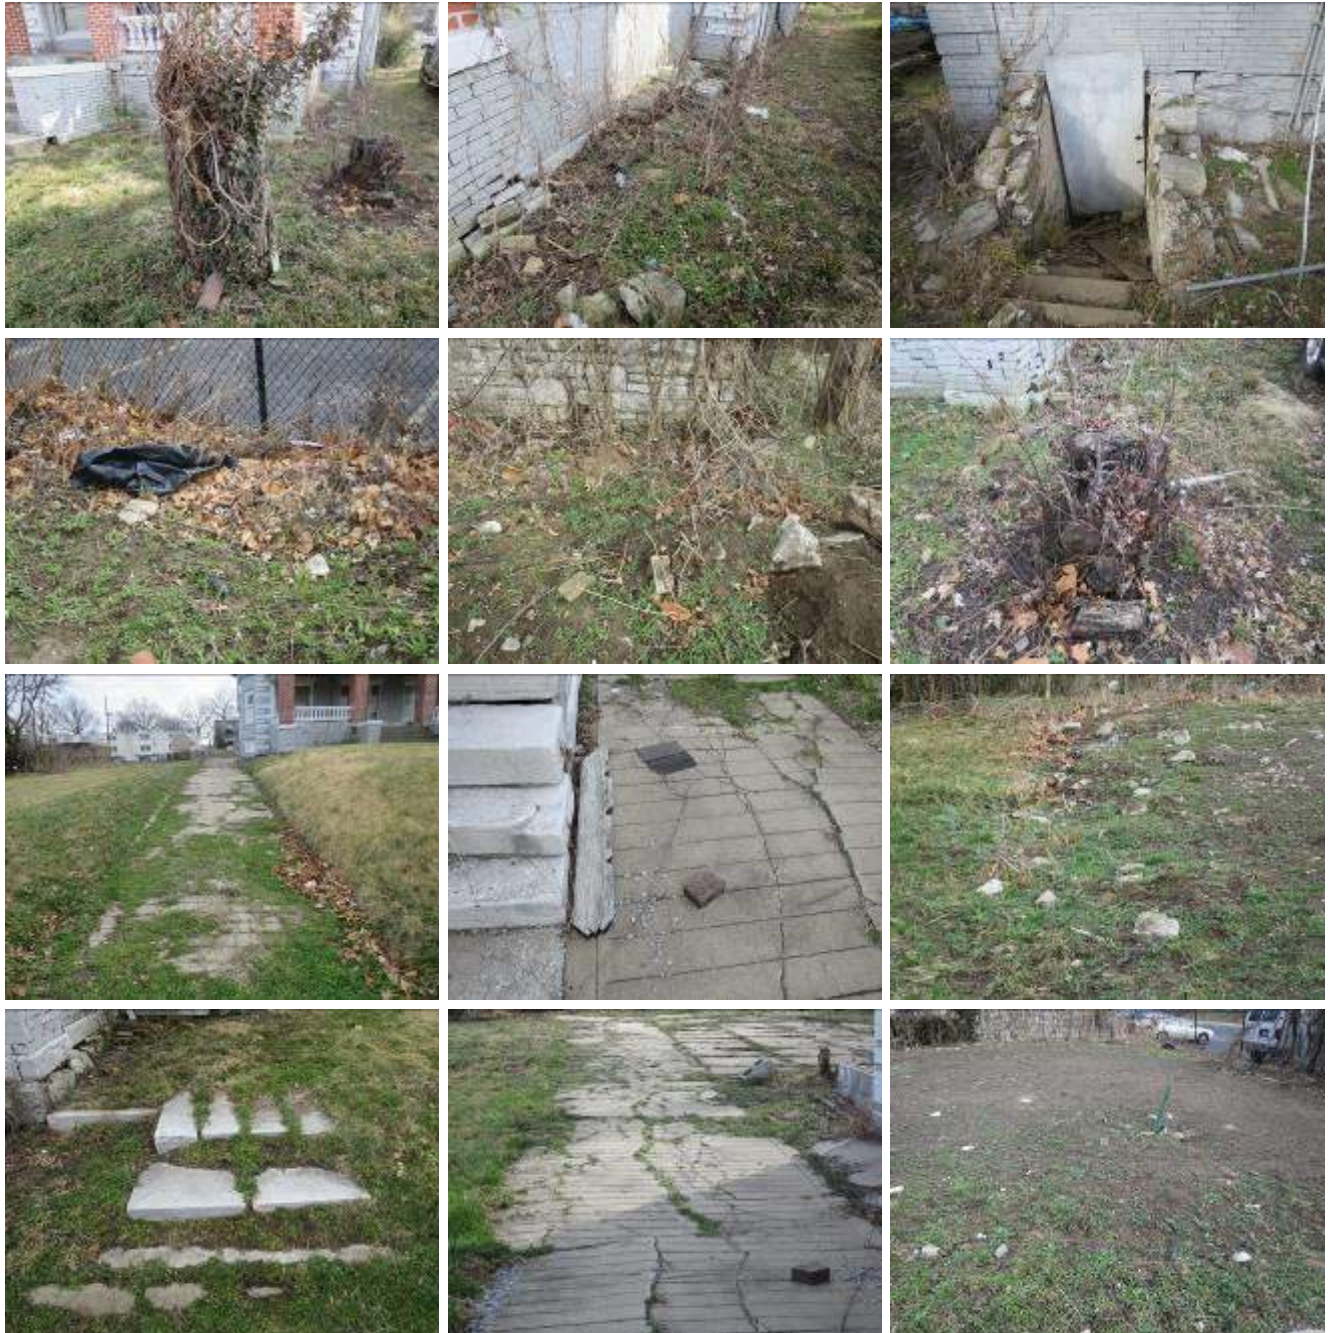
**DETERIORATION SITE IMPROVEMENTS – 2651 VICTOR STREET**

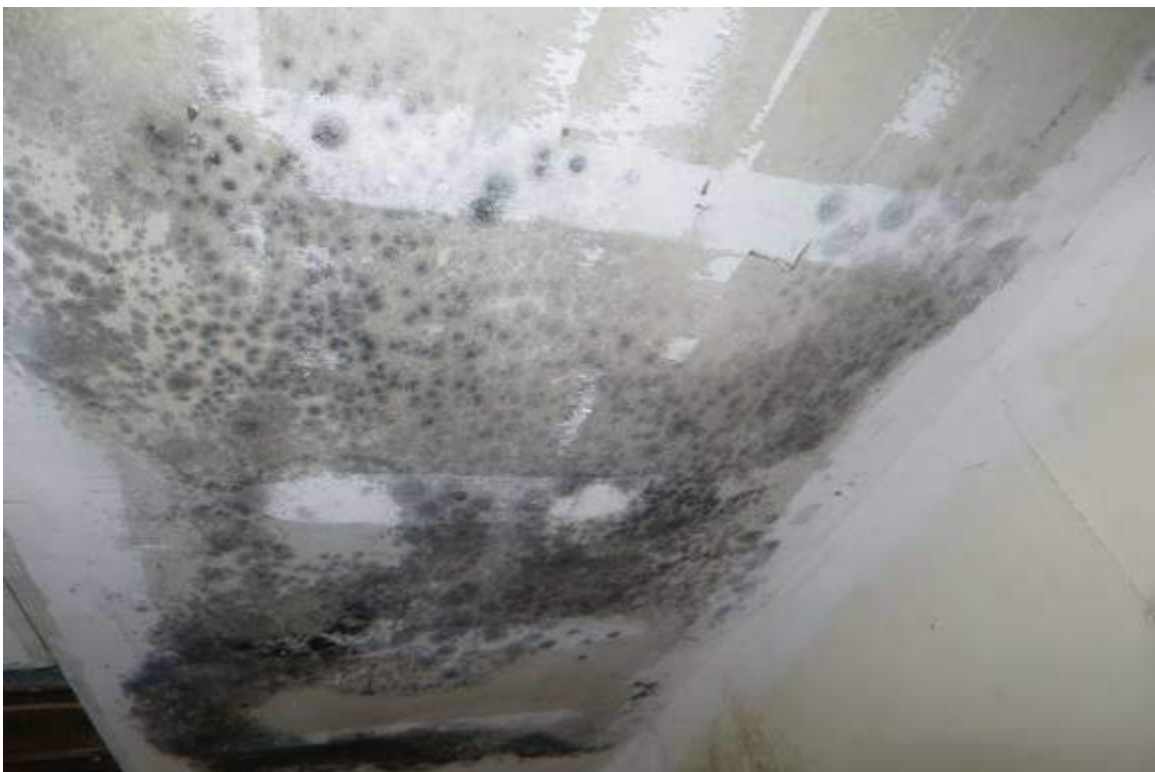
Water Infiltration At 2644 E 29<sup>th</sup> Street

Extensive Mold Due To Water Infiltration – 2644 E 29<sup>th</sup> Street
