Re: Second Supplement to Submittal of Petition to Form Grey Oaks Community Improvement District

Grey Oaks
Community Improvement District

Blight Study

Patro Brothers, LLC
Kansas City, Missouri
June 13, 2025

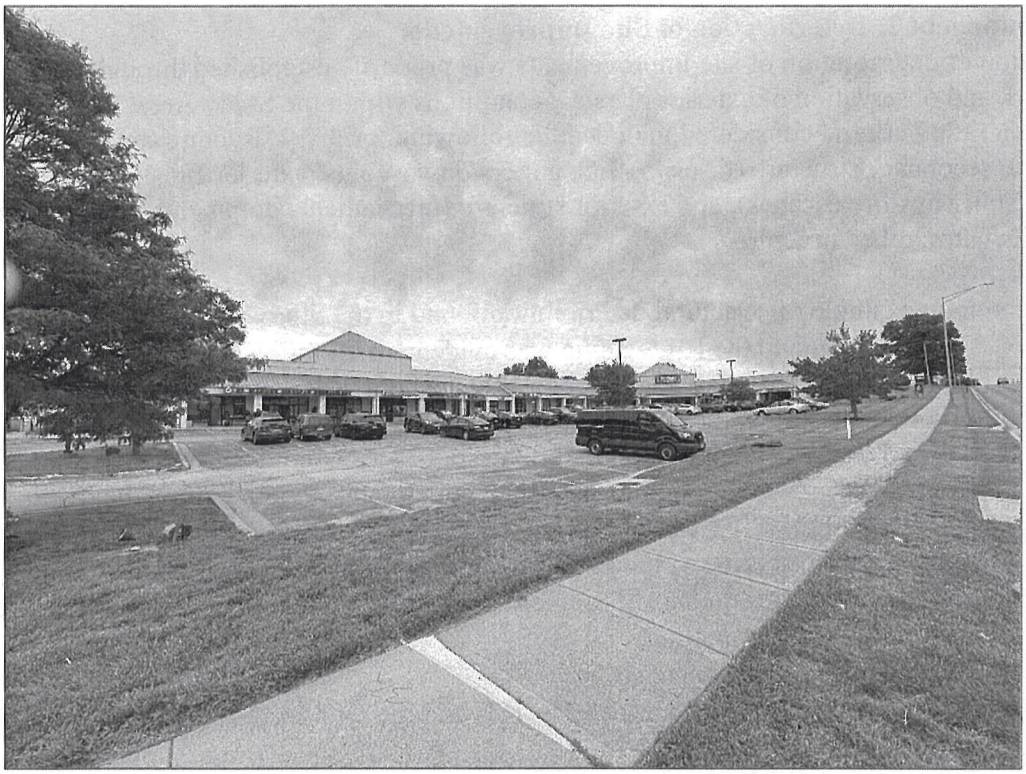
Grey Oaks Commons – looking southeast from northwest corner of Study Area

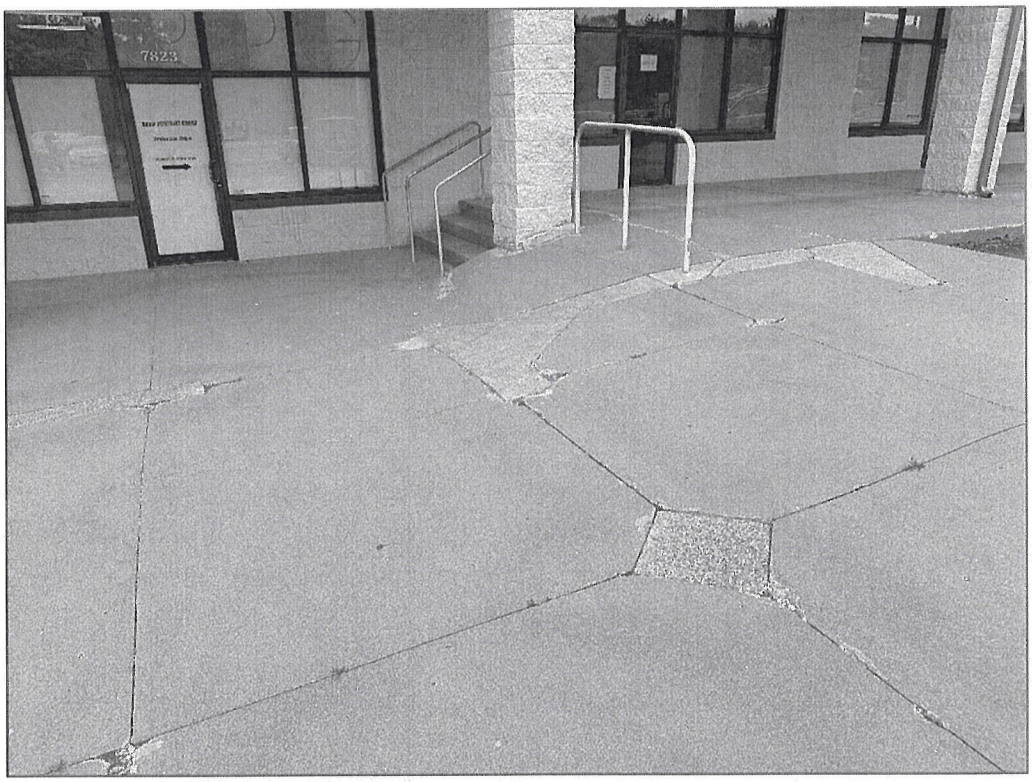
Looking south – deterioration of sidewalk (fall/trip hazard)

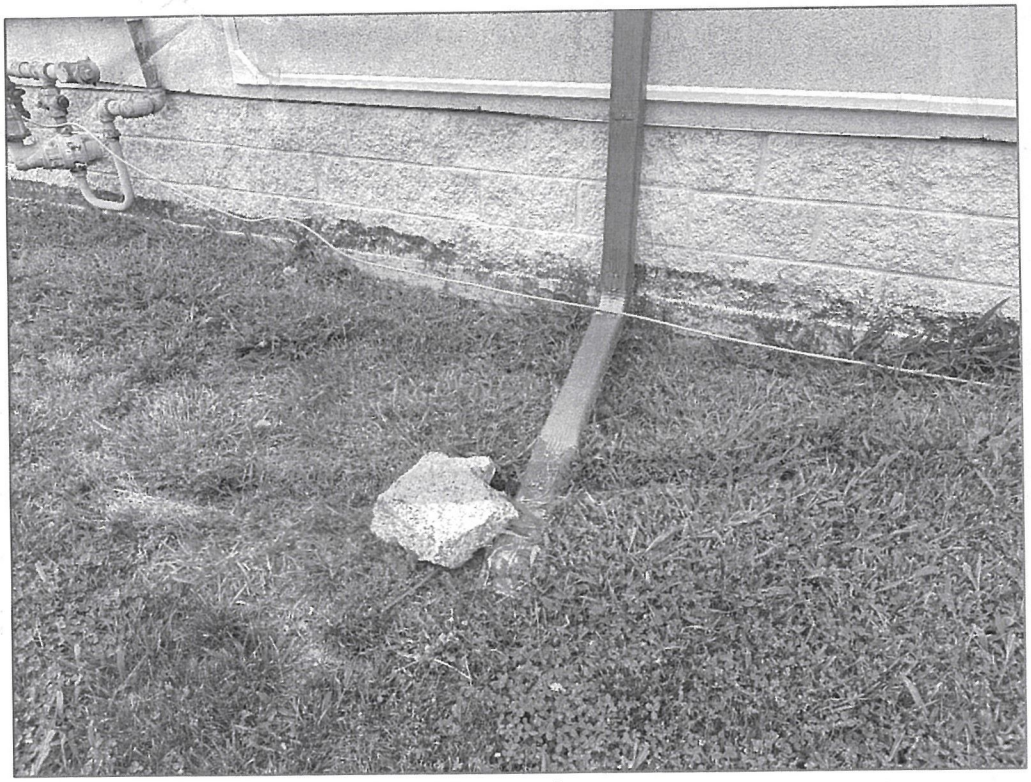
Looking southwest - debris

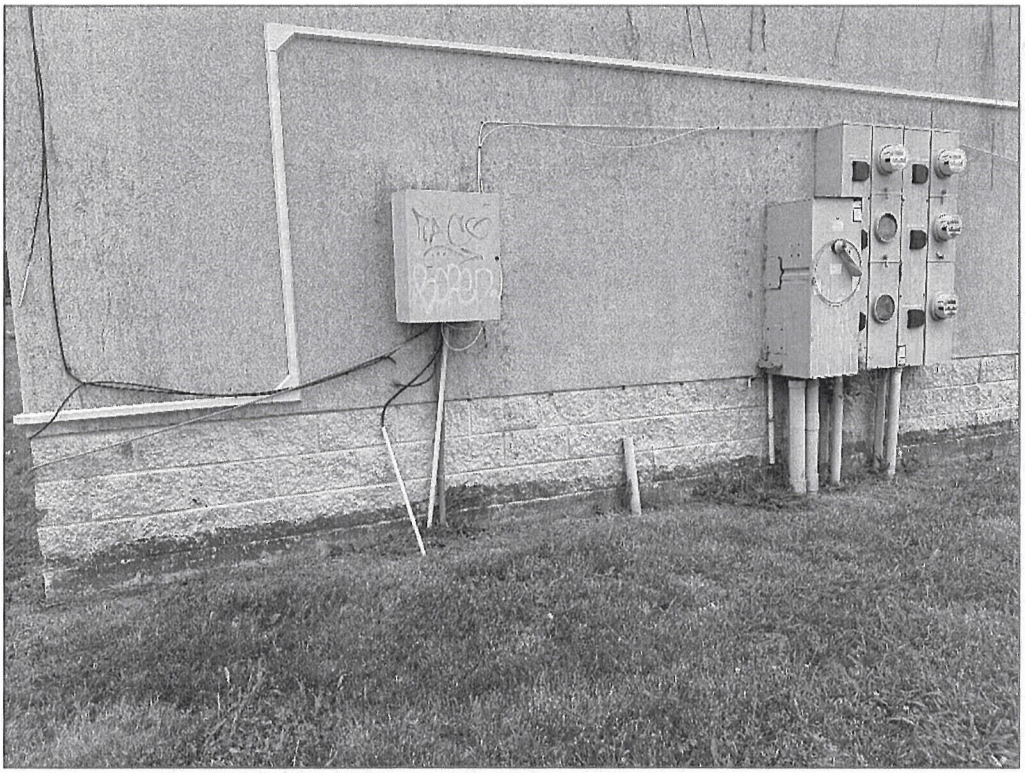
Looking east – graffiti

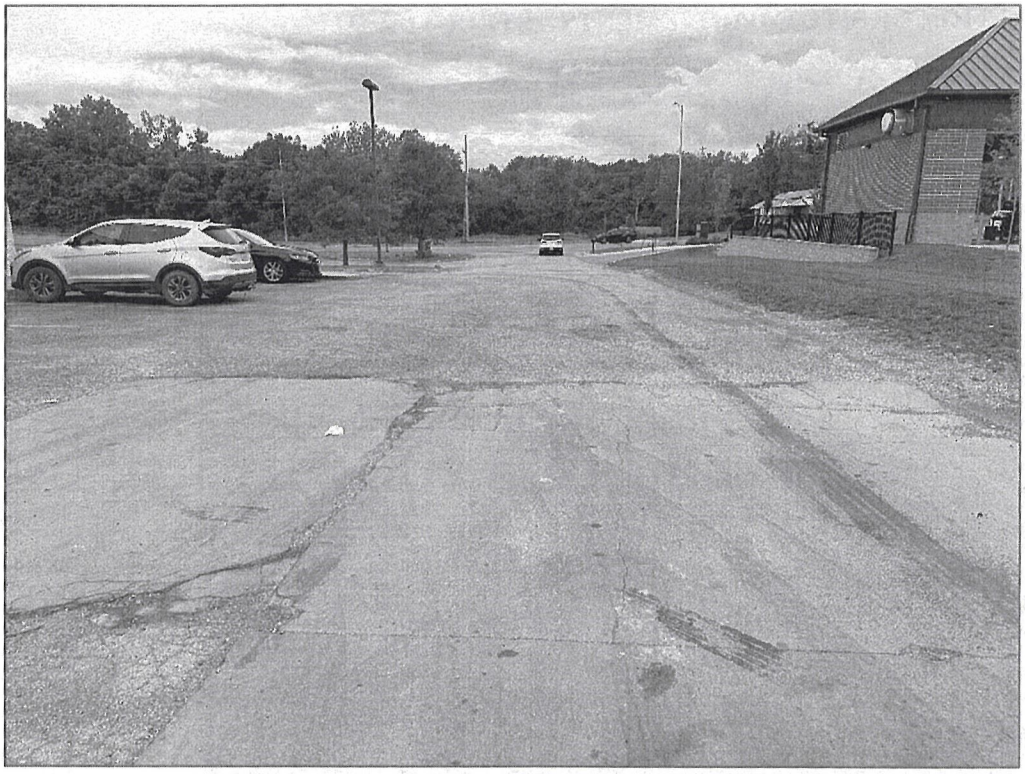
Looking west – deterioration of pavement, poor drainage (tripping/fall hazard)

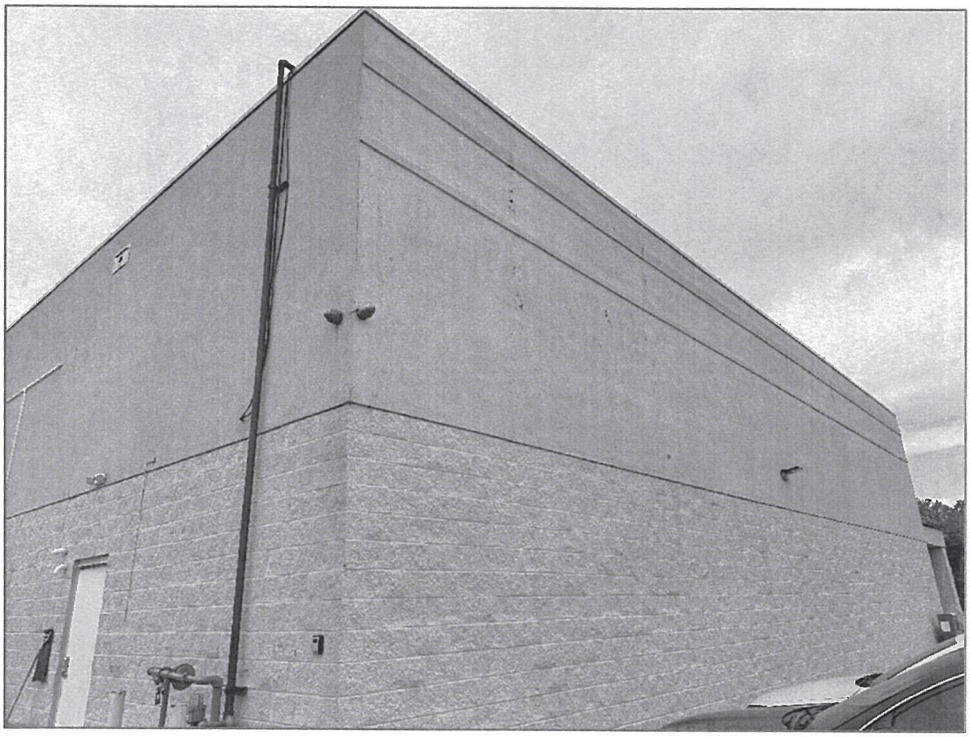
- Cracking of the EIFS was also common, especially near building corners, possibly from settling of the building or other variables;
- Failure of finishes on the EIFS, likely due to water washing over the wall and/or a failure of the paint coating;

Looking southwest – failure of finishes

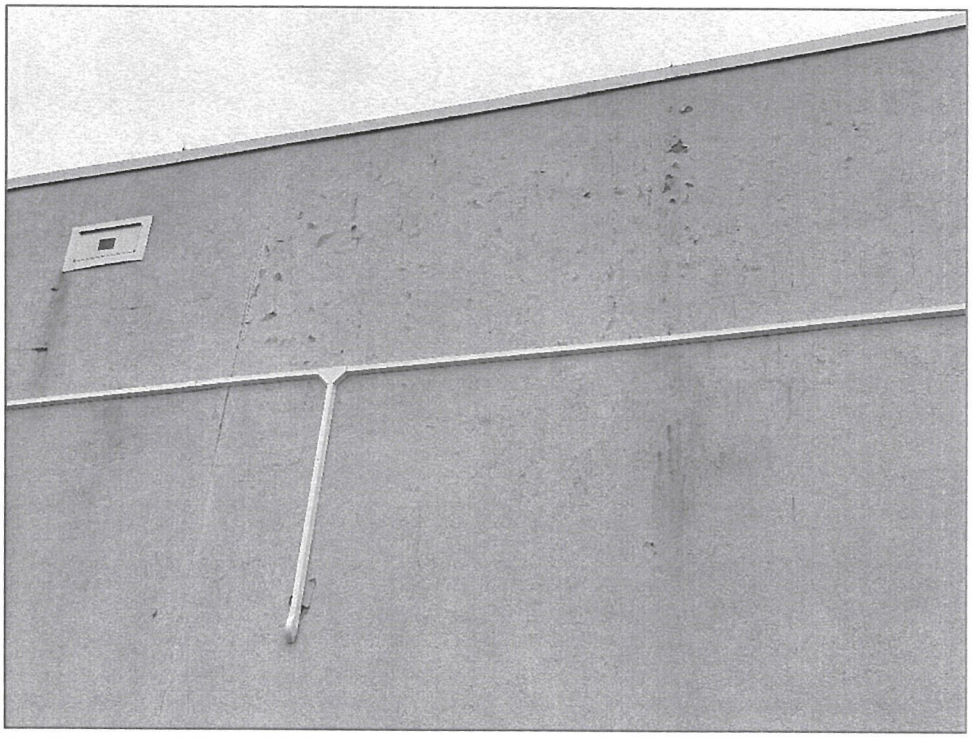
Looking west – failure of finishes

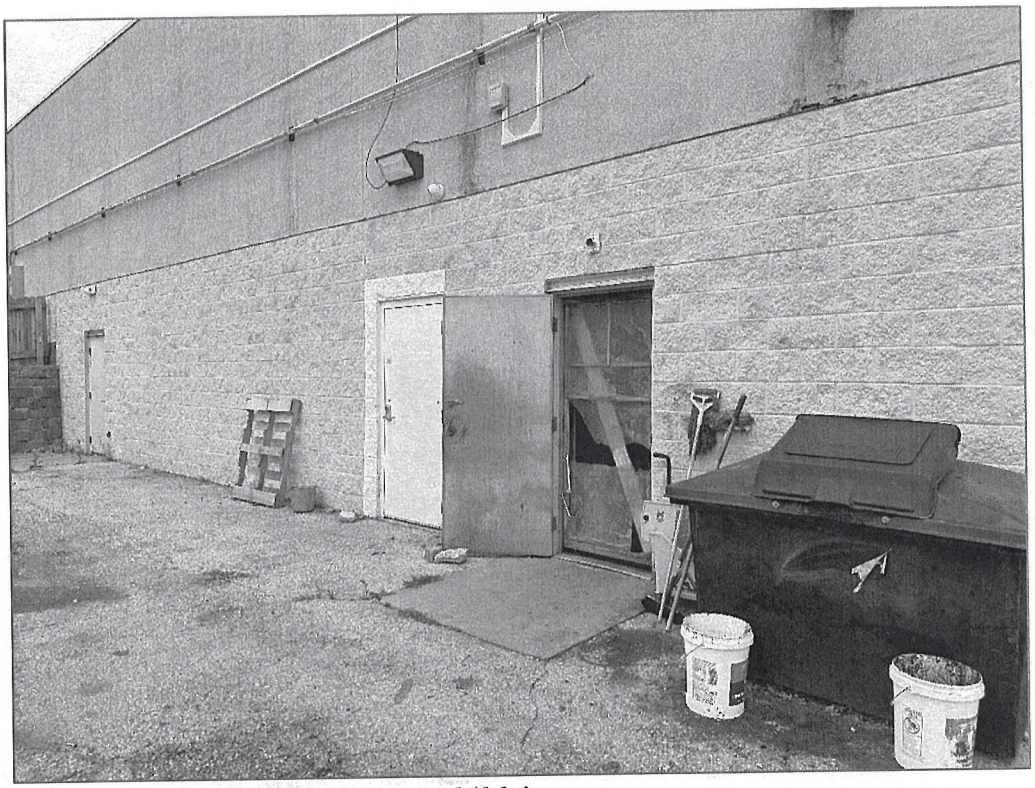
- Damage to some downspouts.
- Corrosion of metal, such as the gas lines and the roof access ladder on the south side of the strip center.
- Deterioration of the doors fronting onto the service drive.

Looking west – deterioration of door; trash/debris

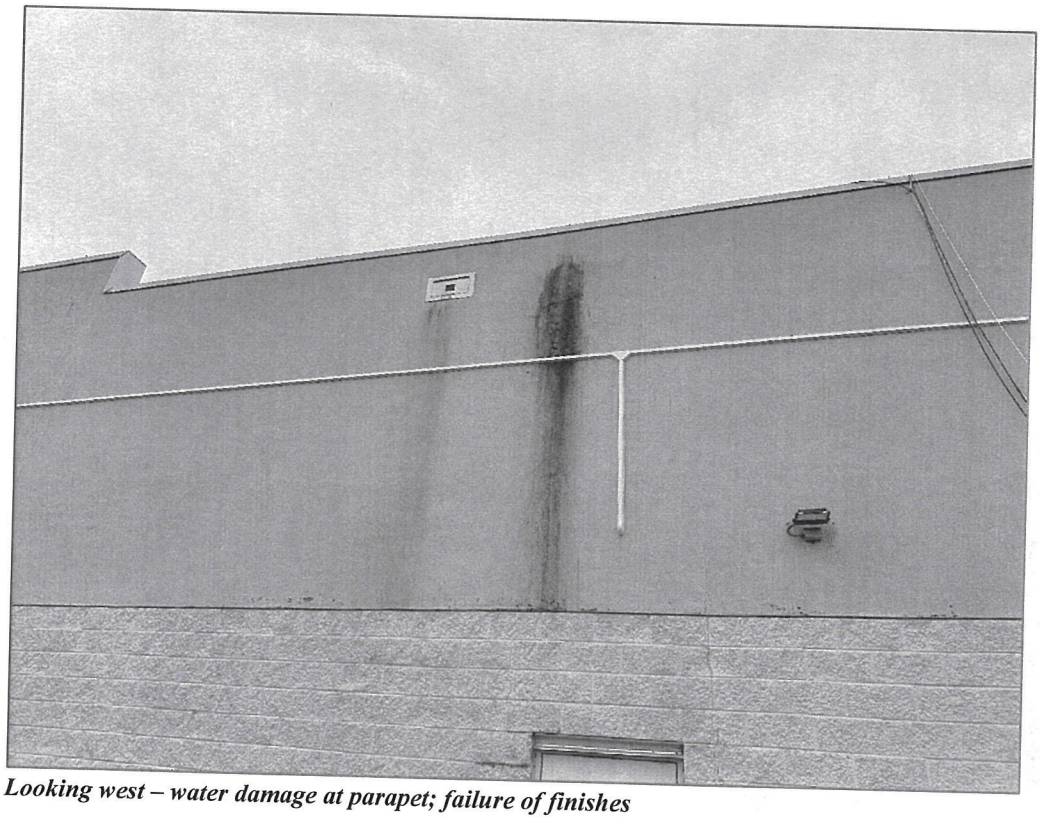
- Water damage to the EIFS siding was evident on all four sides of the building, especially on the south and east elevations where water appeared to be coming through the wall at the parapet level. Damage was also widespread along the bottom of the EIFS at the joint with the split-face concrete masonry units, likely from a lack of venting that would allow moisture to dry out behind the EIFS.

- Deterioration of the soffits, likely due to water intrusion.
- Although the roof could not be accessed for inspection, it would appear from the location of the water damage on the EIFS that the roof requires repair/replacement due to water penetration of the wall at the parapet.

Looking west – water damage at parapet; failure of finishes

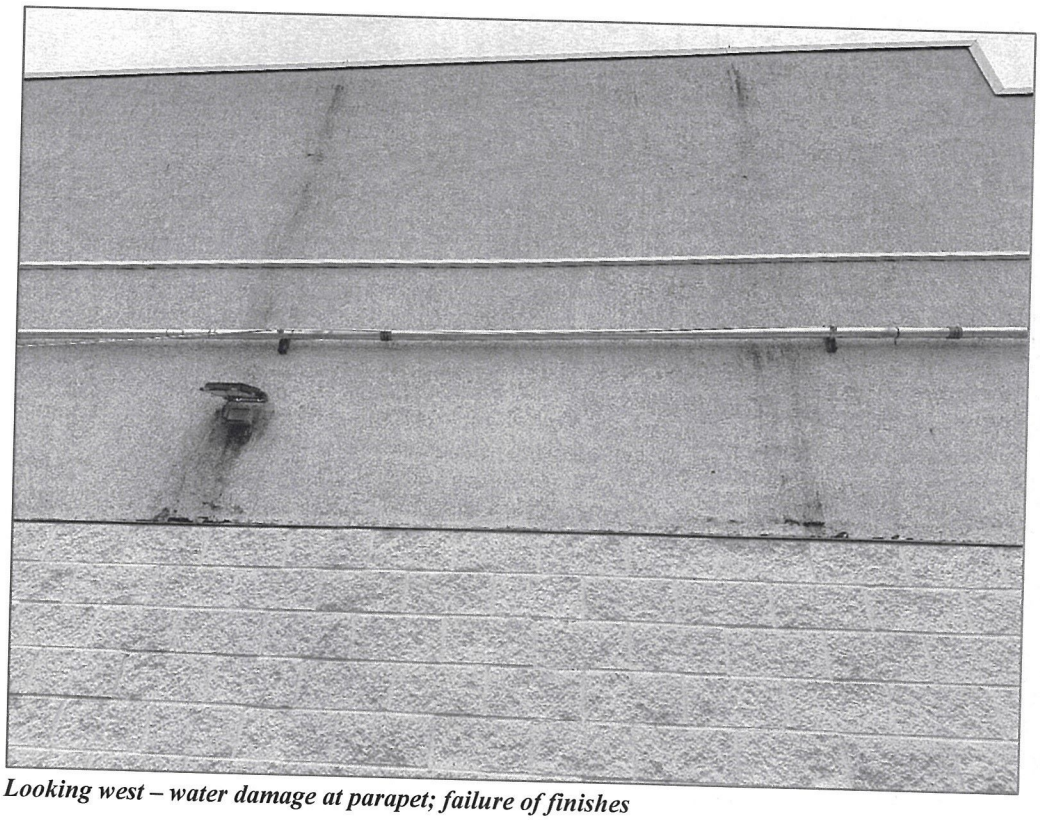
Looking west – water damage at parapet; failure of finishes

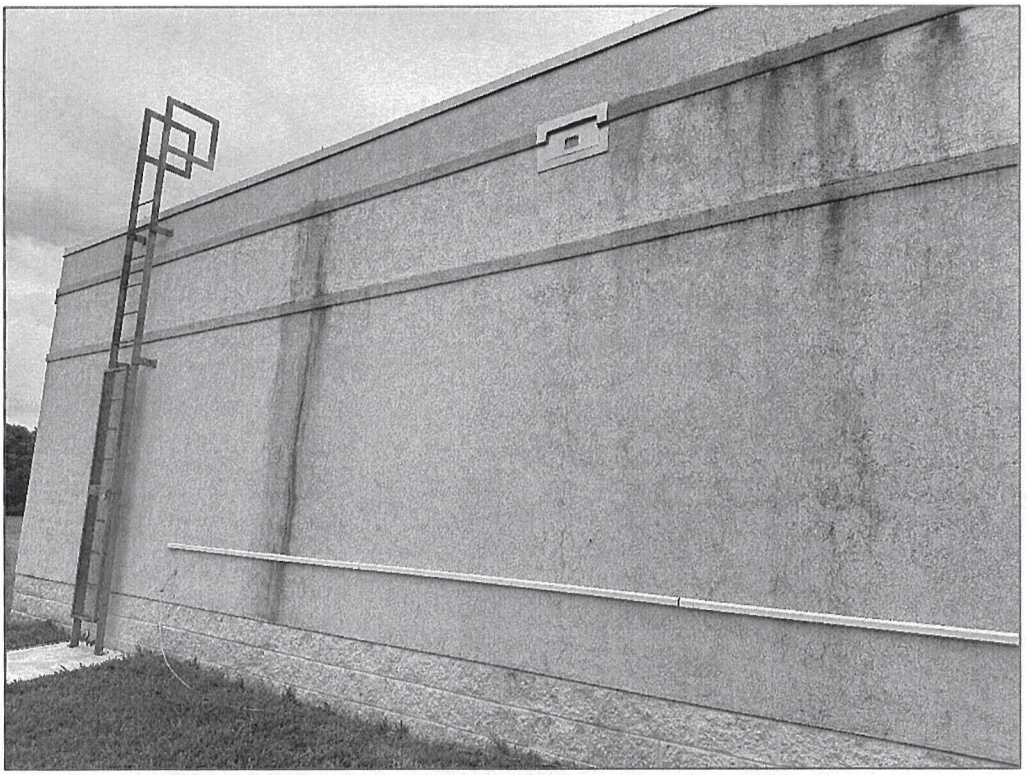
Looking northwest – rusting of ladder/enclosure; water damage to EIFS; failure of finishes

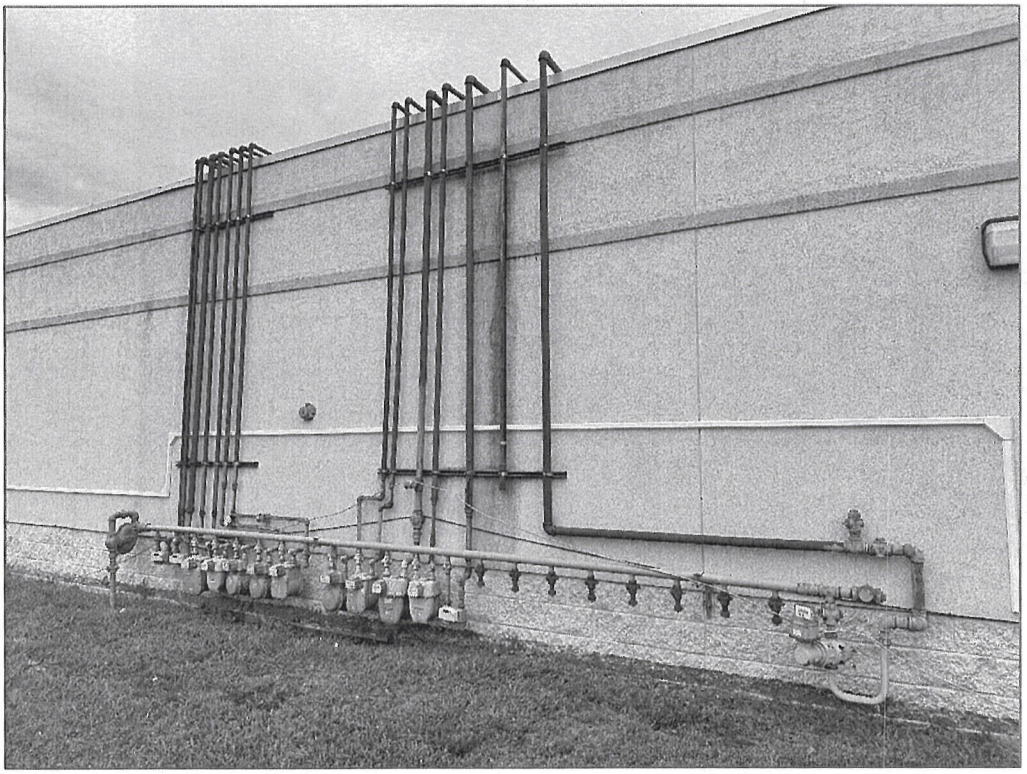
Looking north – rusting/corrosion of gas lines

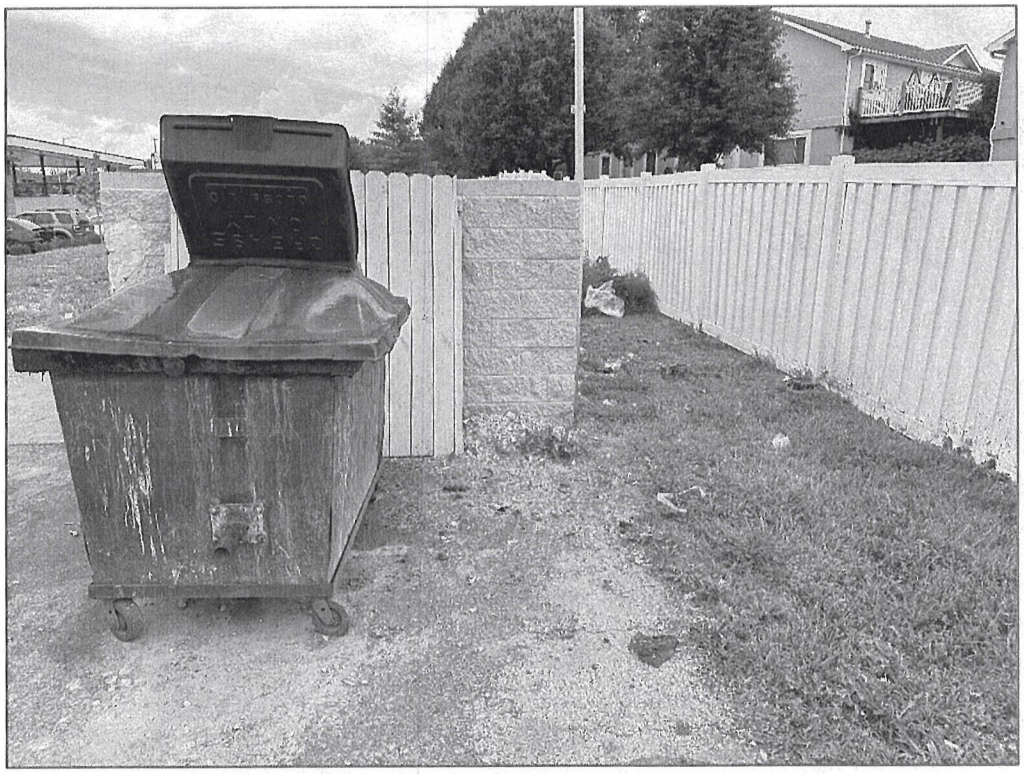
- Deterioration of parking surfaces, drive aisles, curbs and islands require repairs or replacement.
- Repair or replacement of trash dumpster enclosure.
- A portion of the sidewalk along N. Oak Trafficway on the western edge of the Study Area needs to be replaced.
- Sidewalk providing access to the businesses requires repair/replacement in areas due to deterioration, cracking, and uneven pavement. The transition in elevation where steps have been installed also needs improvement.

Looking north – deterioration of trash enclosure, pavement
