AMENDED BLIGHT STUDY

WEST BOTTOMS STUDY AREA

FORESTER VIADUCT/BLUFF ROAD/W 12TH STREET/HICKORY STREET
KANSAS CITY, MISSOURI

NOVEMBER 17, 2023
RECORD No. 1800

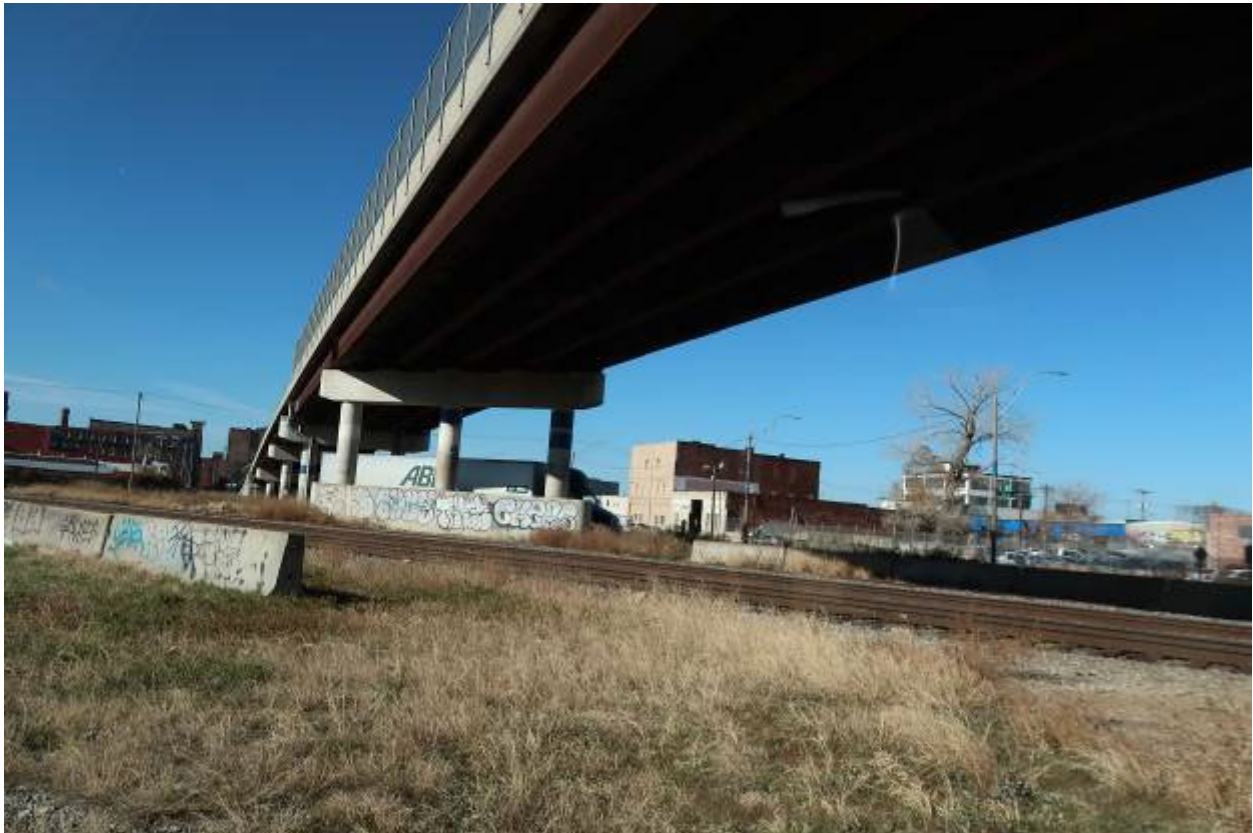
Looking Northwest Across 912 Santa Fe Street

Blight issues involving Insanitary Or Unsafe Conditions observed at the subject tax parcel include trash and illegal dumping as well as the presence of the active railroad tracks bisecting the tax parcel.

Blight issues involving Deterioration Of Site Improvements observed at the subject tax parcel include functional obsolescence/economic underutilization as the tax parcel has no utility or use due to the presence of the active railroad tracks.

Blight issues involving Endangerment By Fire Or Other Causes observed at the subject tax parcel include crime (graffiti) and the endangerment caused by the active railroad tracks bisecting the property.

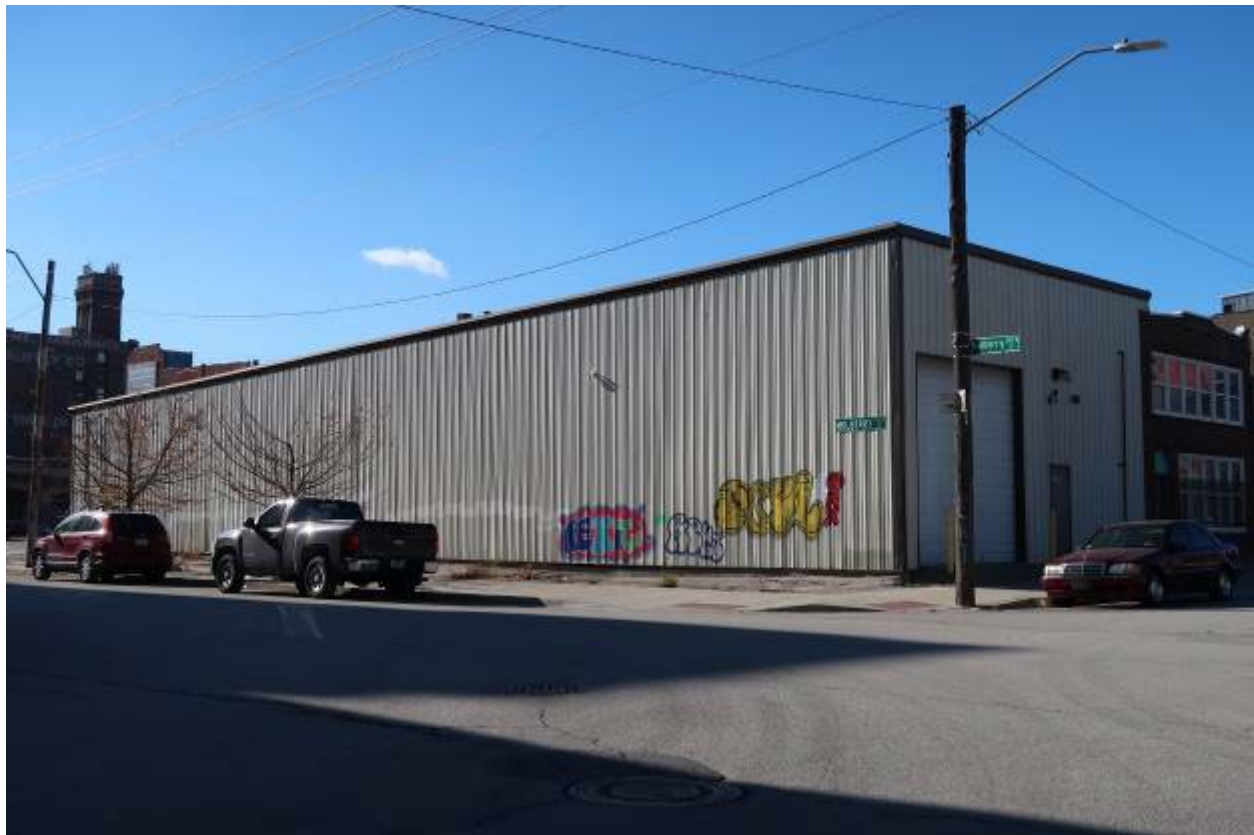
Looking Southwest At The East (Mulberry Street) & North Elevation Of 1301 Union Avenue

The exterior is in poor to fair condition. The foundation below the east elevation and the adjoining sidewalk are settling noticeably. The exterior walls have dents and have graffiti or whited out graffiti areas. The roof is newer. The structure lacks windows. Finished space is minimal. Elongated buildings are less functional. The structure would be a poor candidate for residential or commercial conversion.

Blight issues involving Deterioration Of Site Improvements observed at the subject tax parcel include deterioration of the exterior facades, the foundation settling along the east elevation, and functional obsolescence issues dealing with the elongated structure, lack of windows, and minimal finished space.

Blight issues involving Endangerment By Fire Or Other Causes observed at the subject tax parcel include crime (graffiti and loitering), the settling along the adjoining pedestrian sidewalk to the east, the roof draining onto the easterly adjoining sidewalk, and the trash dumpster blocking the alleyway.

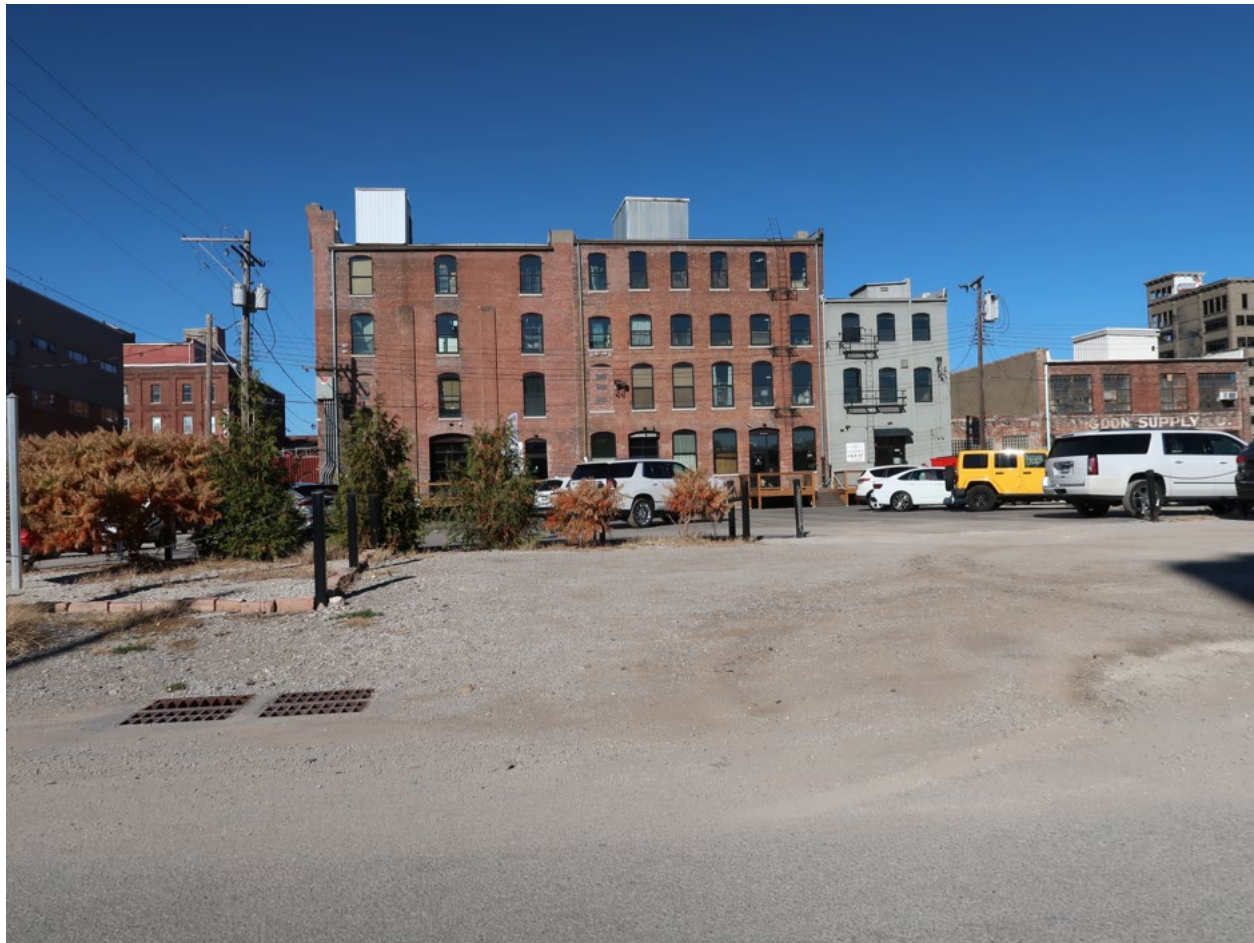
Looking North From E 11th Street Across The Dirt Access To 1027 Hickory Street

The subject tax parcel is utilized as a surface parking yard. The property is paved (asphalt) in the northerly 82% but the southerly 18% is dirt and includes the access from E 11th Street. The asphalt paving and striping is in acceptable condition. Small landscaping areas lack supervision (unkempt, accumulated trash).

Gravel parking/storage lots in the urban setting can be a nuisance (dust in the air, dirt on adjoining sidewalks and streets). Pedestrian sidewalks and curbs along Hickory Street are in poor condition creating safety concern. Pedestrian sidewalks and curbs are lacking along E 11th Street.
