STATUS REPORT

Auditorium Parking Garage

On Tuesday, March 31, 2020, TranSystems, pkmr Engineers, and City of Kansas City, Missouri General Services staff toured the Auditorium Parking Garage (APG).

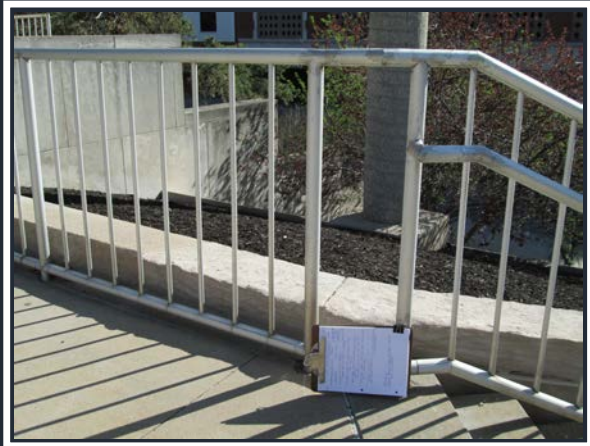
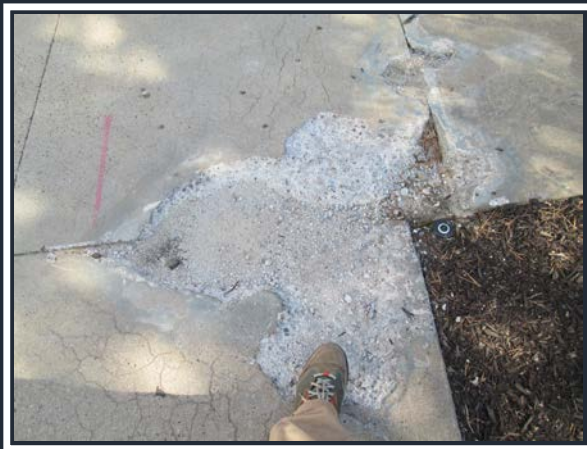
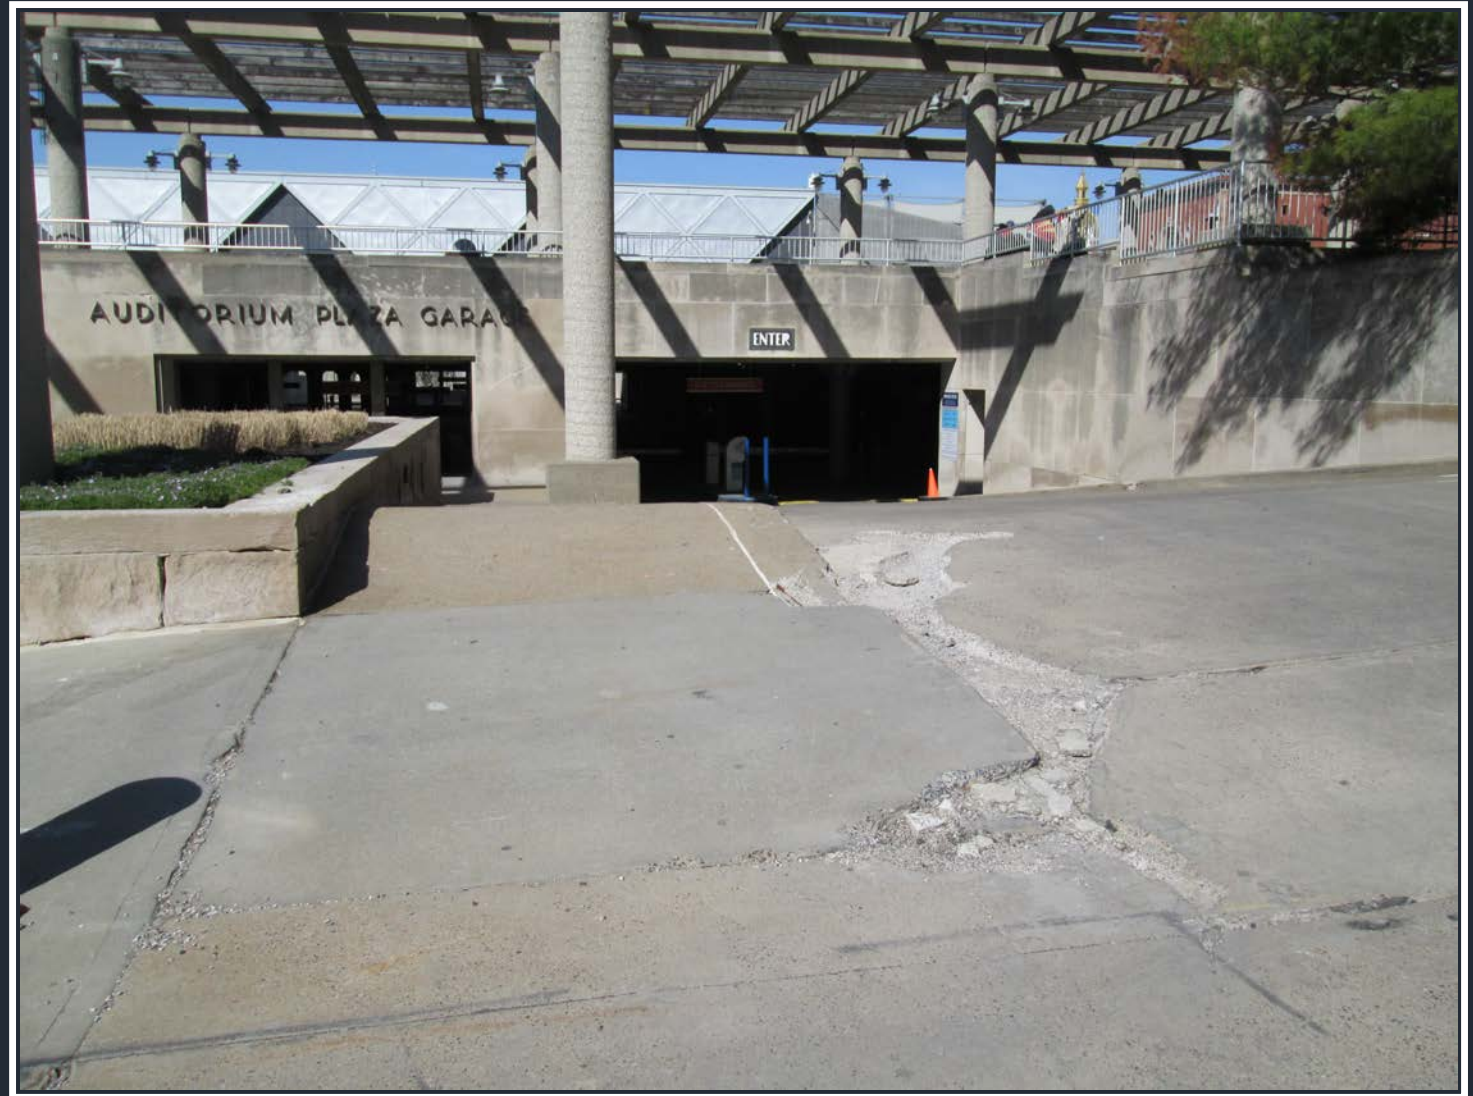
Egress

- The existing stairs within the garage are not code compliant because the configuration of the handrails and guardrails do not meet current code requirements.
- Some doors do not close properly to provide a safe fire enclosure.
- Perimeter sidewalks have numerous areas of serious spalling that have created hazardous walking conditions and a danger to accessibility.
