# QUALIFICATION ANALYSIS

29<sup>TH</sup> & BENTON PIEA STUDY AREA  
NWQ BENTON BOULEVARD & E 29<sup>TH</sup> STREET  
KANSAS CITY, MISSOURI

APRIL 3, 2020  
RECORD NO. 1730

BELKE APPRAISAL & CONSULTING SERVICES, INC.

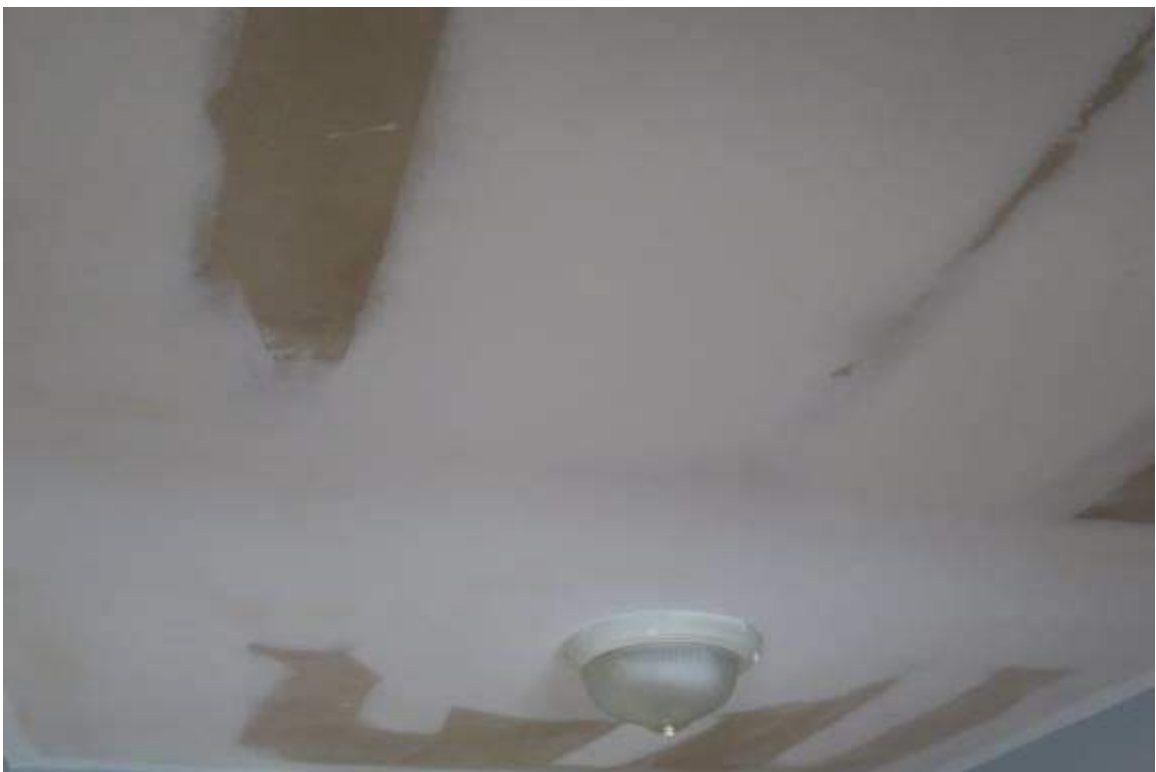
**CEILING DETERIORATION – 2702 E 29<sup>TH</sup> STREET**

In-Process Ceiling Repair
