AMENDED BLIGHT STUDY

WEST BOTTOMS STUDY AREA

FORESTER VIADUCT/BLUFF ROAD/W 12TH STREET/HICKORY STREET
KANSAS CITY, MISSOURI

NOVEMBER 17, 2023
RECORD No. 1800

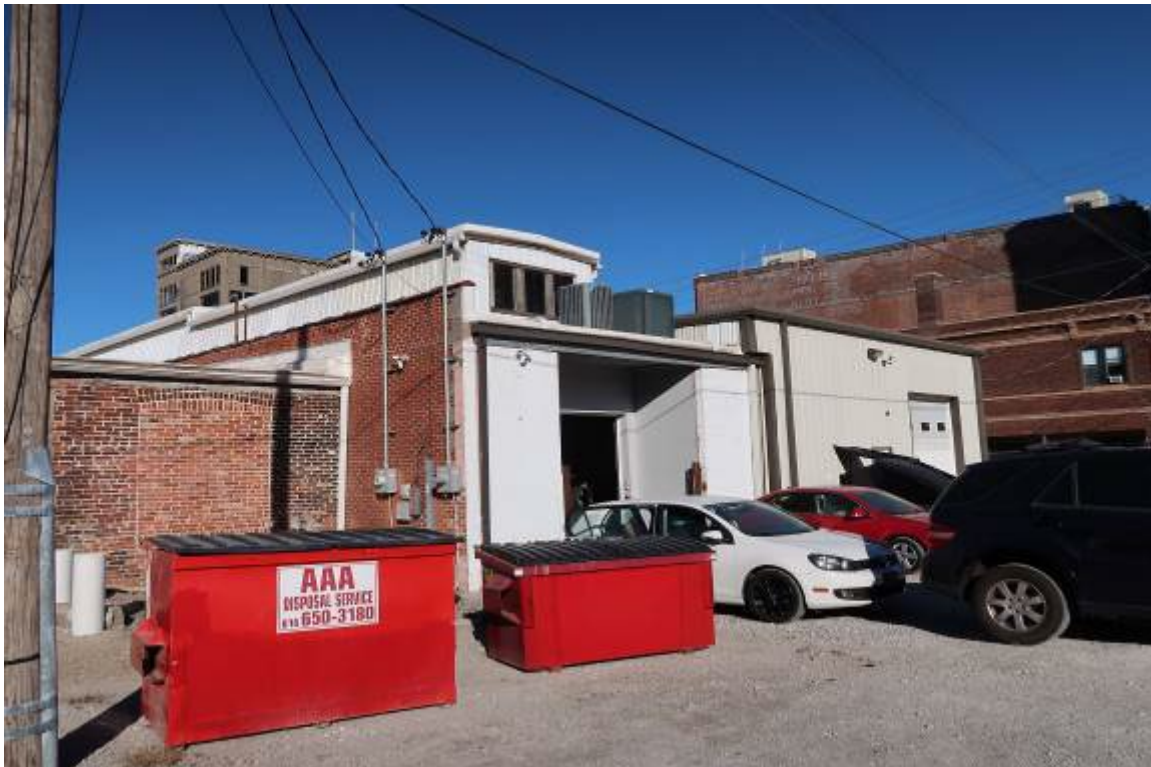
Trash Dumpsters & Tenant Vehicles Blocking The Adjoining Unpaved Alleyway

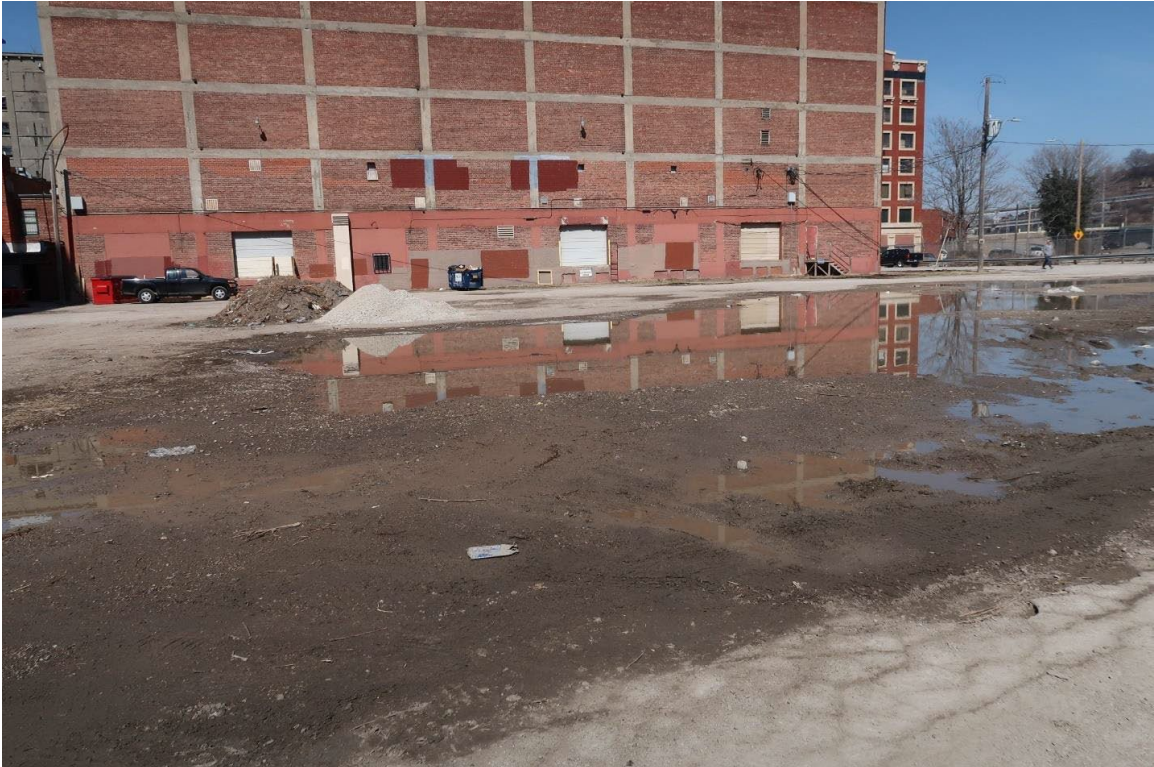
Dirt Parking Lot At 1015 Mulberry Street – 2022

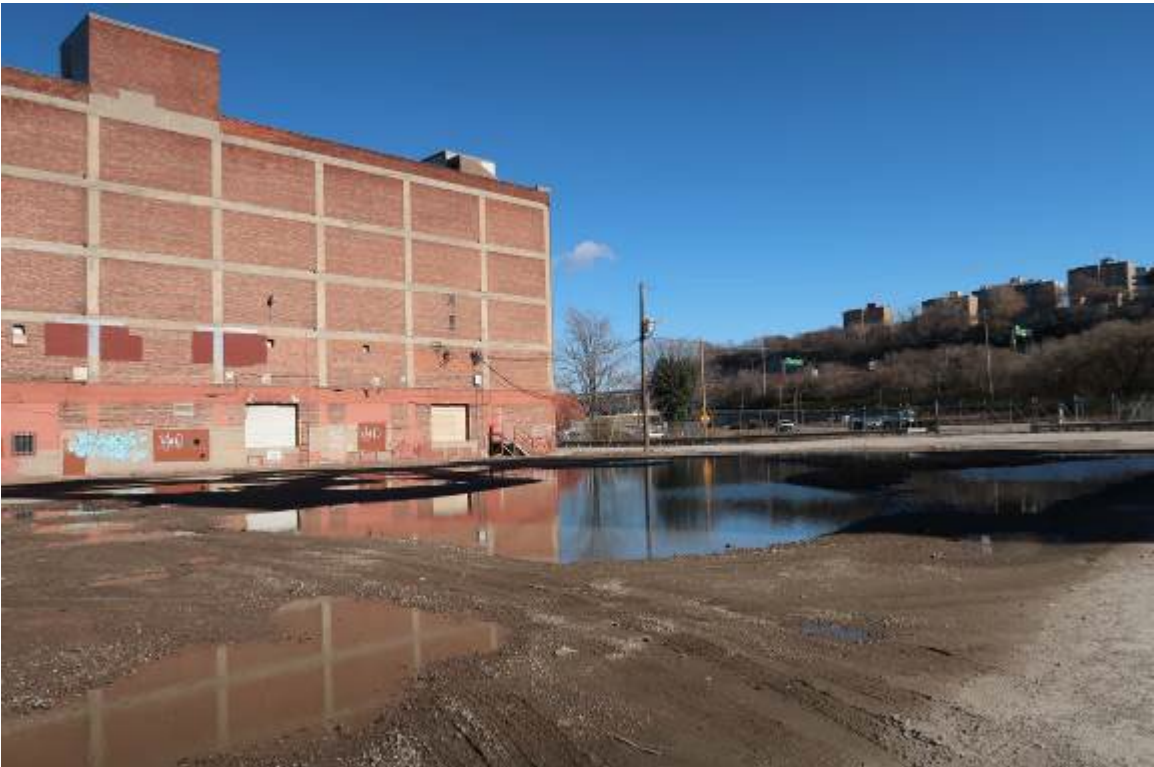
Dirt Lot Parking At 1015 Mulberry Street – 2023
