# QUALIFICATION ANALYSIS

29<sup>TH</sup> & BENTON PIEA STUDY AREA  
NWQ BENTON BOULEVARD & E 29<sup>TH</sup> STREET  
KANSAS CITY, MISSOURI

APRIL 3, 2020  
RECORD NO. 1730

BELKE APPRAISAL & CONSULTING SERVICES, INC.

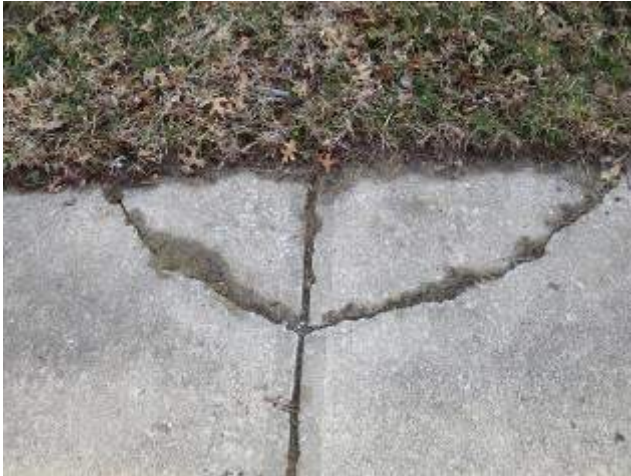
Public Sidewalk – E 29<sup>th</sup> Street

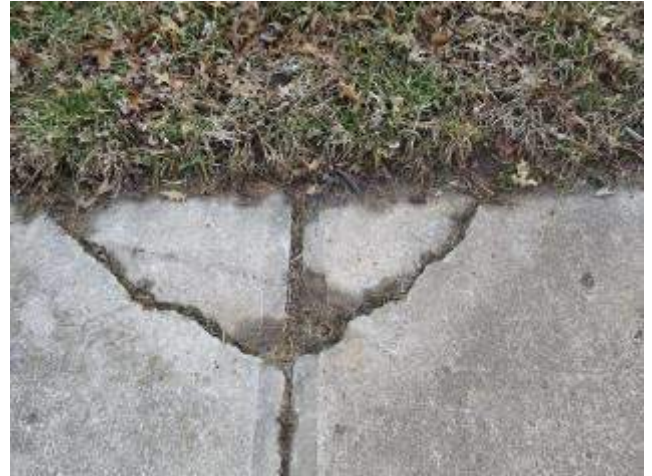
Public Sidewalk – E 29<sup>th</sup> Street

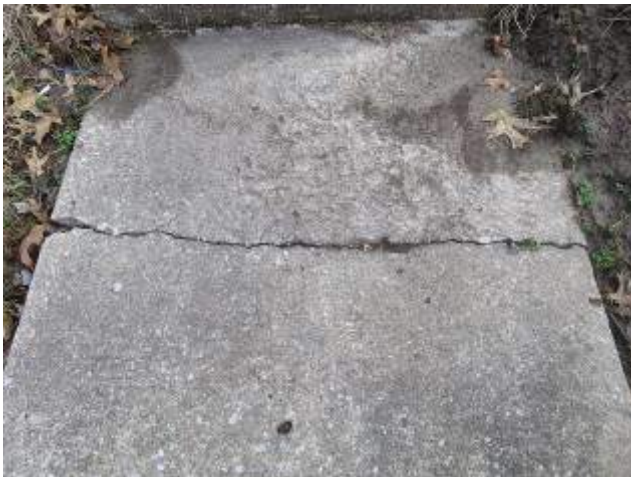
Private Walkway – Parking Lot

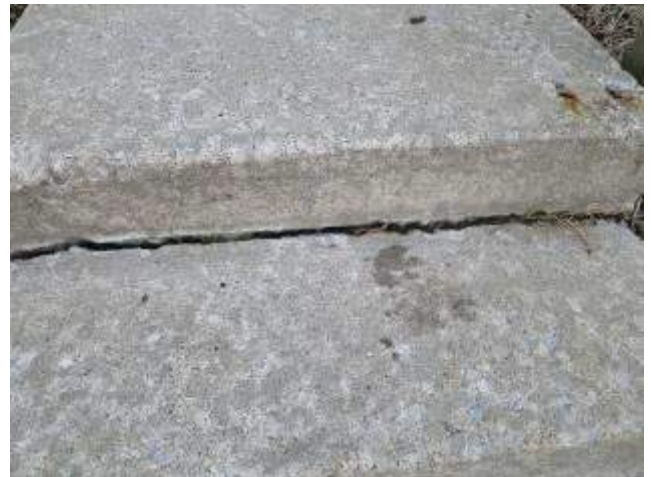
Private Walkway – Parking Lot

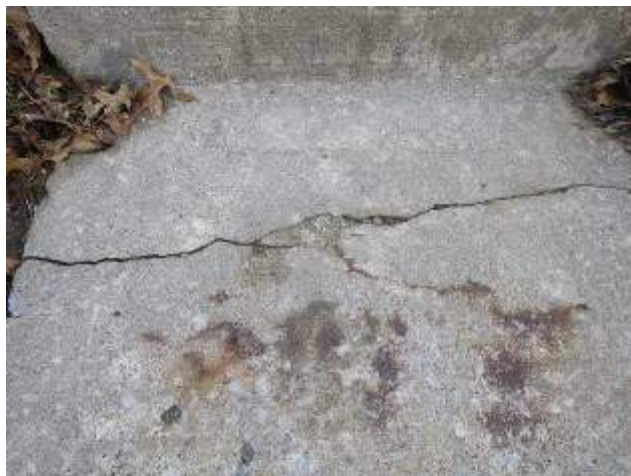
Private Walkway – Parking Lot

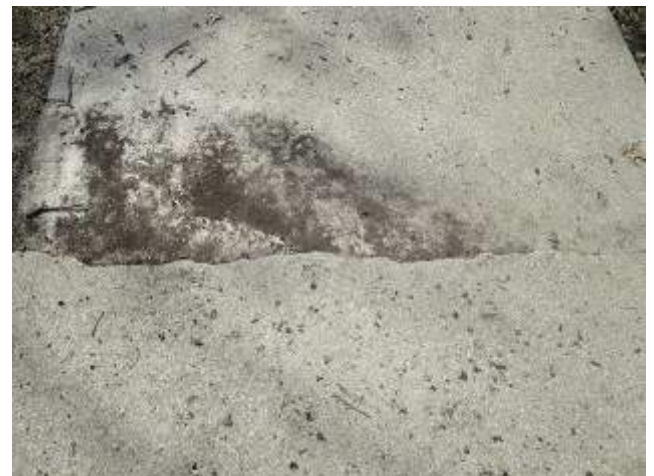
Private Walkway – Parking Lot

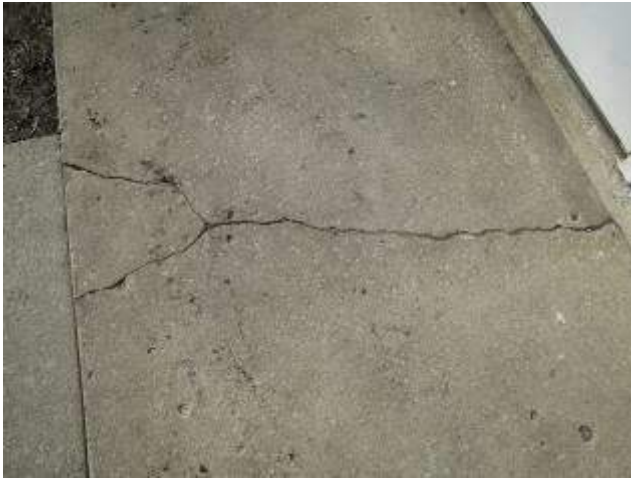
Entrance Stoop – E 29<sup>th</sup> Street

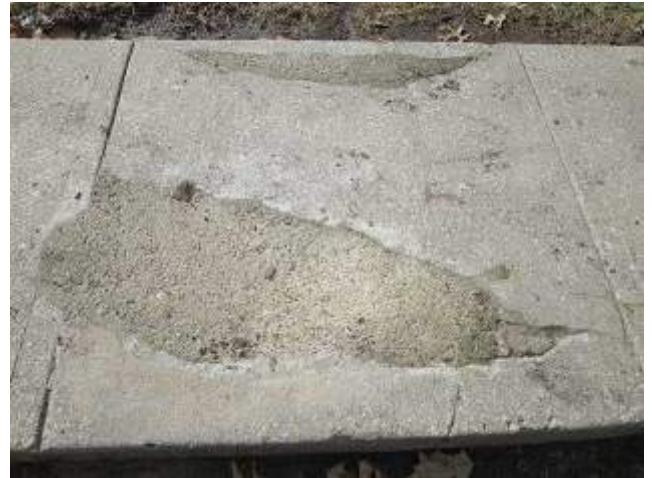
Private Walkway – E 29<sup>th</sup> Street

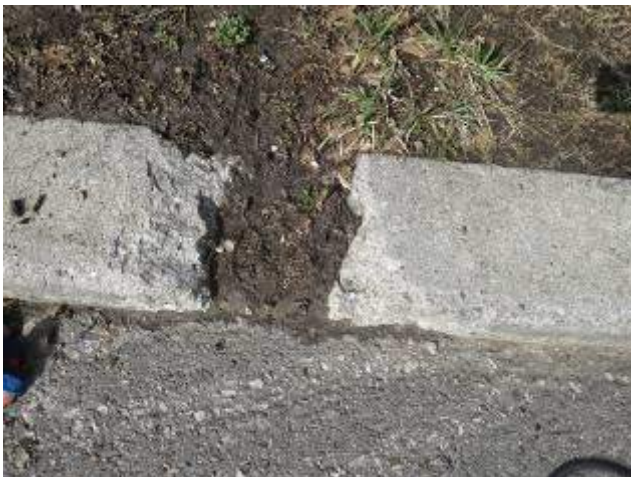
Curb – E 29<sup>th</sup> Street

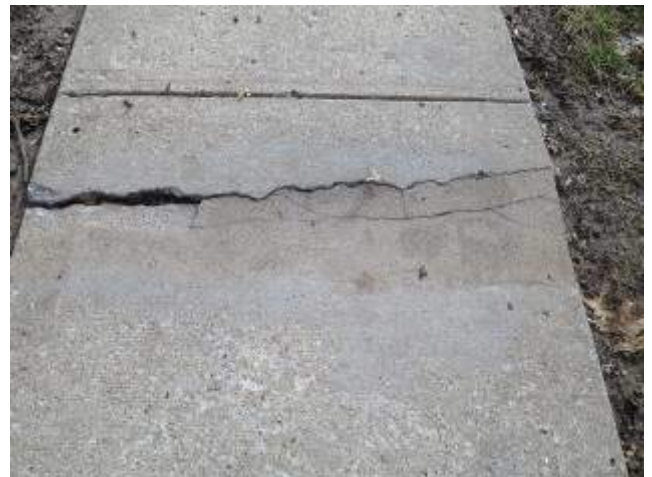
Public Sidewalk – E 29<sup>th</sup> Street

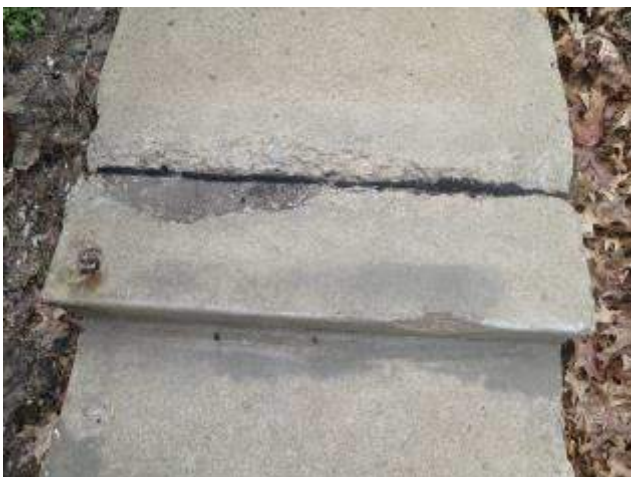
Private Walkway – E 29<sup>th</sup> Street

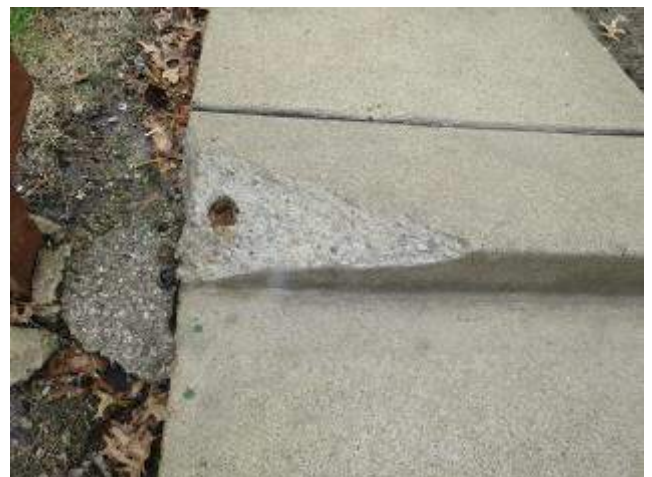
Private Walkway – E 29<sup>th</sup> Street

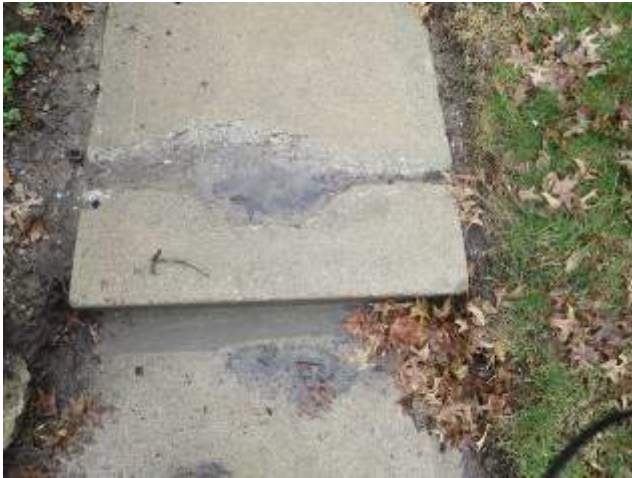
Private Walkway – E 29<sup>th</sup> Street

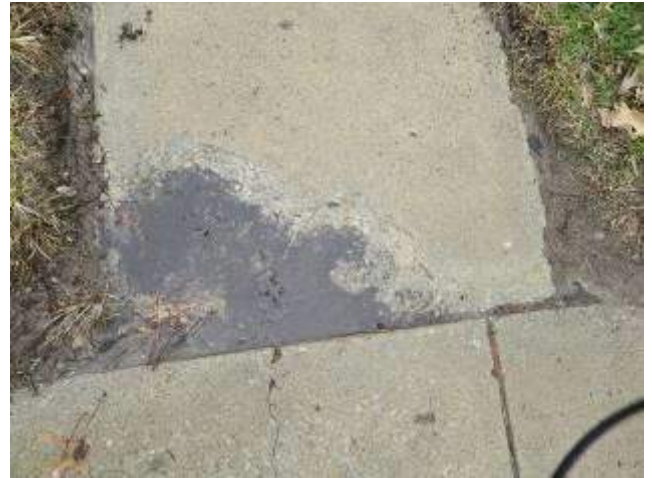
Private Walkway – E 29<sup>th</sup> Street

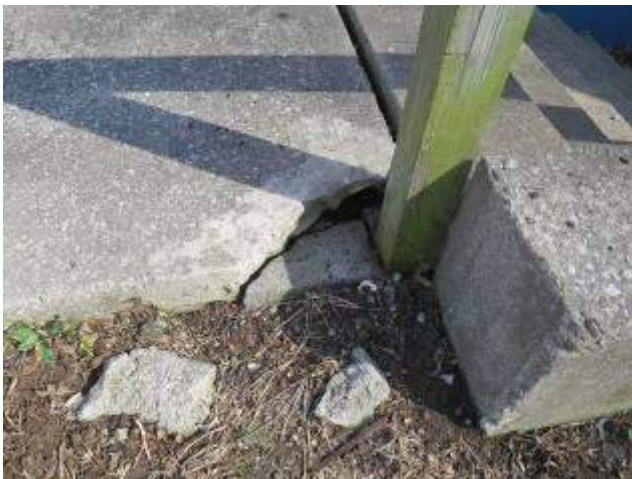
Private Walkway – E 29<sup>th</sup> Street

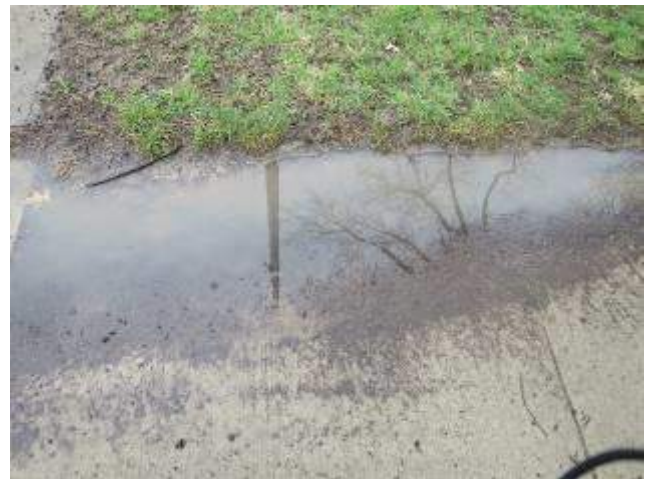
Private Walkway – E 29<sup>th</sup> Street

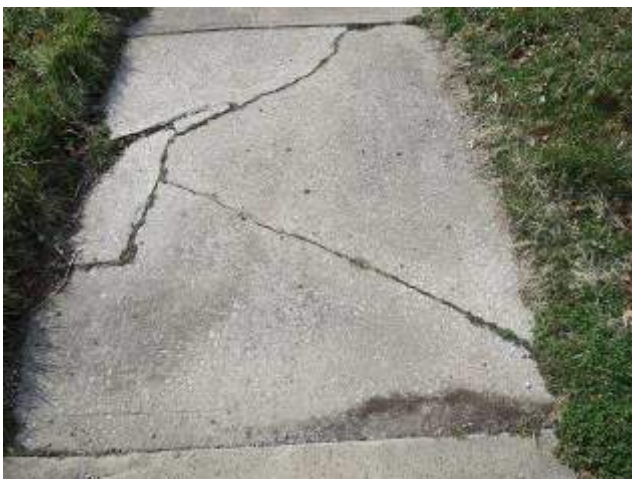
Public Sidewalk – Victor Street

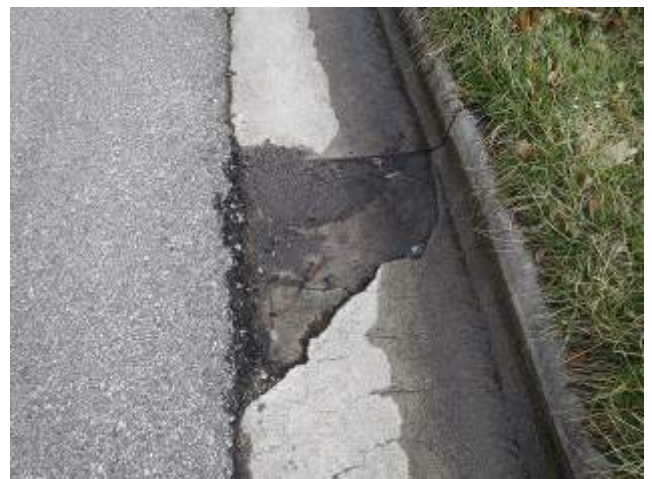
Curbing – Victor Street

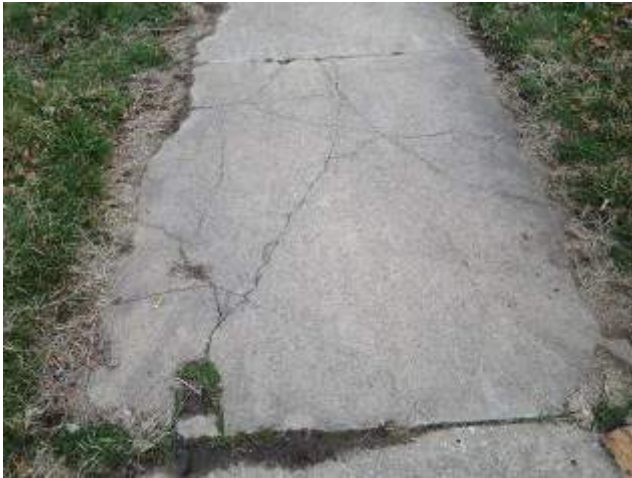
Public Sidewalk – Victor Street

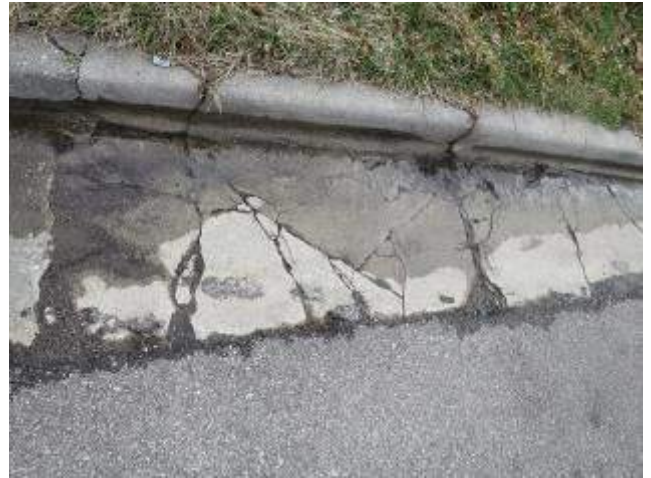
Curbing – Victor Street

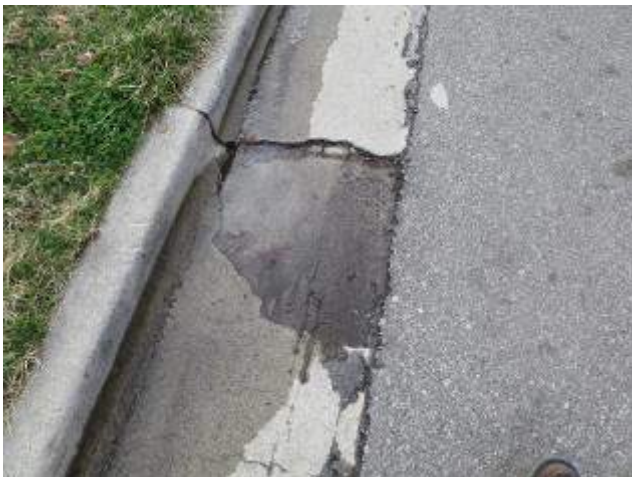
Curbing – Victor Street

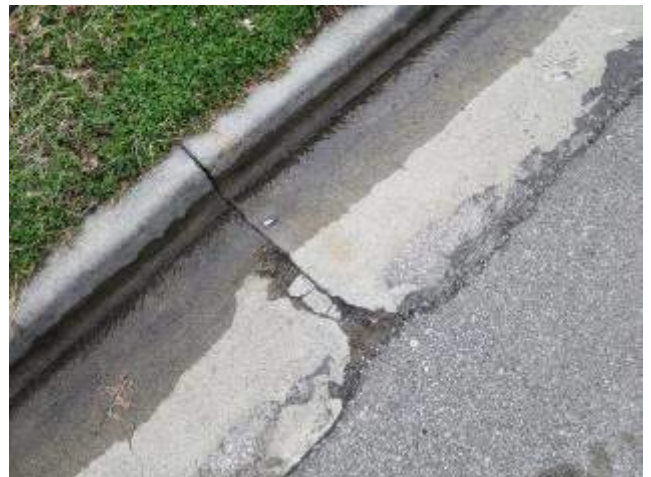
Curbing – Victor Street

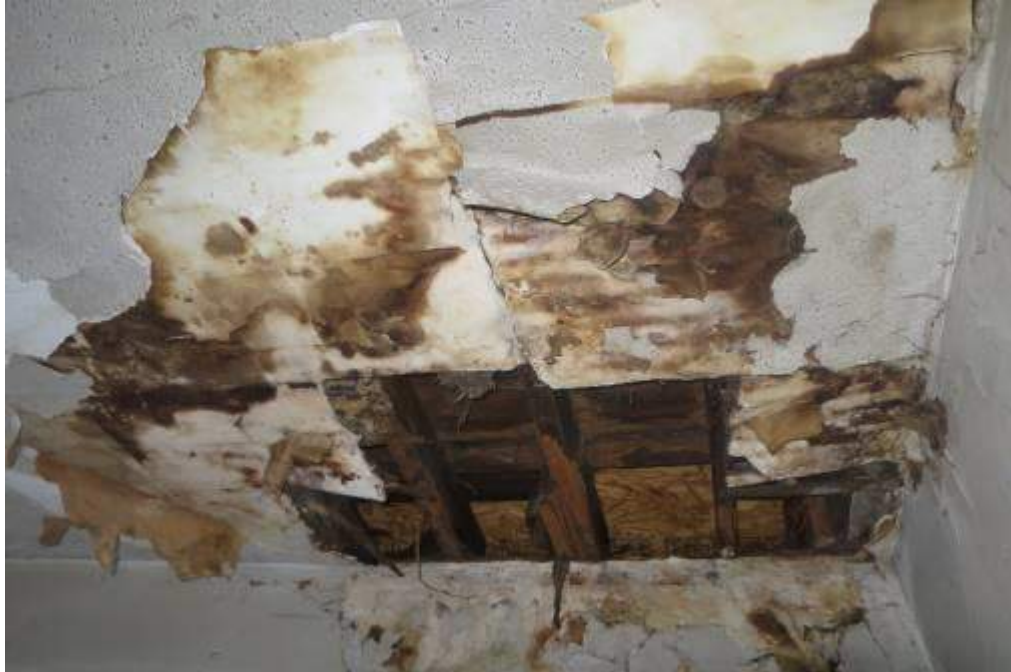
Ceiling Damage & Water Infiltration – 2651 Victor Street

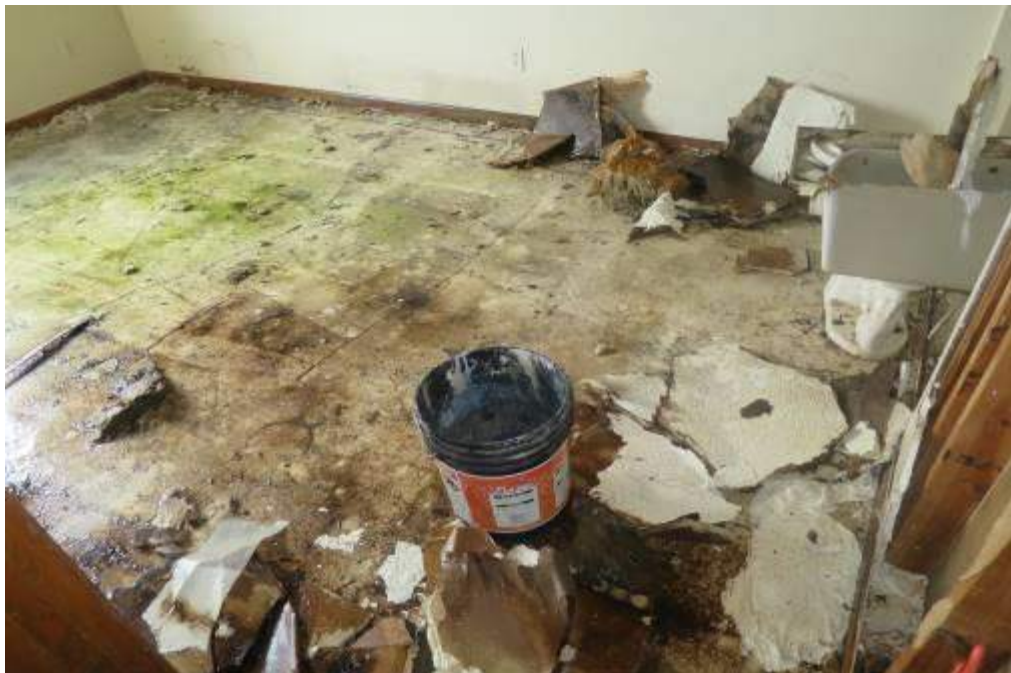
Interior Damage & Water Infiltration – 2644 E 29<sup>th</sup> Street

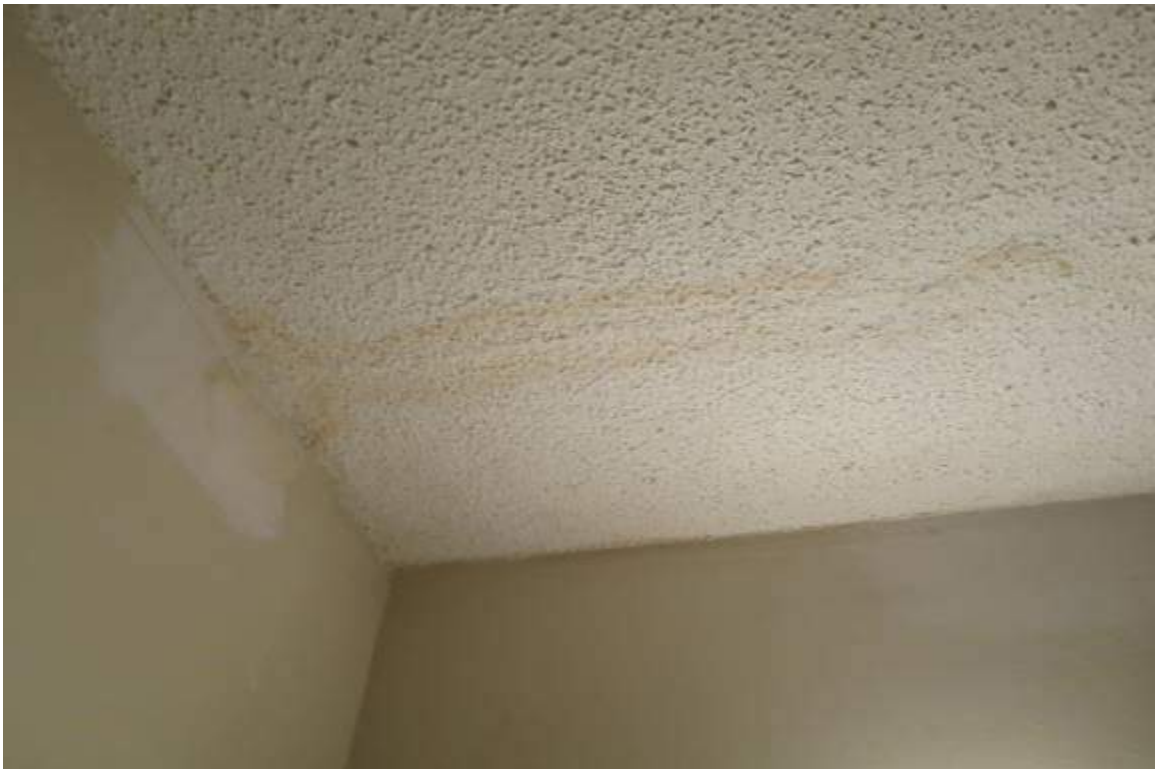
Potential ACMs – Textured Ceiling – 2702 E 29<sup>th</sup> Street

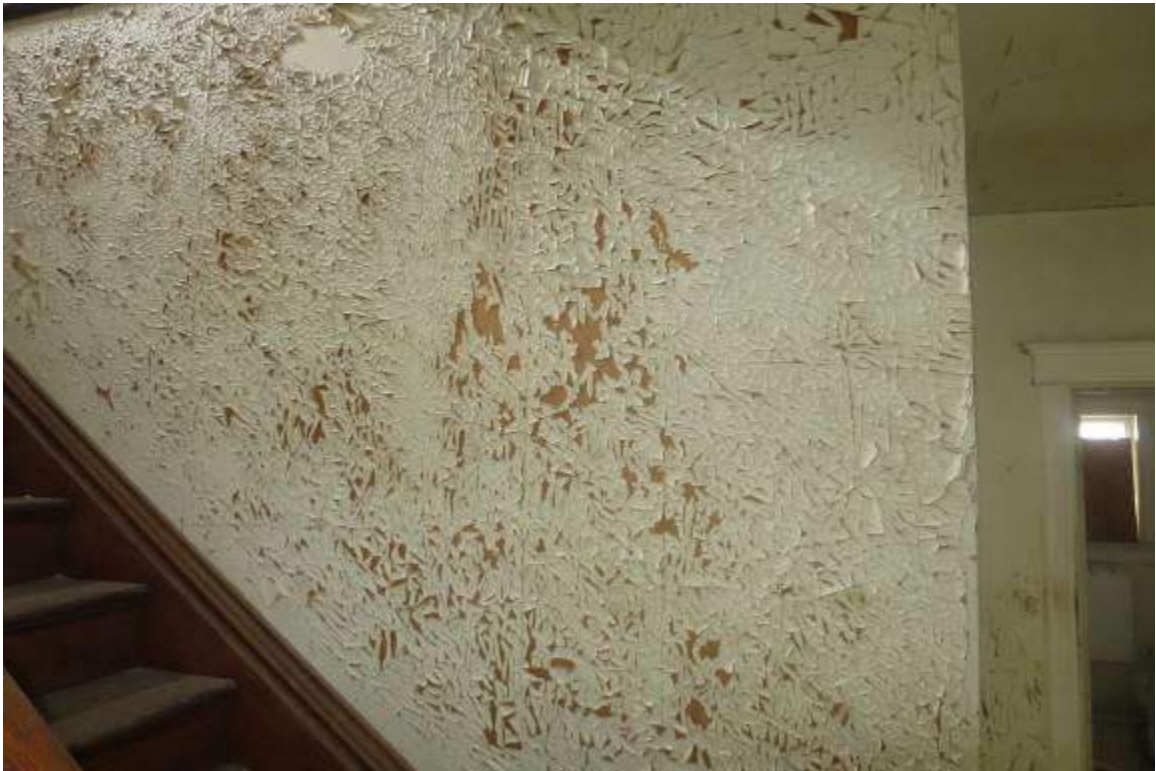
Lead-based paint and piping was not banned until 1978. Considering the improvements in the study area date to 1905 and 1971, various building components might be affected negatively. Extensive peeling paint was observed inside 2651 Victor Street that might easily predate 1978.

Potential Lead-Based Paint – 2651 Victor Street

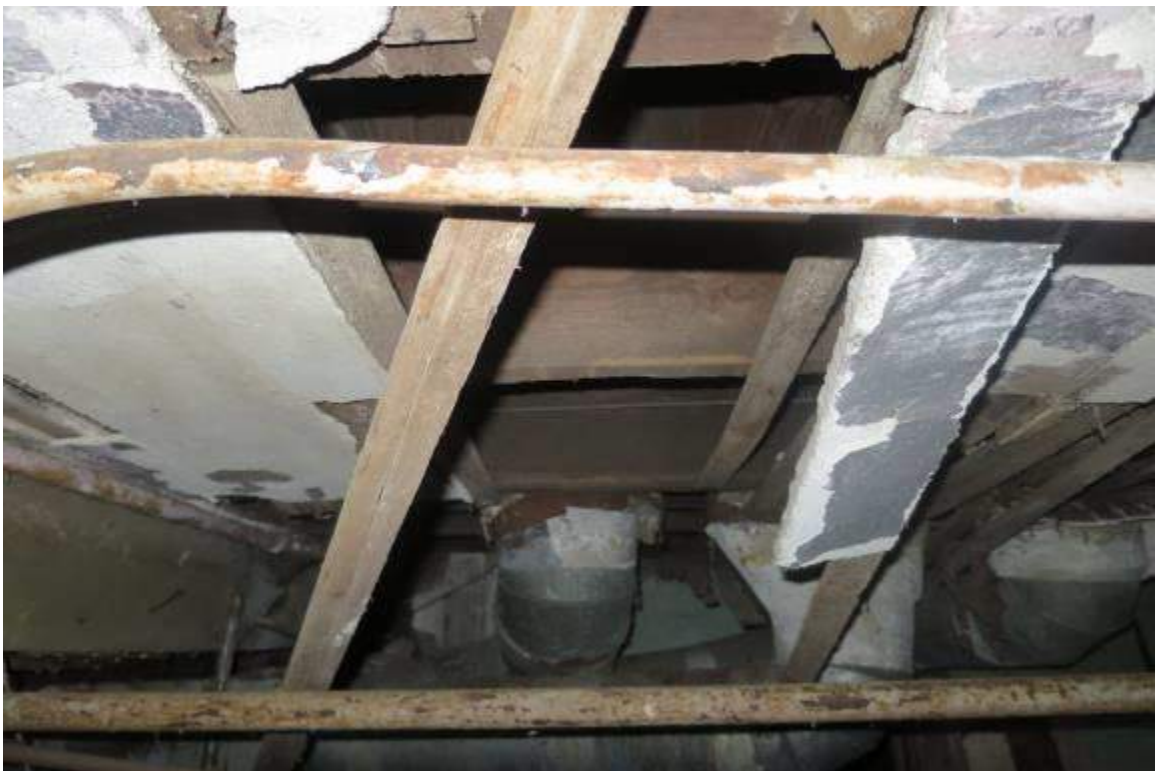
Potential Lead-Based Piping – 2651 Victor Street

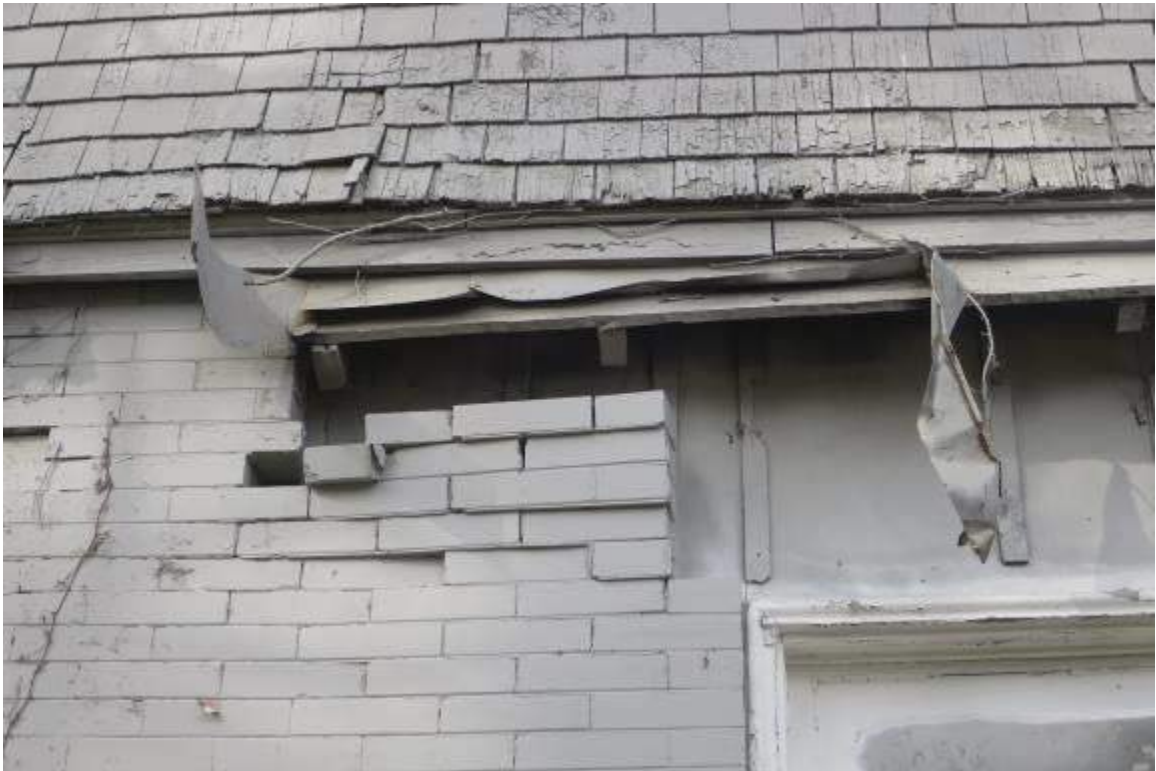
Collapsing Wall Structures – 2651 Victor Street

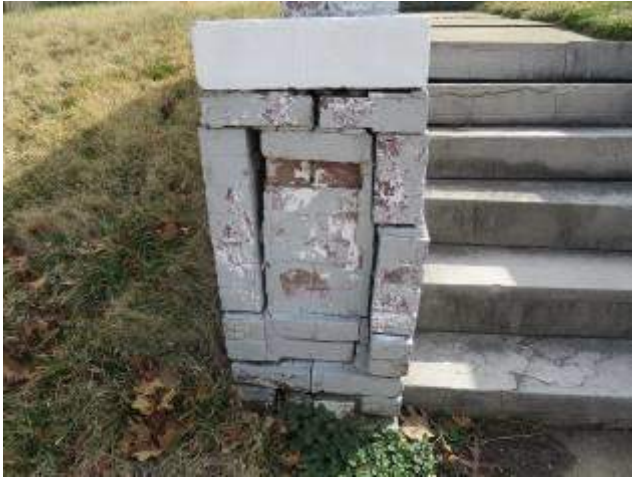
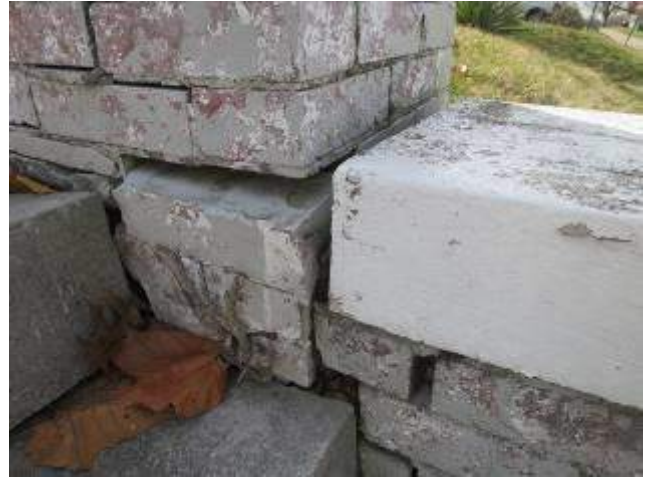
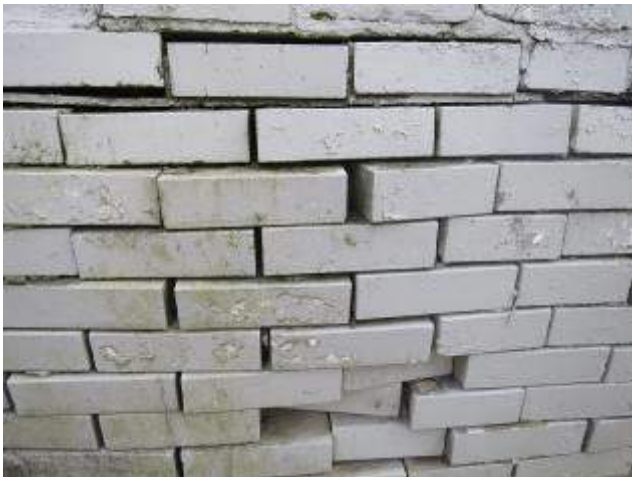
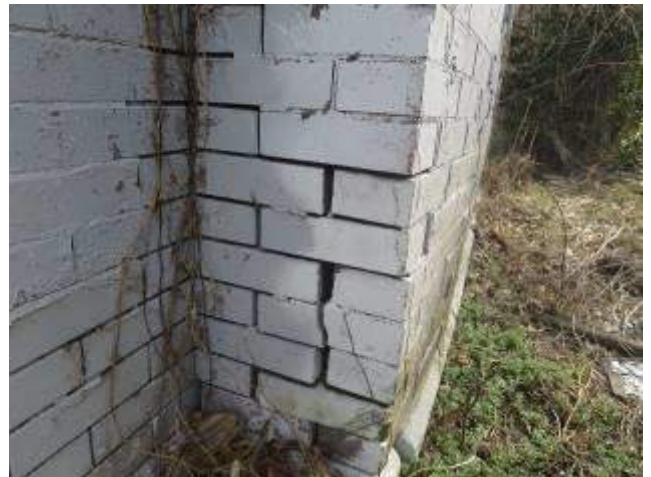
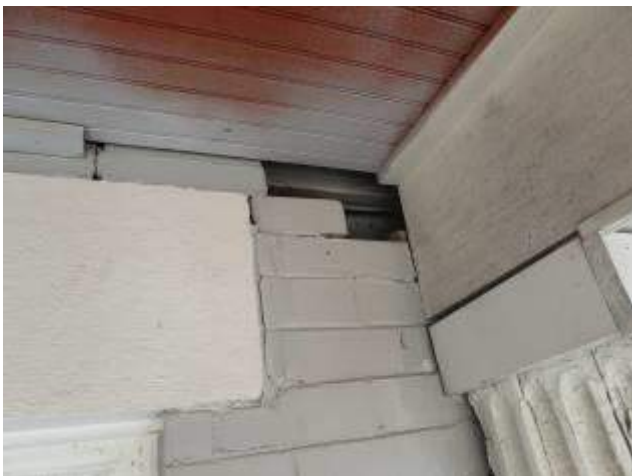
## INSANITARY OR UNSAFE CONDITIONS – COLLAPSING STRUCTURES

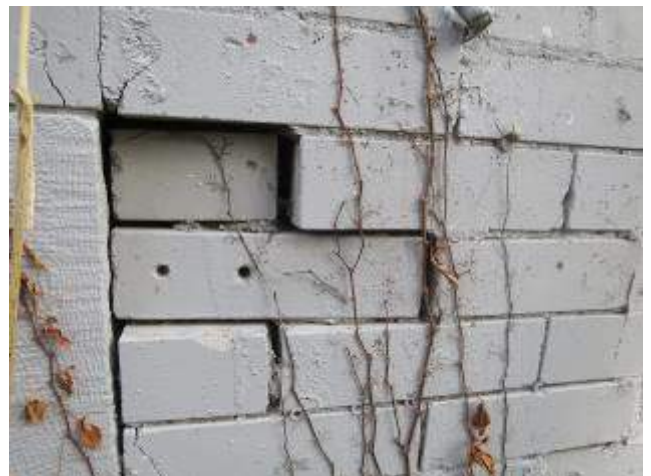
Bricks are dislodging in numerous areas from the exterior, porches, and walkway structure at 2651 Victor Street. A significant number of wood and composition shingles (mansard) are dislodging at 2644 E 29<sup>th</sup> Street. Ceilings, walls, and floors have collapsed throughout 2644 E 29<sup>th</sup> Street and 2651 Victor Street due to water leaks from deteriorated roofs.

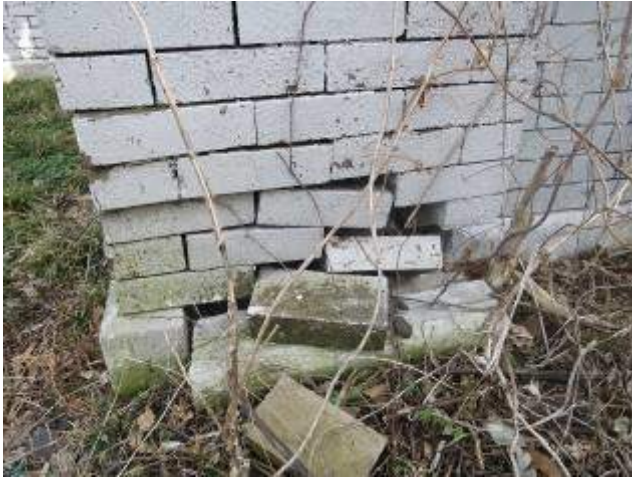
2651 Victor Street

**INSANITARY OR UNSAFE CONDITIONS – COLLAPSING STRUCTURES**

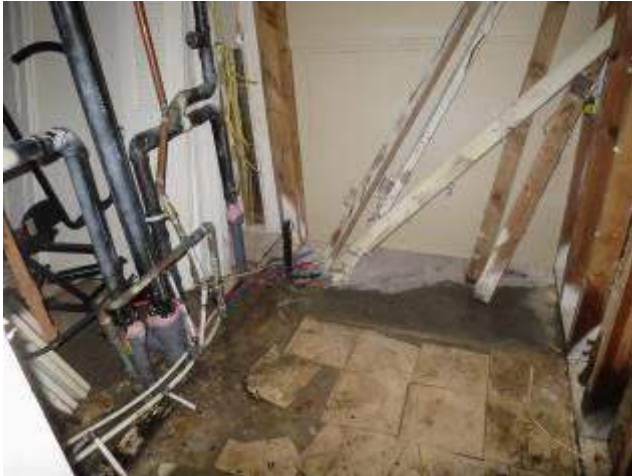
Extensive black substance was observed within 2644 E 29<sup>th</sup> Street and 2651 Victor Street due to roof failure. Extensive ceiling damage and dripping and standing water was observed throughout 2644 E 29<sup>th</sup> Street while extensive ceiling damage was observed at 2651 Victor Street. The CDC (Centers for Disease Control and Prevention) indicates the Institute of Medicine (IOM) found sufficient evidence in 2004 to link indoor exposure to mold with upper respiratory tract symptoms, cough, and wheeze in otherwise healthy people; with asthma symptoms in people with asthma; and with hypersensitivity pneumonitis in individuals susceptible to that immune-mediated condition. In 2009, the World Health Organization issued additional guidance on exposure to mold.

**INSANITARY OR UNSAFE CONDITIONS – FLOOR DAMAGE & WATER INFILTRATION**

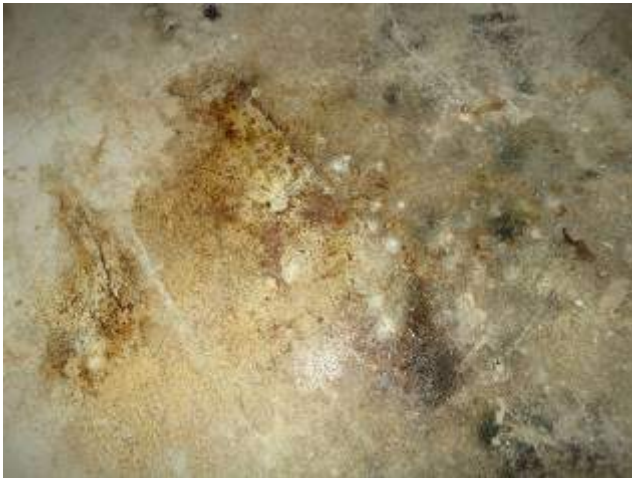
2644 E 29<sup>th</sup> Street

**INSANITARY OR UNSAFE CONDITIONS – FLOOR DAMAGE & WATER INFILTRATION**

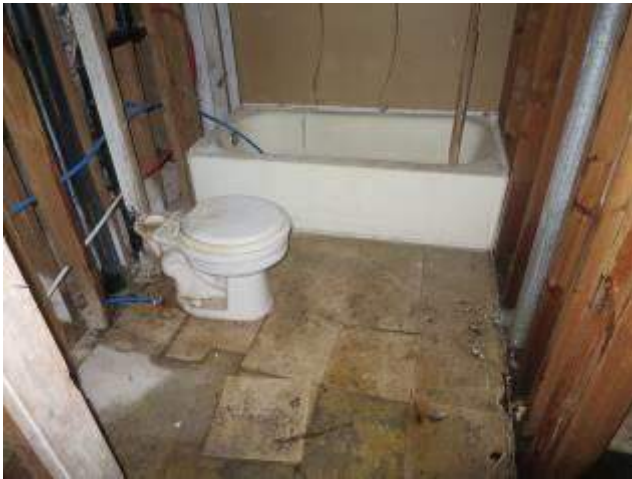
2644 E 29<sup>th</sup> Street

**INSANITARY OR UNSAFE CONDITIONS – FLOOR DAMAGE & WATER INFILTRATION**

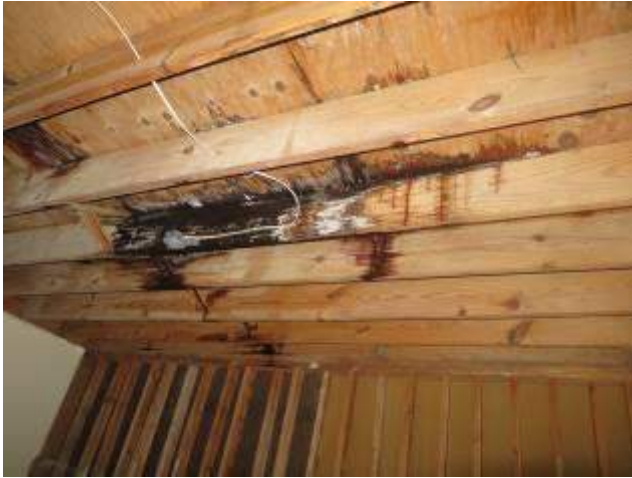
2644 E 29<sup>th</sup> Street

**INSANITARY OR UNSAFE CONDITIONS – CEILING DAMAGE & WATER INFILTRATION**

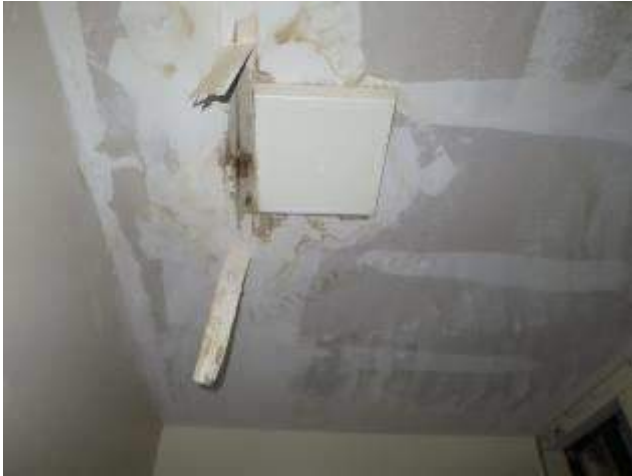
2644 E 29<sup>th</sup> Street

**INSANITARY OR UNSAFE CONDITIONS – CEILING DAMAGE & WATER INFILTRATION**

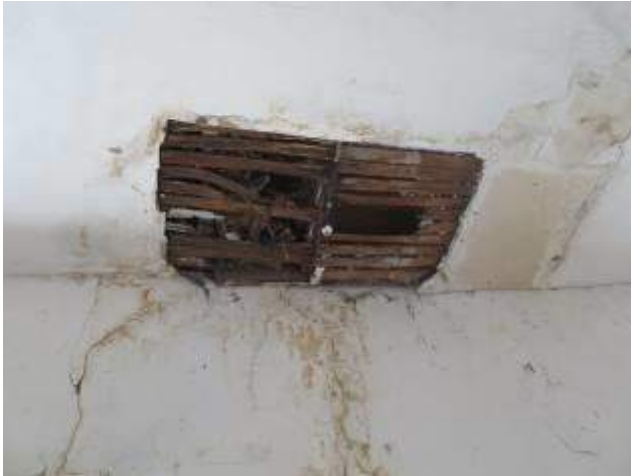
2651 Victor Street

**INSANITARY OR UNSAFE CONDITIONS – CEILING DAMAGE & WATER INFILTRATION**

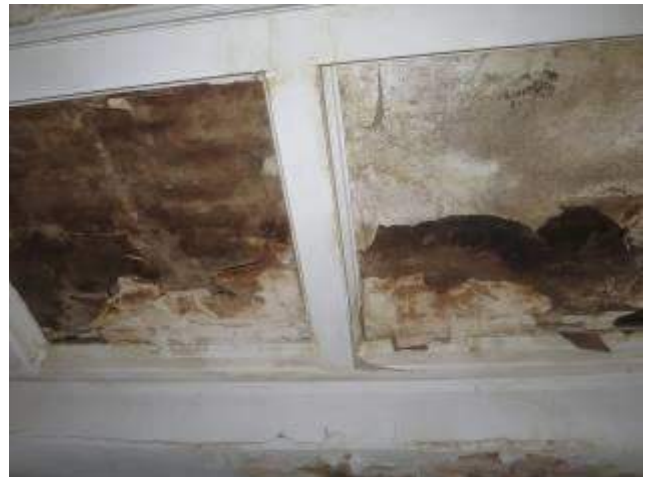
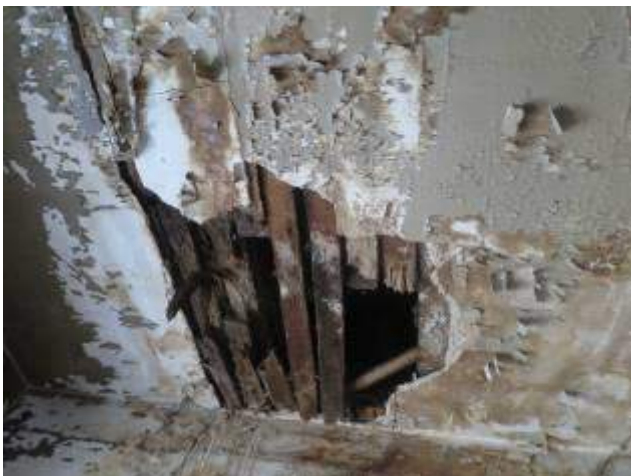
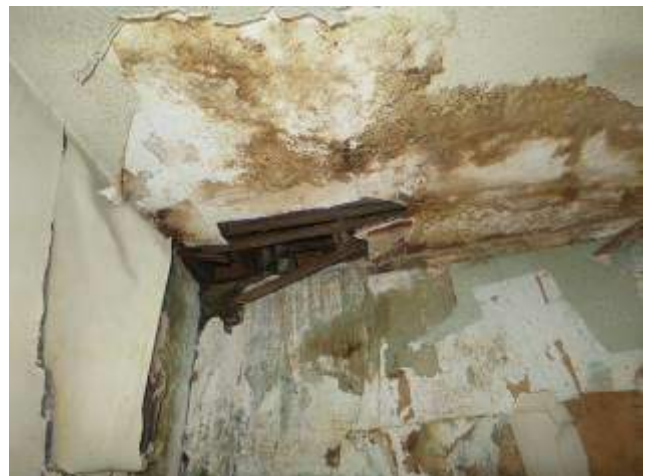
Some of the upper floor apartment units at 2702 E 29<sup>th</sup> Street exhibit water stains but no collapses have occurred. Ceiling collapses have occurred at 2644 E 29<sup>th</sup> Street and 2651 Victor Street due to water infiltration, advanced age, and lack of maintenance.

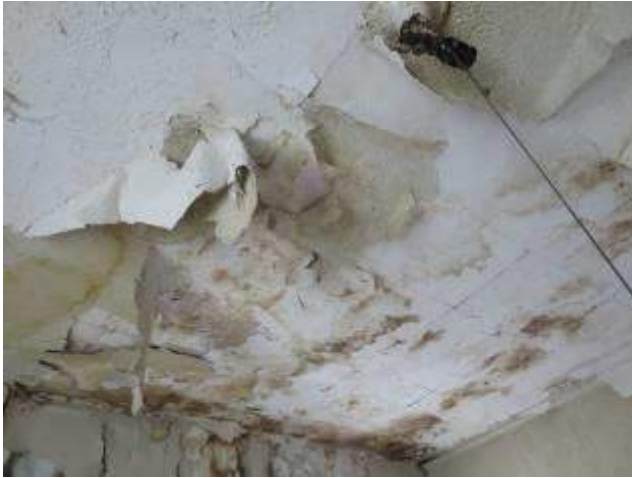
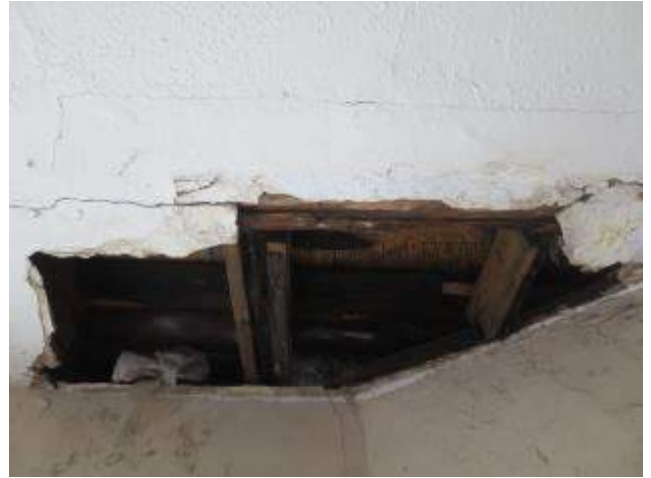
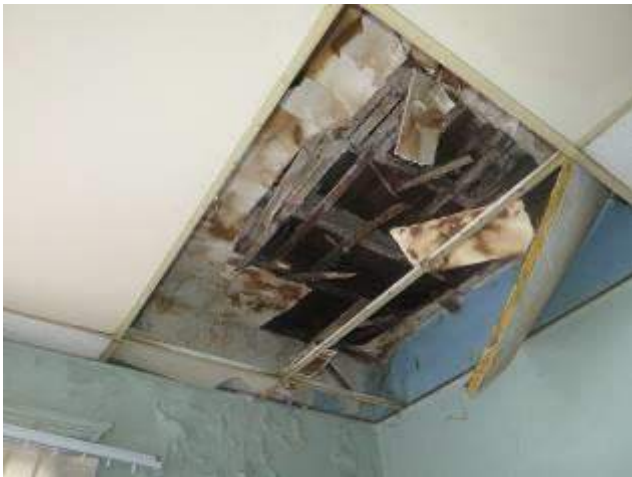
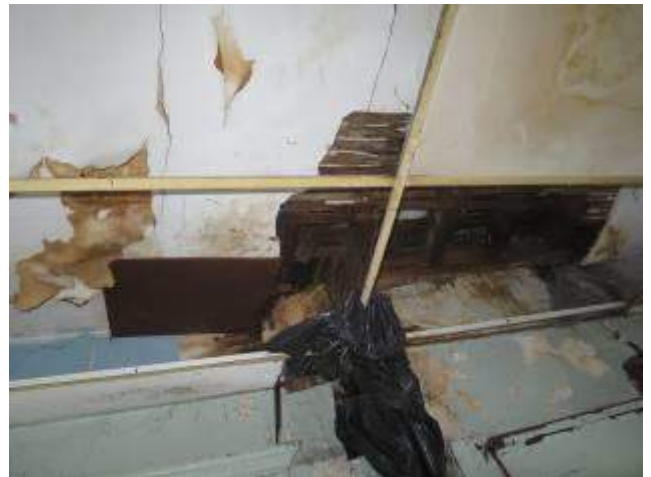
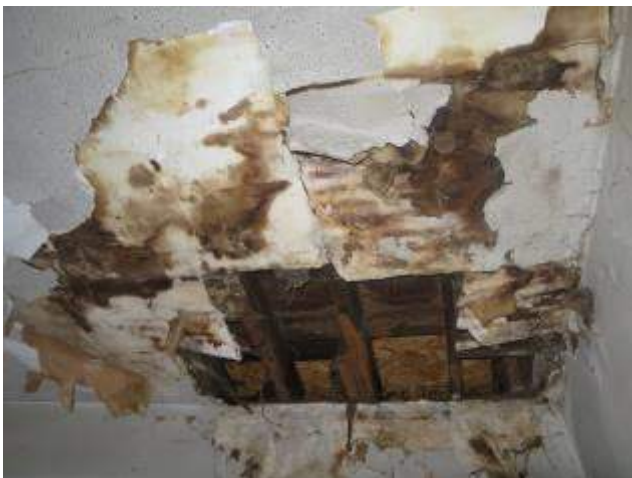
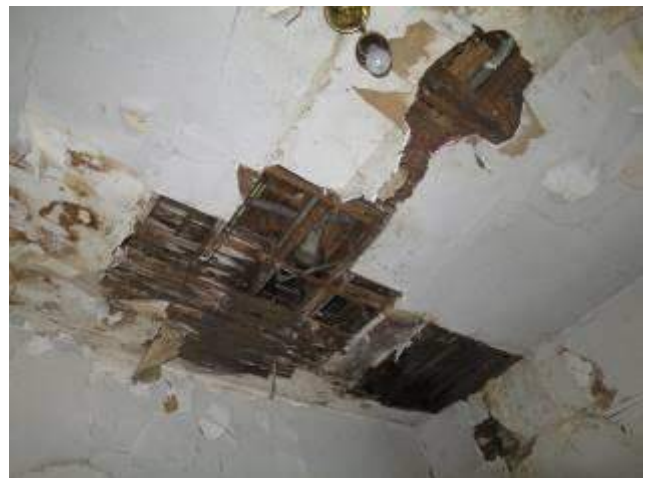
2651 Victor Street

**INSANITARY OR UNSAFE CONDITIONS – CEILING DAMAGE & WATER INFILTRATION**

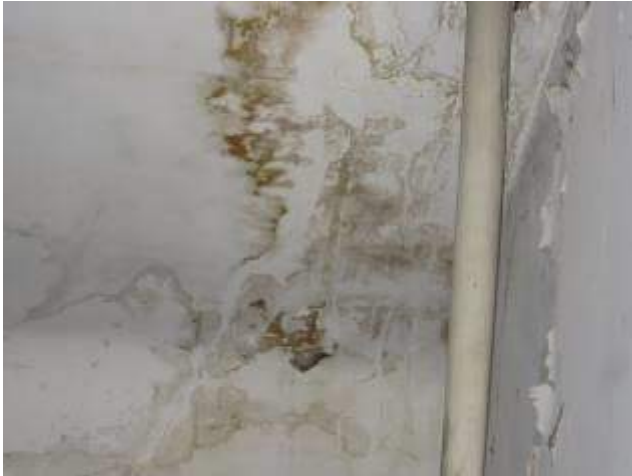
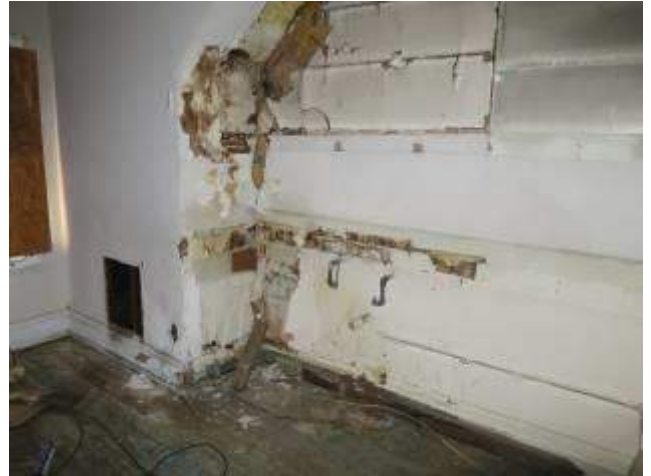
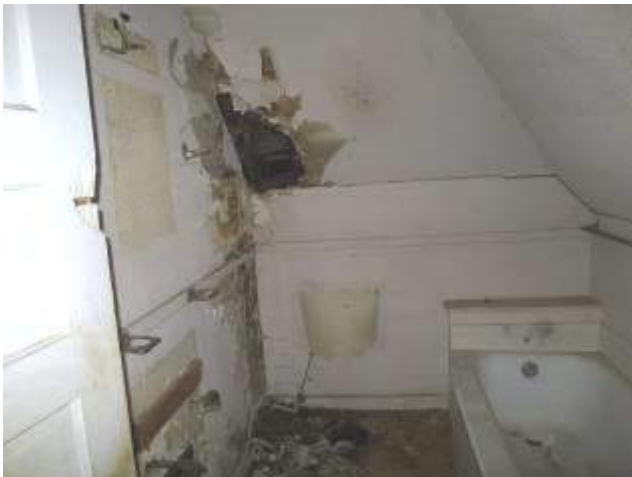
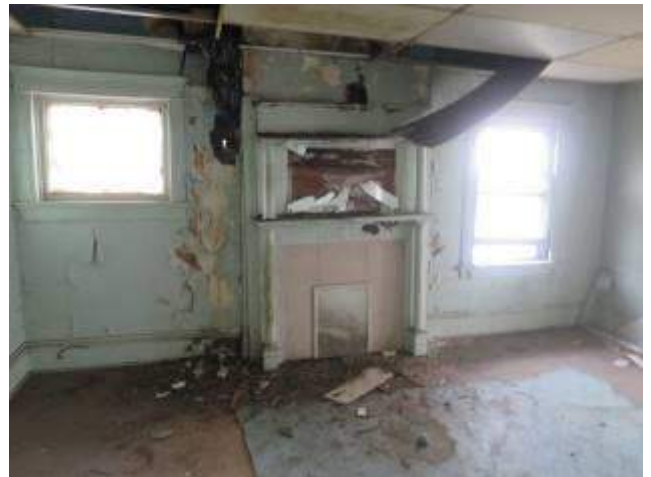
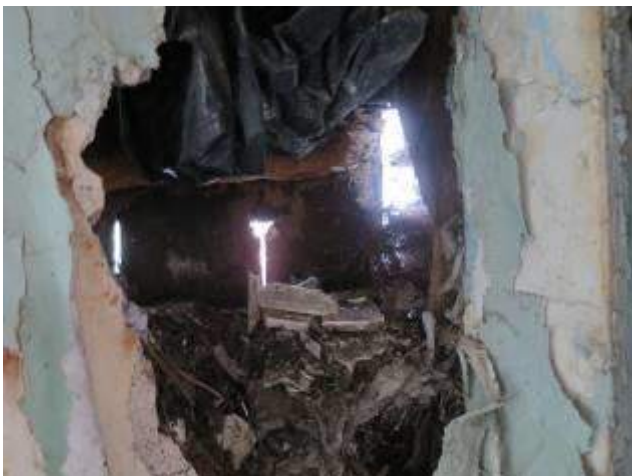
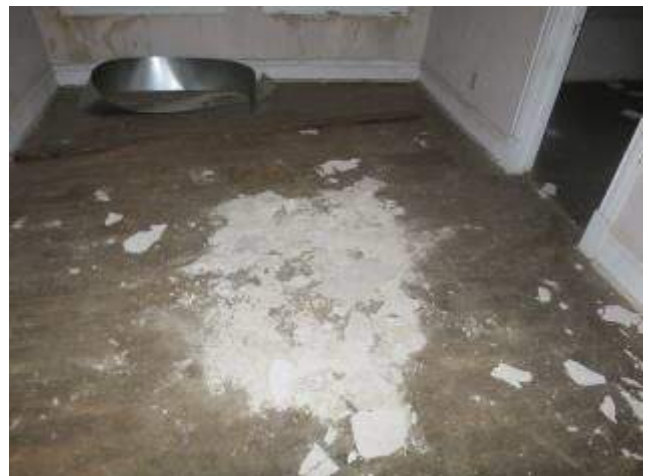
2651 Victor Street

**INSANITARY OR UNSAFE CONDITIONS – CEILING DAMAGE & WATER INFILTRATION**
