# QUALIFICATION ANALYSIS

29<sup>TH</sup> & BENTON PIEA STUDY AREA  
NWQ BENTON BOULEVARD & E 29<sup>TH</sup> STREET  
KANSAS CITY, MISSOURI

APRIL 3, 2020  
RECORD NO. 1730

BELKE APPRAISAL & CONSULTING SERVICES, INC.

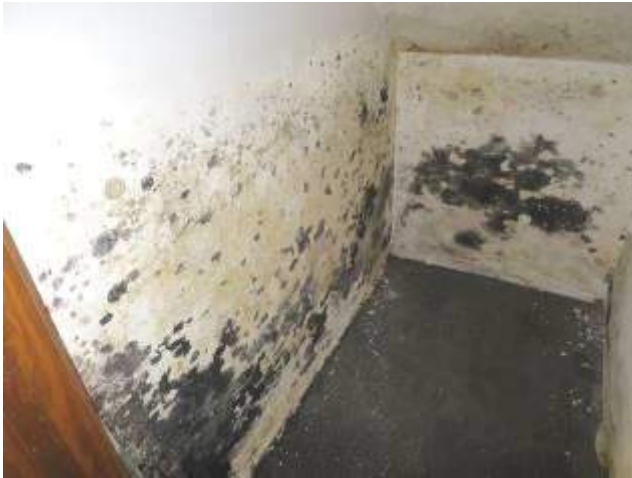
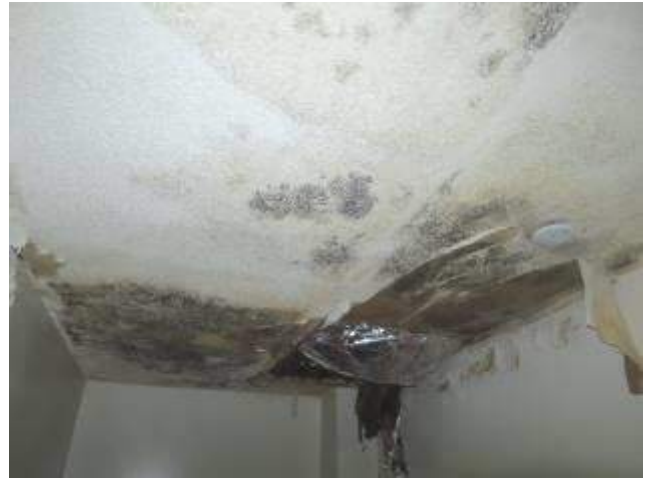
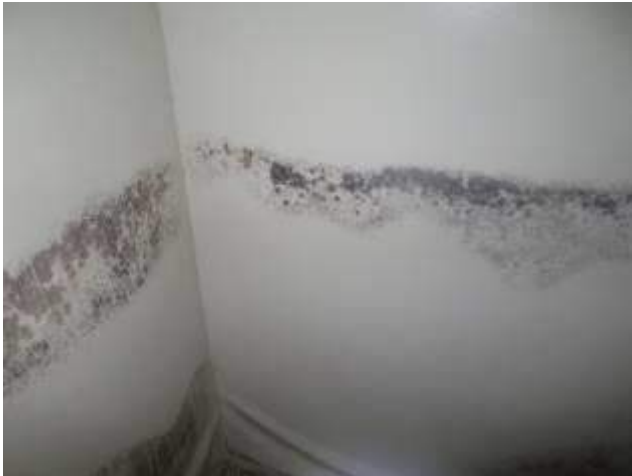
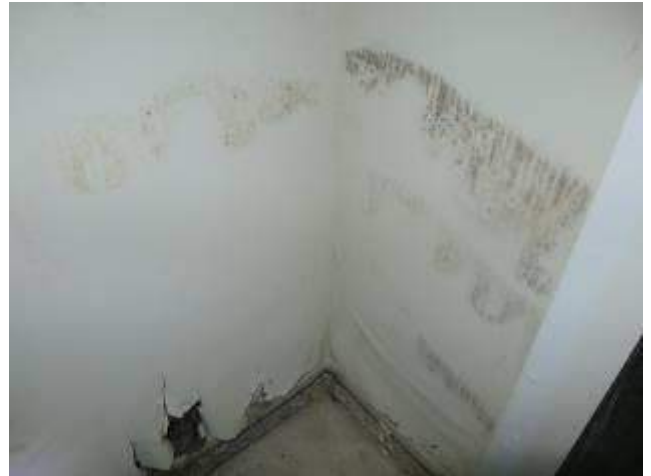
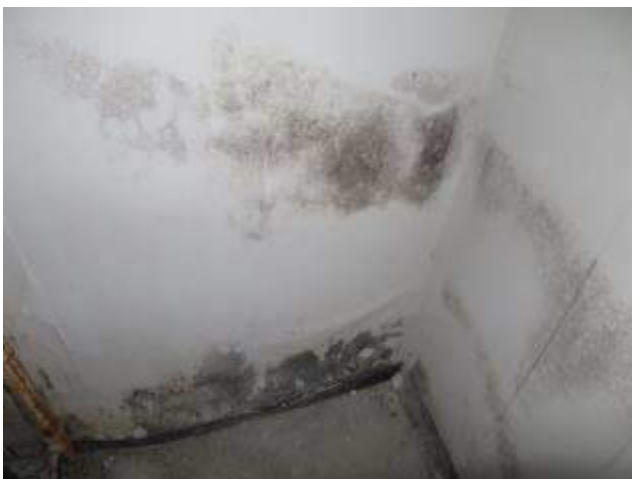
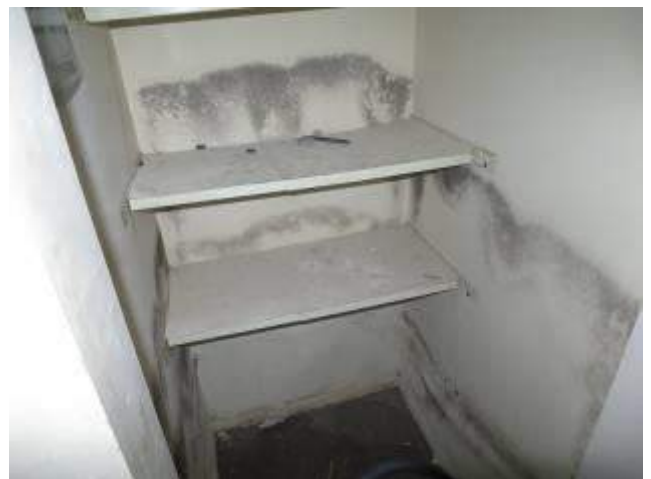
**INSANITARY OR UNSAFE CONDITIONS – WATER INFILTRATION & MOLD**

The membrane coverings on the two apartment buildings fronting E 29<sup>th</sup> Street are heavily deteriorated and need to be replaced. Water infiltration at 2644 E 29<sup>th</sup> Street has caused extensive damage throughout the structure. The city reportedly required replacement of the roof at 2651 Victor Street. Significant damage occurred to the interior of the structure due to water infiltration. Exterior drainage (gutters and downspouts) have been damaged in several locations creating erosion issues or ponding issues around the structures.

Interior walls are generally in acceptable condition at 2702 E 29<sup>th</sup> Street. Many of the interior demising walls at 2644 E 29<sup>th</sup> Street have been fully or partially removed. Water infiltration has damaged most wall surfaces. 2651 Victor Street also has extensive wall damage due to advancing age and water infiltration including openings to the outside.

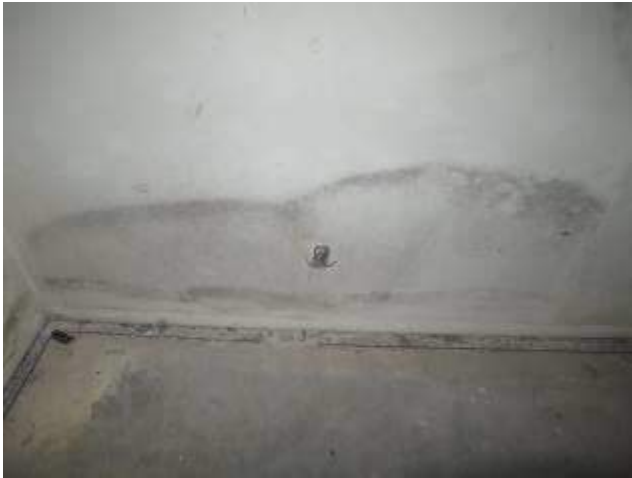
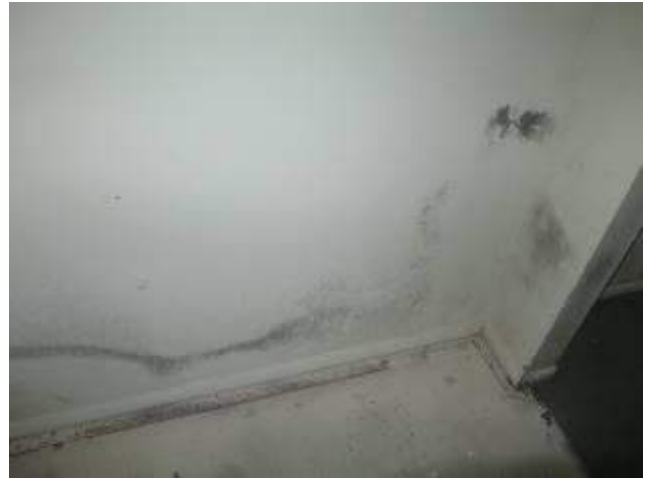
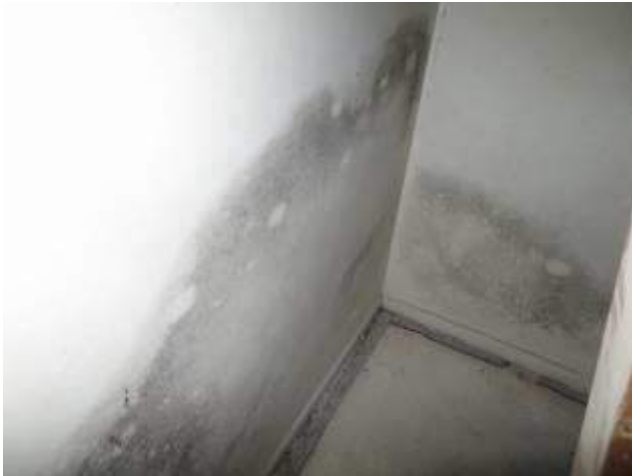
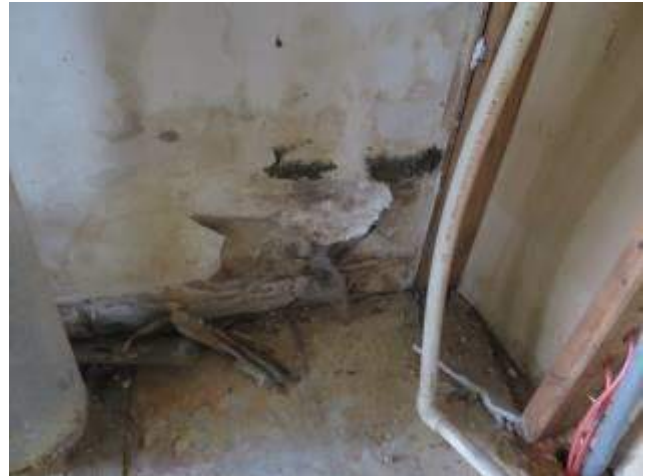
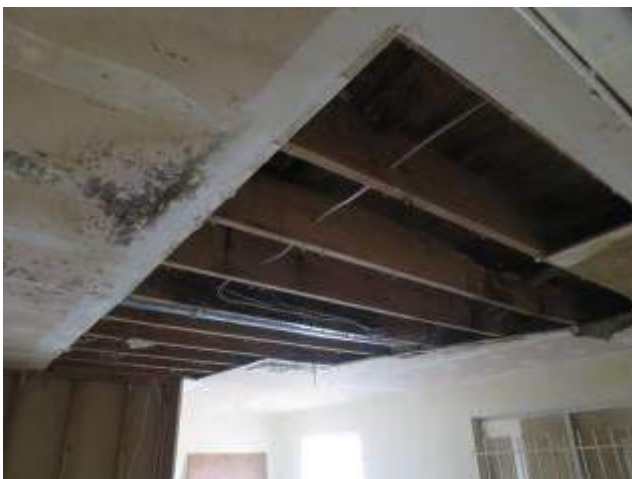
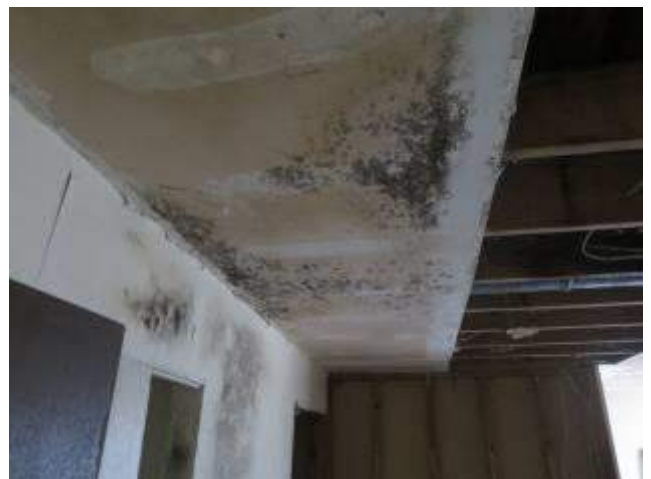
2644 E 29<sup>th</sup> Street

**INSANITARY OR UNSAFE CONDITIONS – WATER INFILTRATION & MOLD**

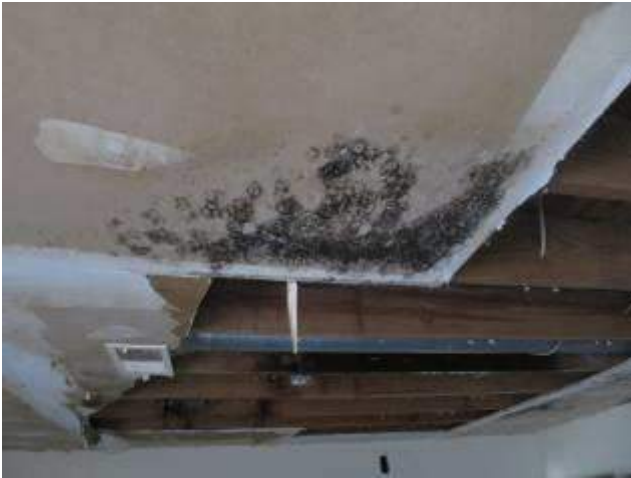
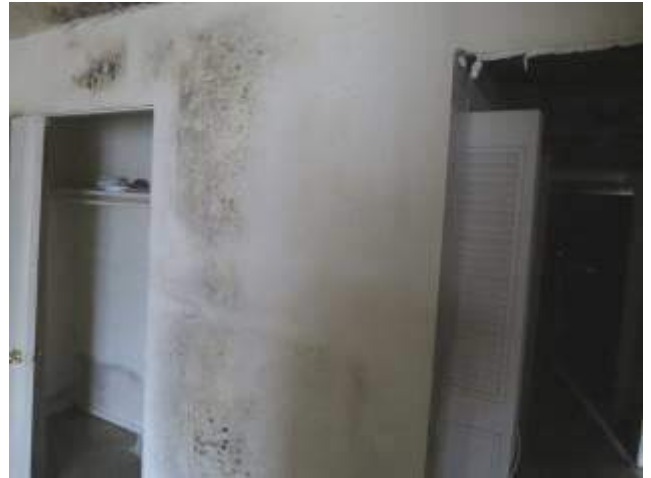
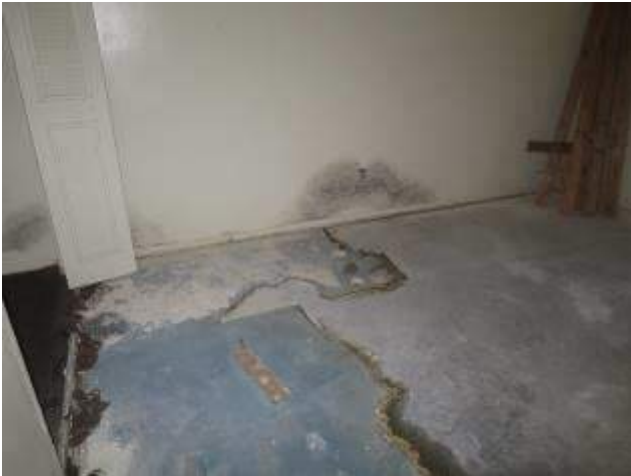
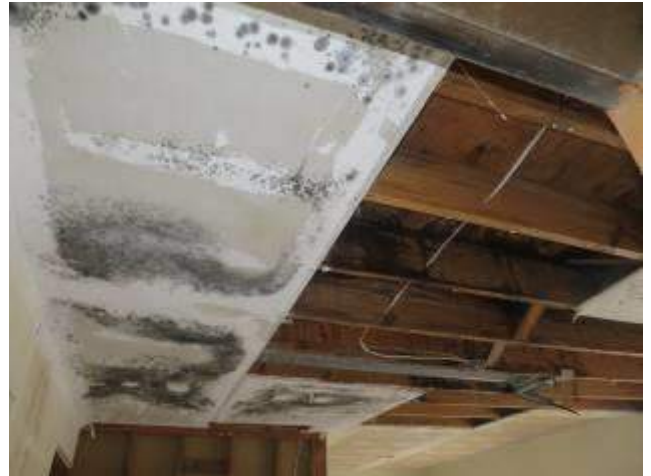
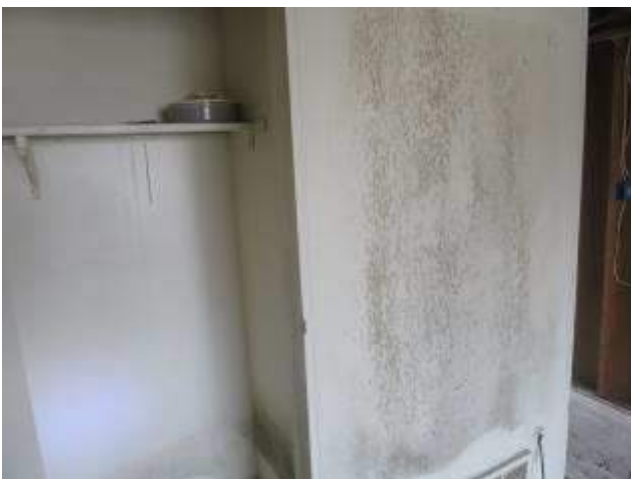
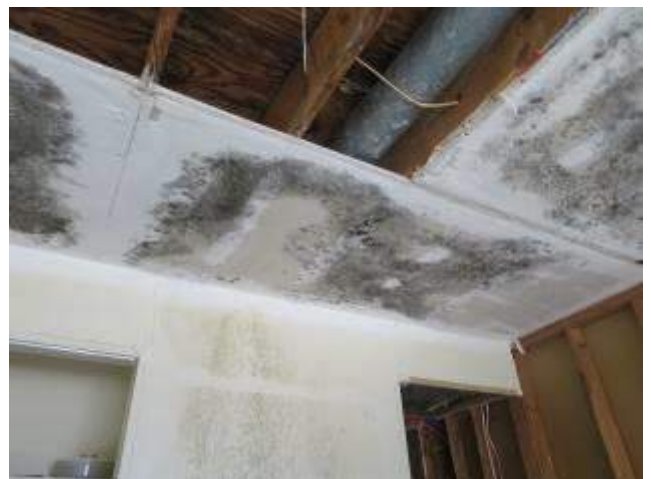
2644 E 29<sup>th</sup> Street

**INSANITARY OR UNSAFE CONDITIONS – WATER INFILTRATION & MOLD**

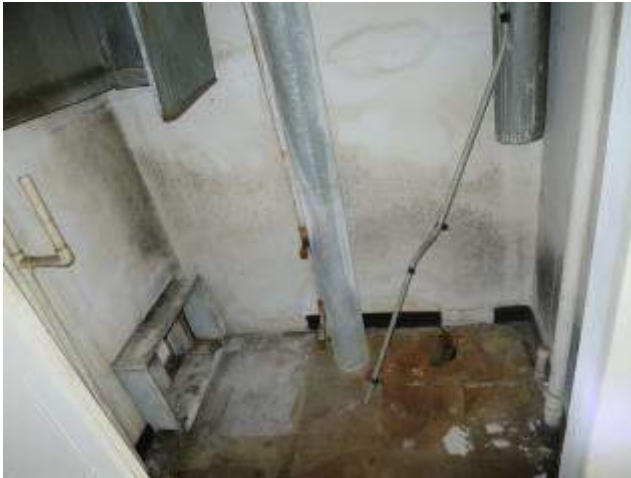
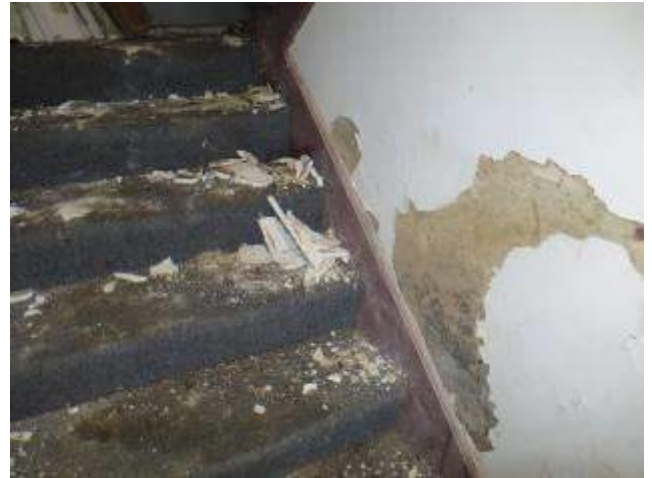
2644 E 29<sup>th</sup> Street

**INSANITARY OR UNSAFE CONDITIONS – WATER INFILTRATION & MOLD**

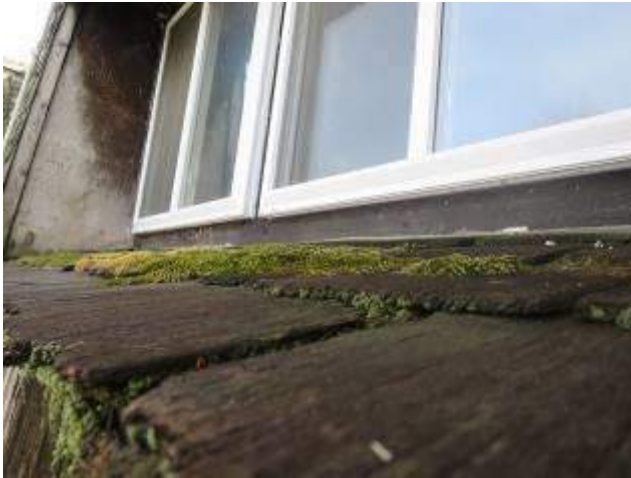
2644 E 29<sup>th</sup> Street

**INSANITARY OR UNSAFE CONDITIONS – MOSS**

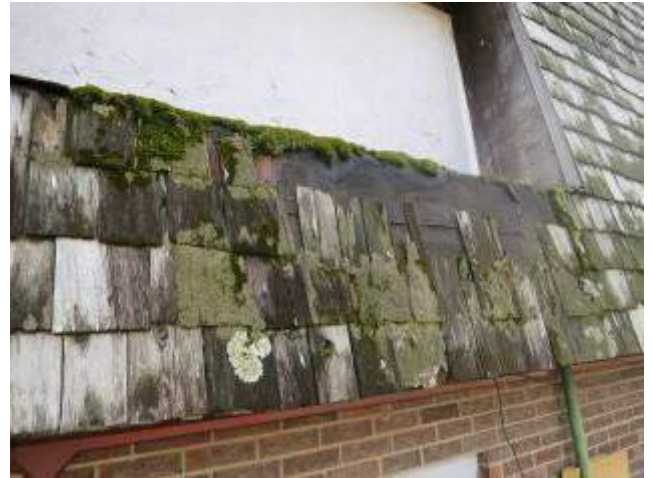
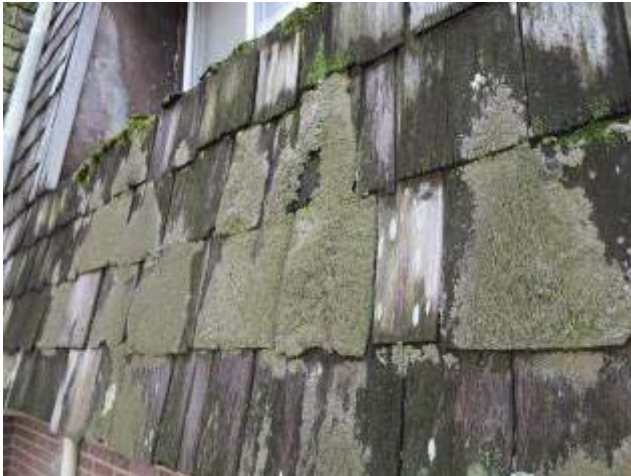
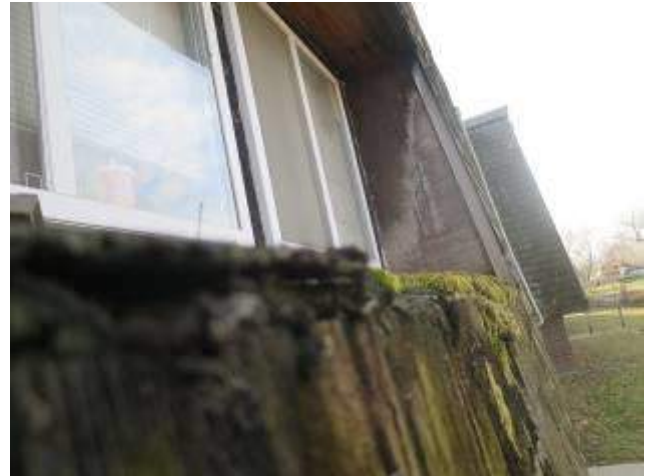
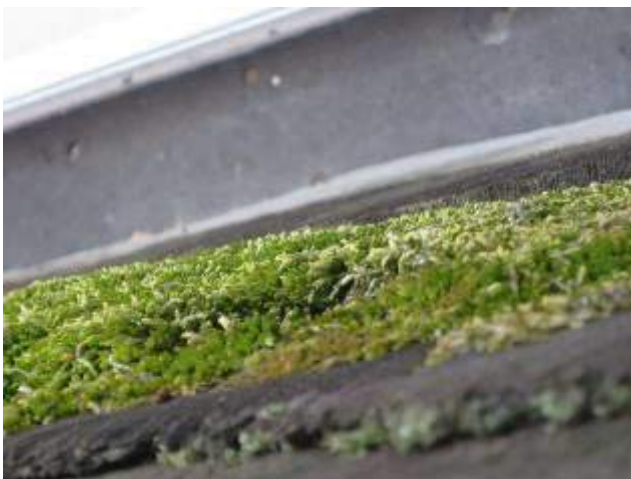
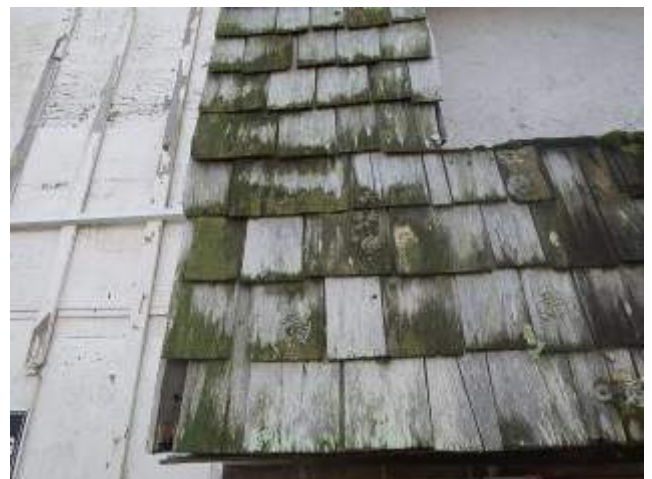
**INSANITARY OR UNSAFE CONDITIONS – MOSS**

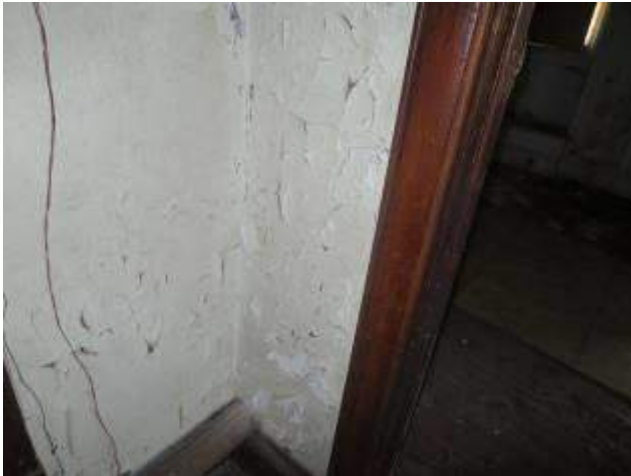
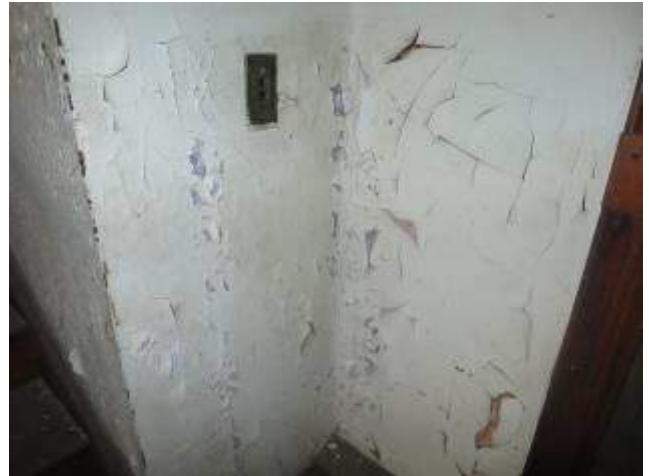
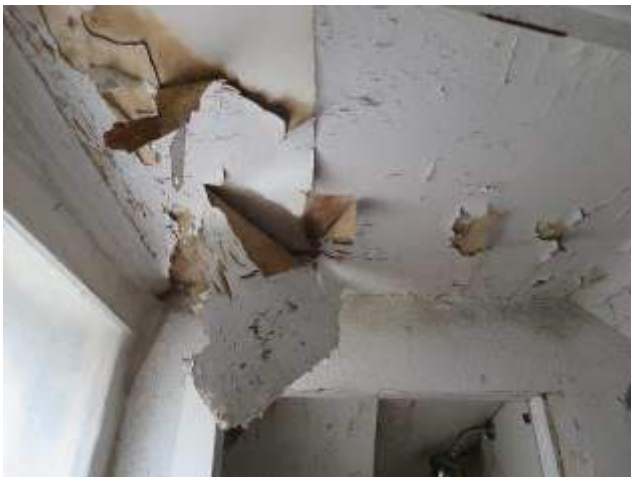
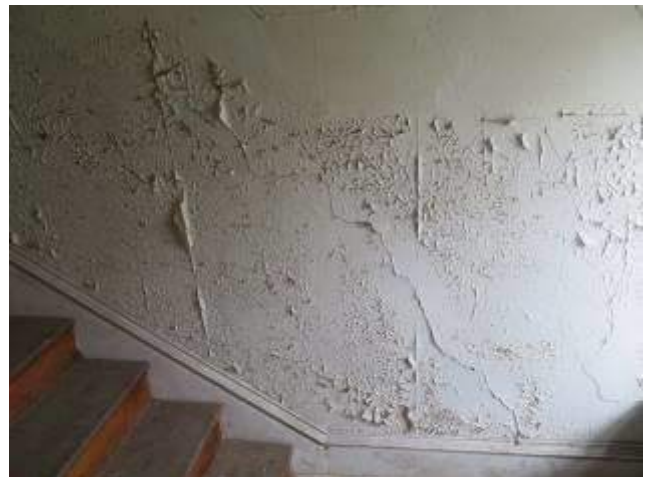
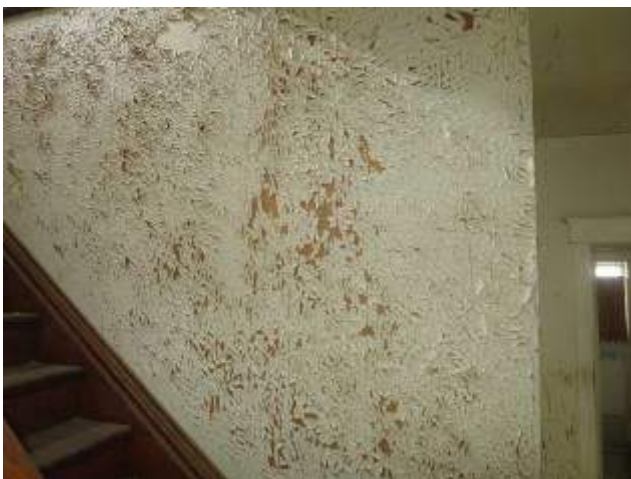
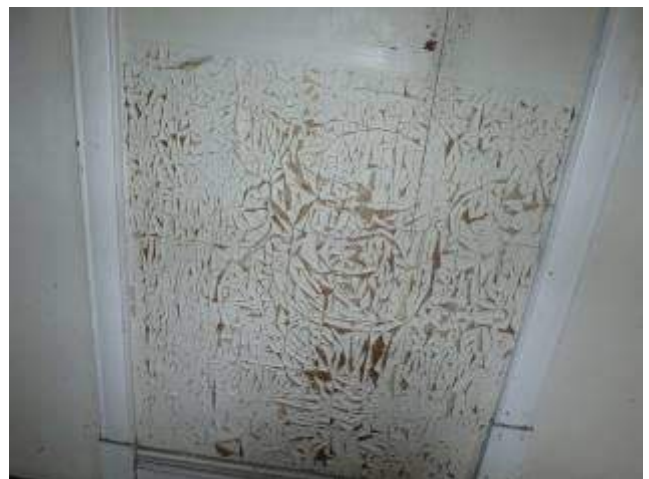
**INSANITARY OR UNSAFE CONDITIONS – POTENTIAL LEAD-BASED PAINT**

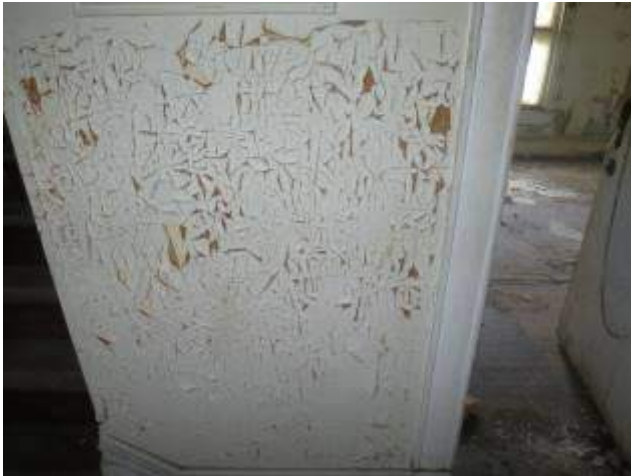
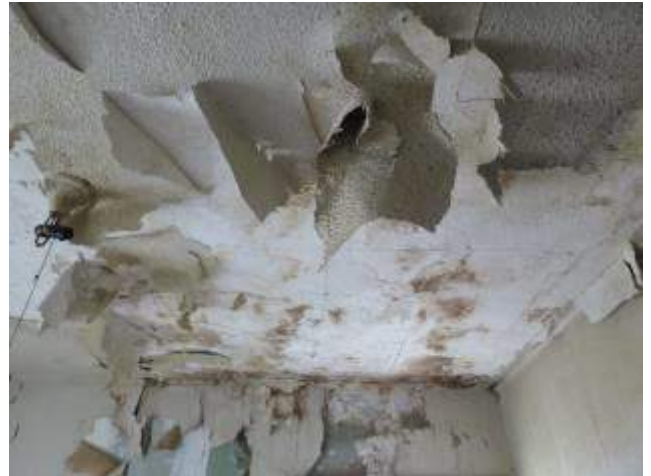
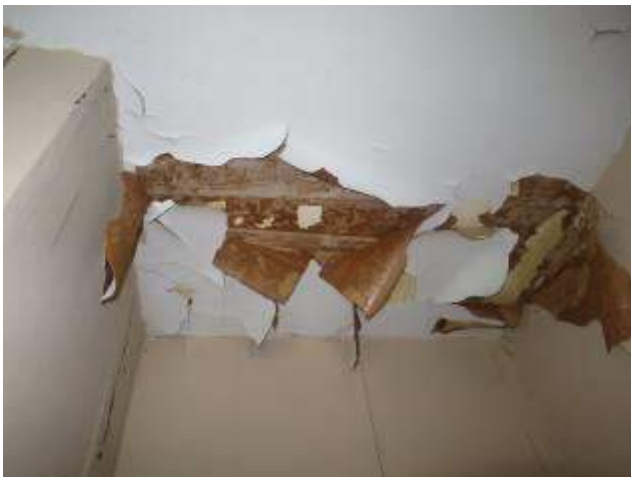
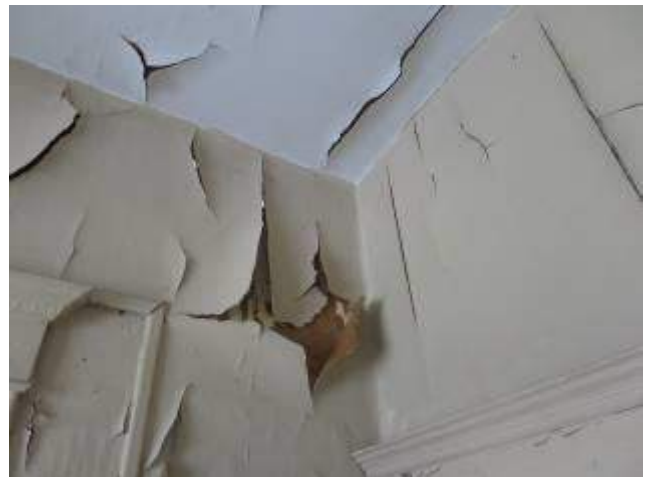
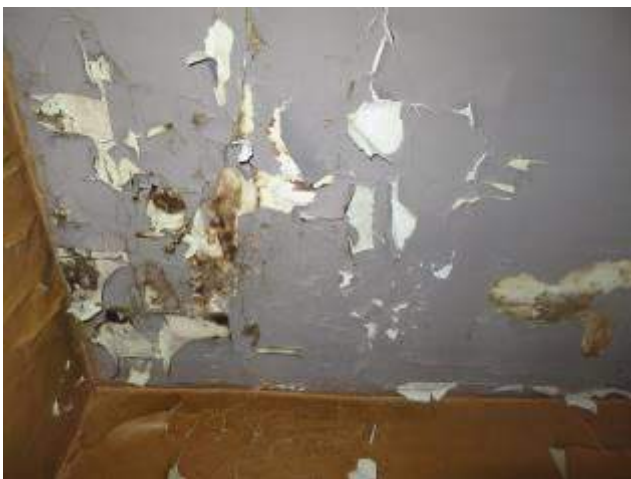
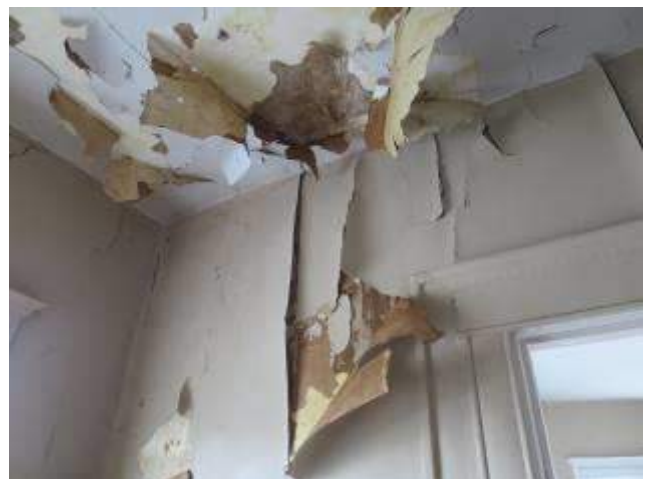
**INSANITARY OR UNSAFE CONDITIONS – POTENTIAL LEAD-BASED PAINT**

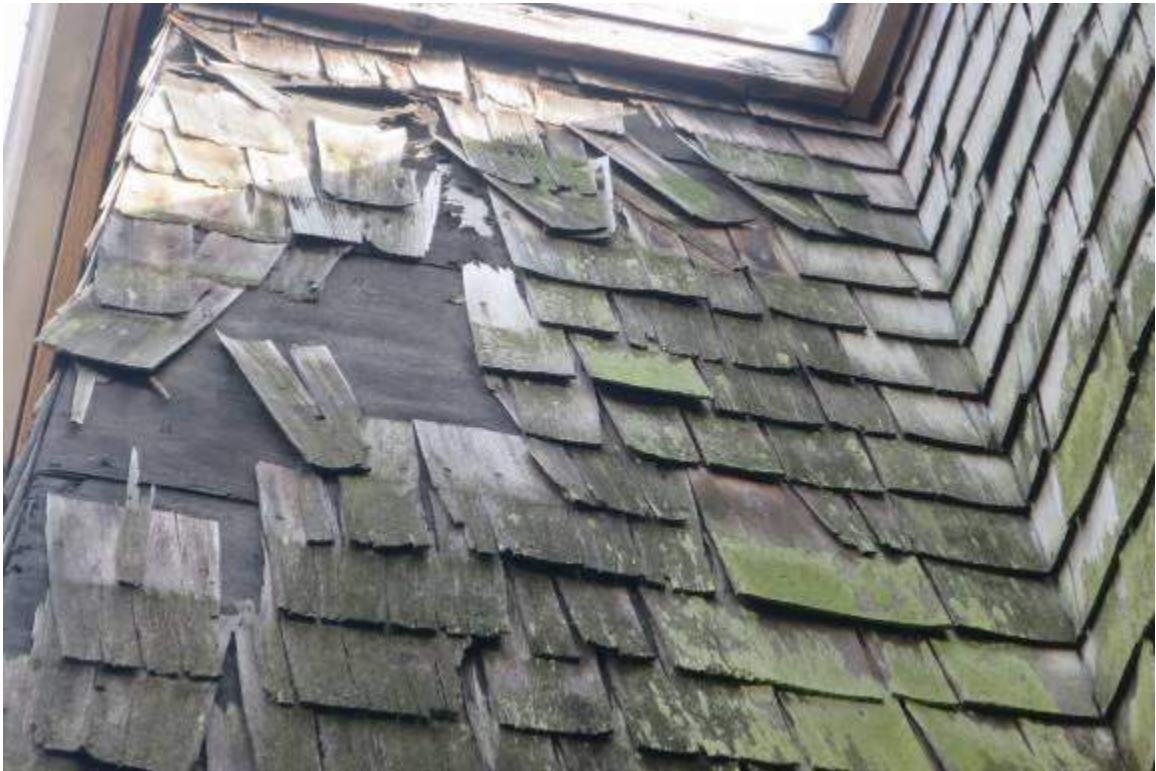
The North Elevation

Exterior walls of all structures are in poor condition. Damaged hardboard siding, wood shingle siding, batten board, and masonry structures evidence disrepair and lack of maintenance.

**EXTERIOR WALL DETERIORATION – 2644 E 29<sup>TH</sup> STREET**

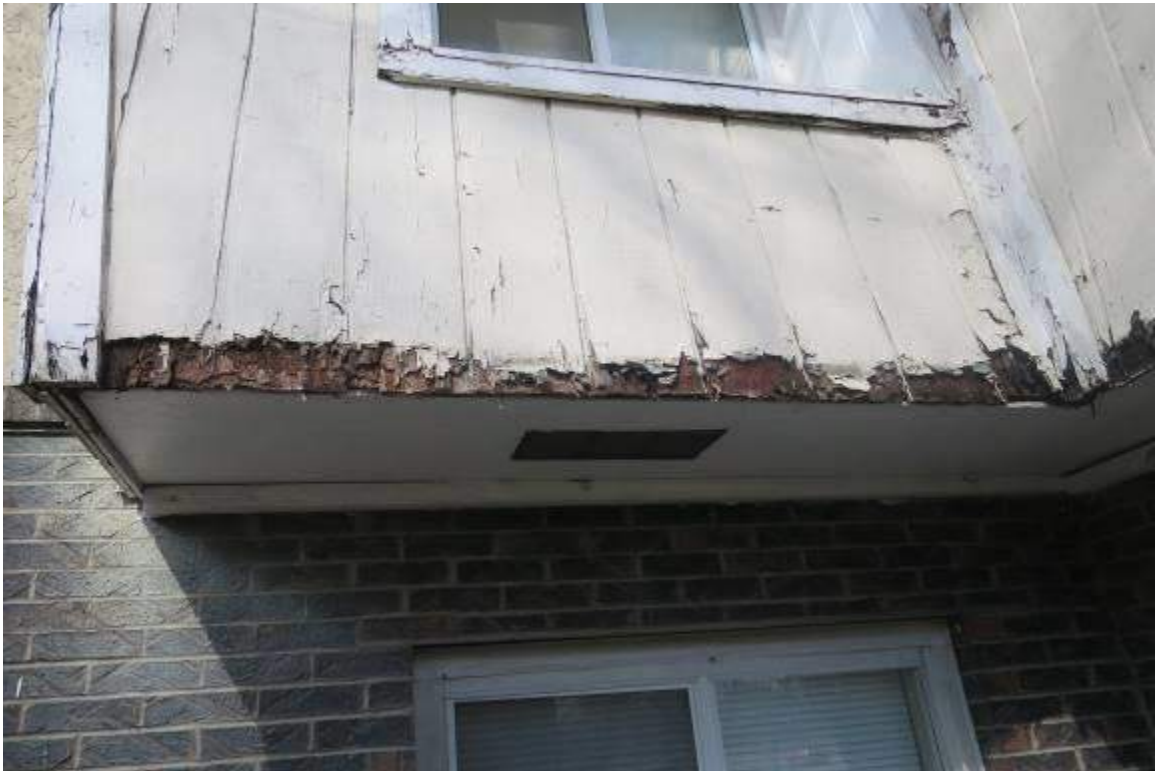
The South Elevation

**EXTERIOR WALL DETERIORATION – 2702 E 29<sup>TH</sup> STREET**

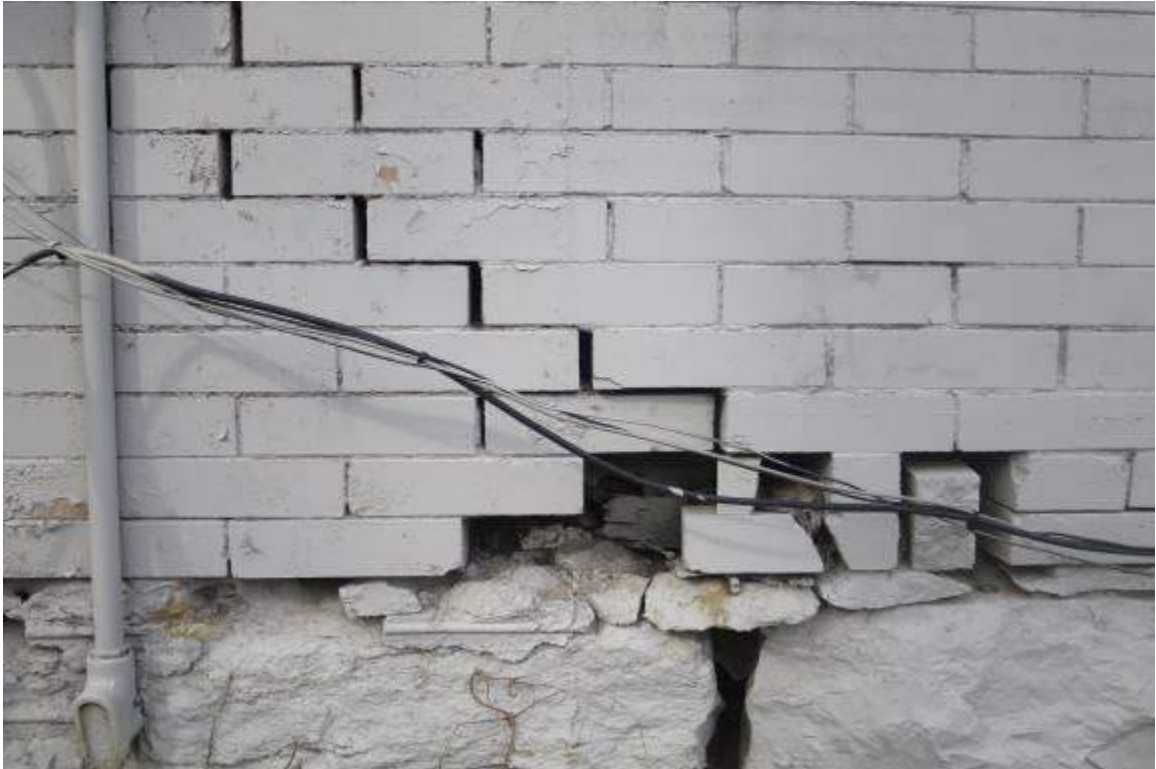
East Elevation

## EXTERIOR WALL DETERIORATION – 2651 VICTOR STREET

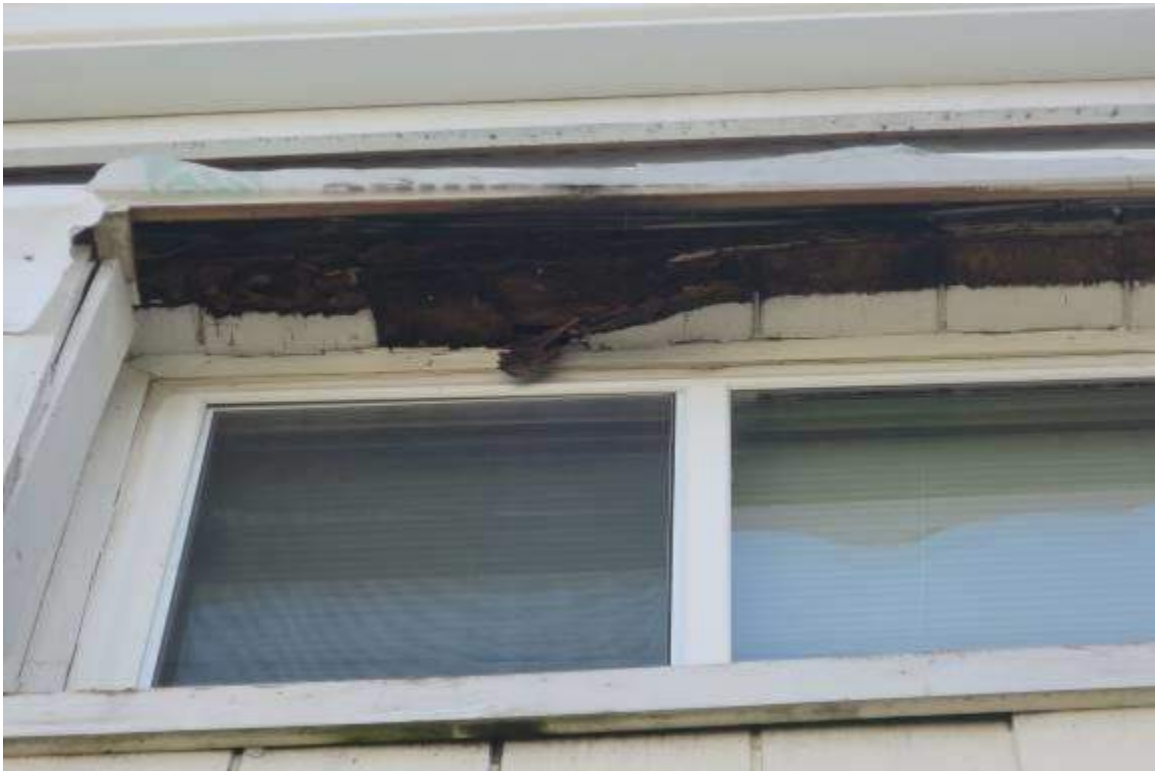
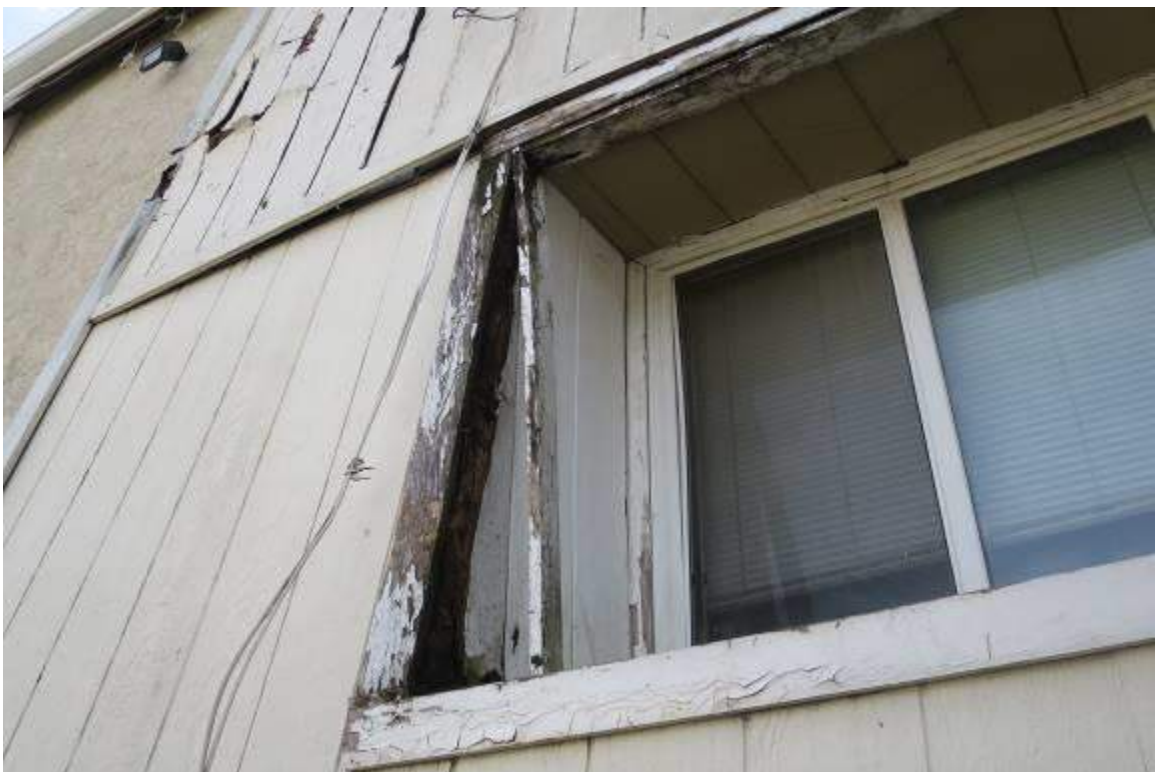
North Elevation

Some windows have been replaced. However, original windows (49 to 115 years in age) exist that are deteriorated and energy inefficient (single glazed panes). A number of window panes are broken and several are boarded over. Doors are generally wood and are deteriorated.

**WINDOW DETERIORATION – 2702 E 29<sup>TH</sup> STREET**

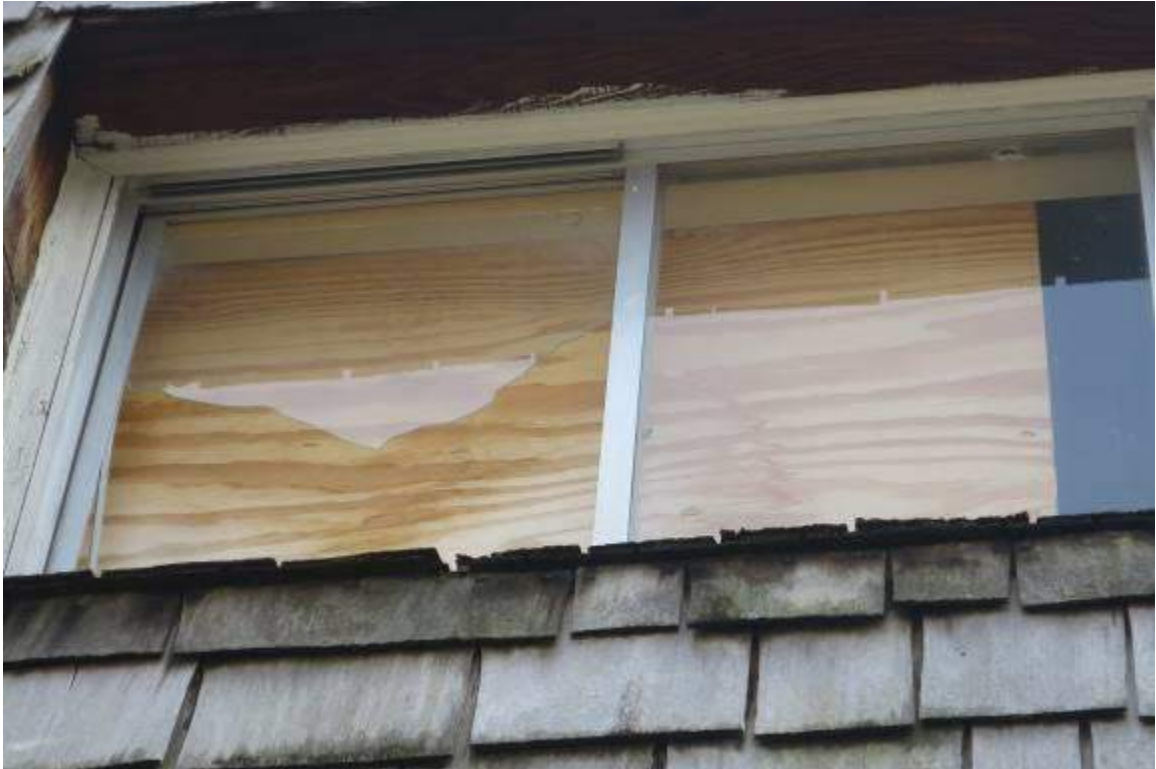
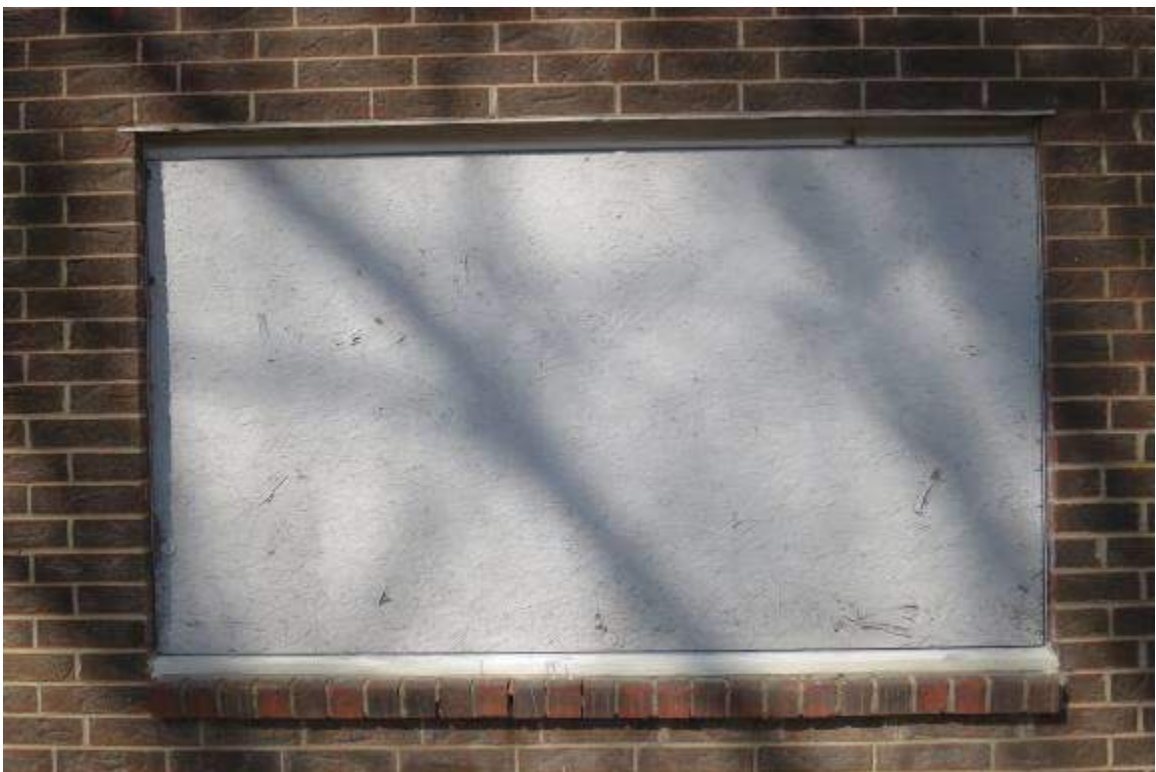
**WINDOW DETERIORATION – 2644 E 29<sup>TH</sup> STREET**

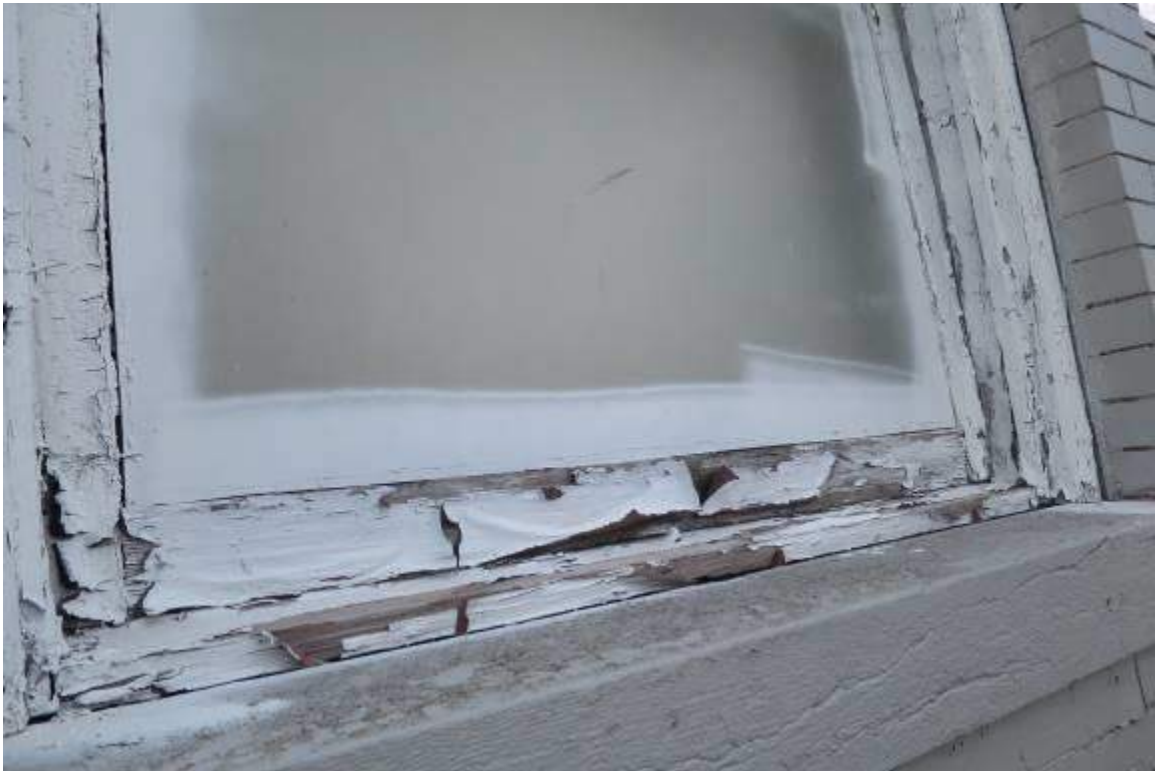
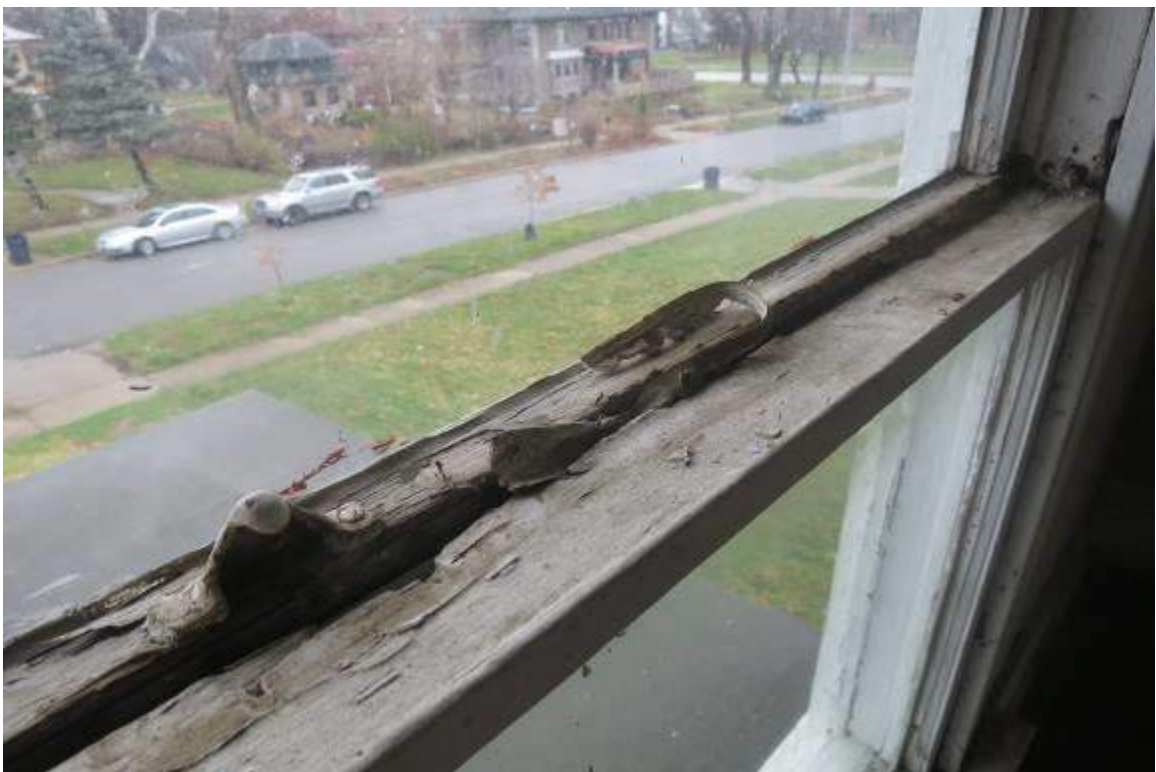
## WINDOW DETERIORATION – 2651 VICTOR STREET

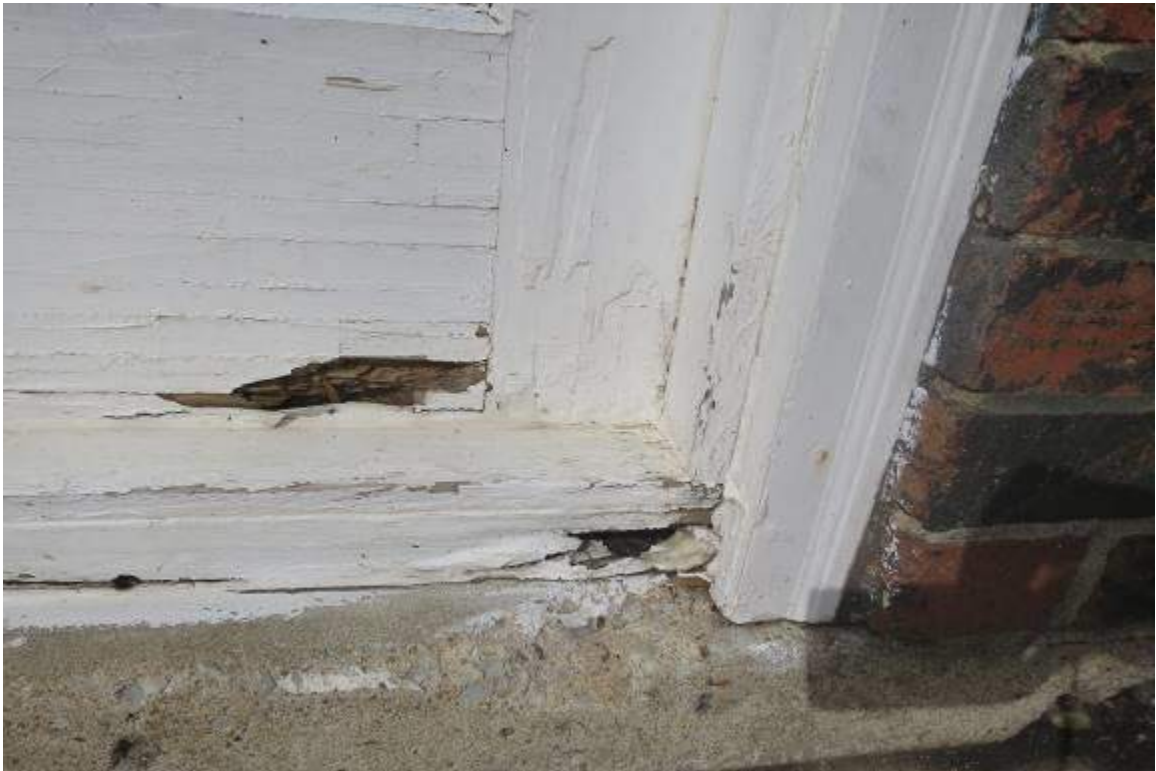
South Elevation Main Entrance

**DOOR DETERIORATION – 2702 E 29<sup>TH</sup> STREET**

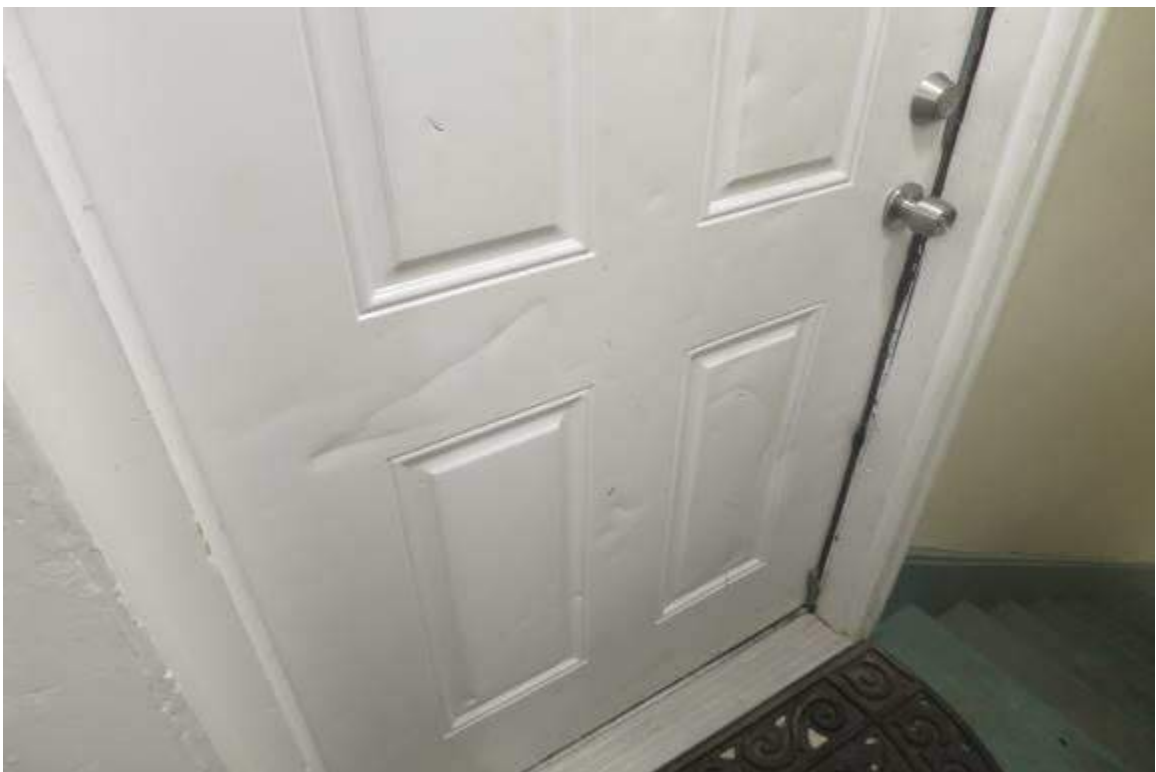
Damaged Apartment Unit Entrance Door
