# QUALIFICATION ANALYSIS

29<sup>TH</sup> & BENTON PIEA STUDY AREA  
NWQ BENTON BOULEVARD & E 29<sup>TH</sup> STREET  
KANSAS CITY, MISSOURI

APRIL 3, 2020  
RECORD NO. 1730

BELKE APPRAISAL & CONSULTING SERVICES, INC.

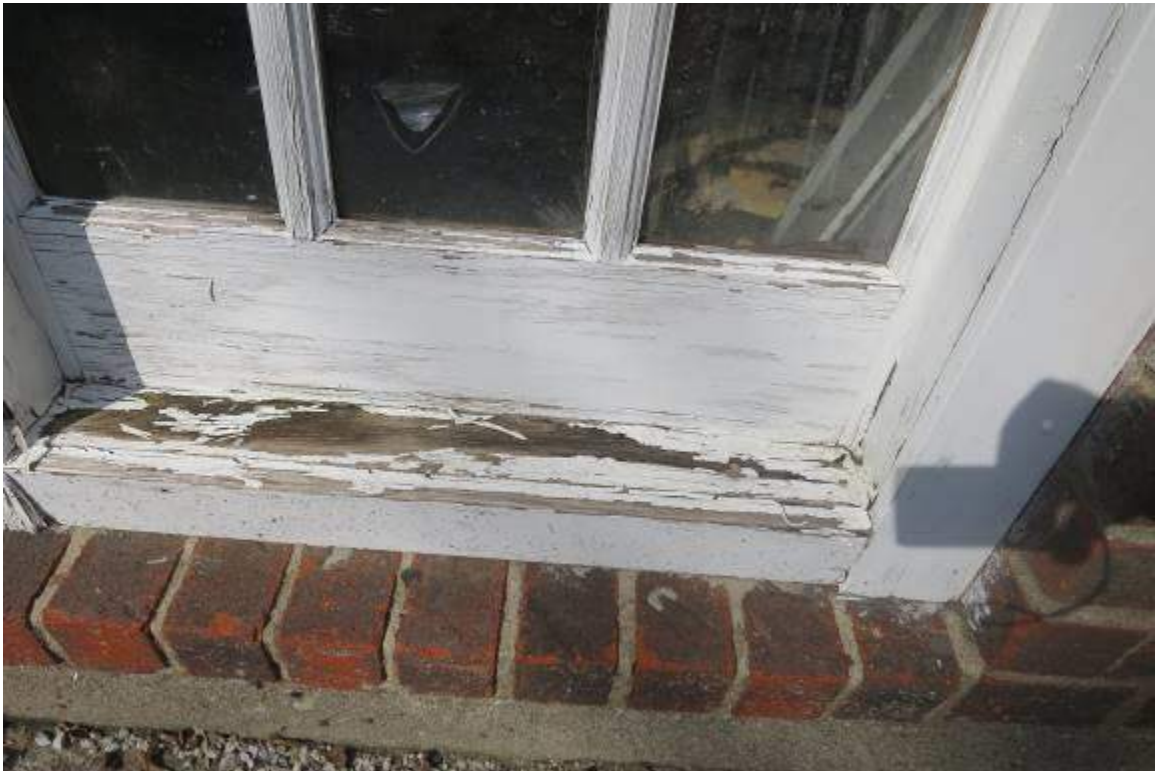
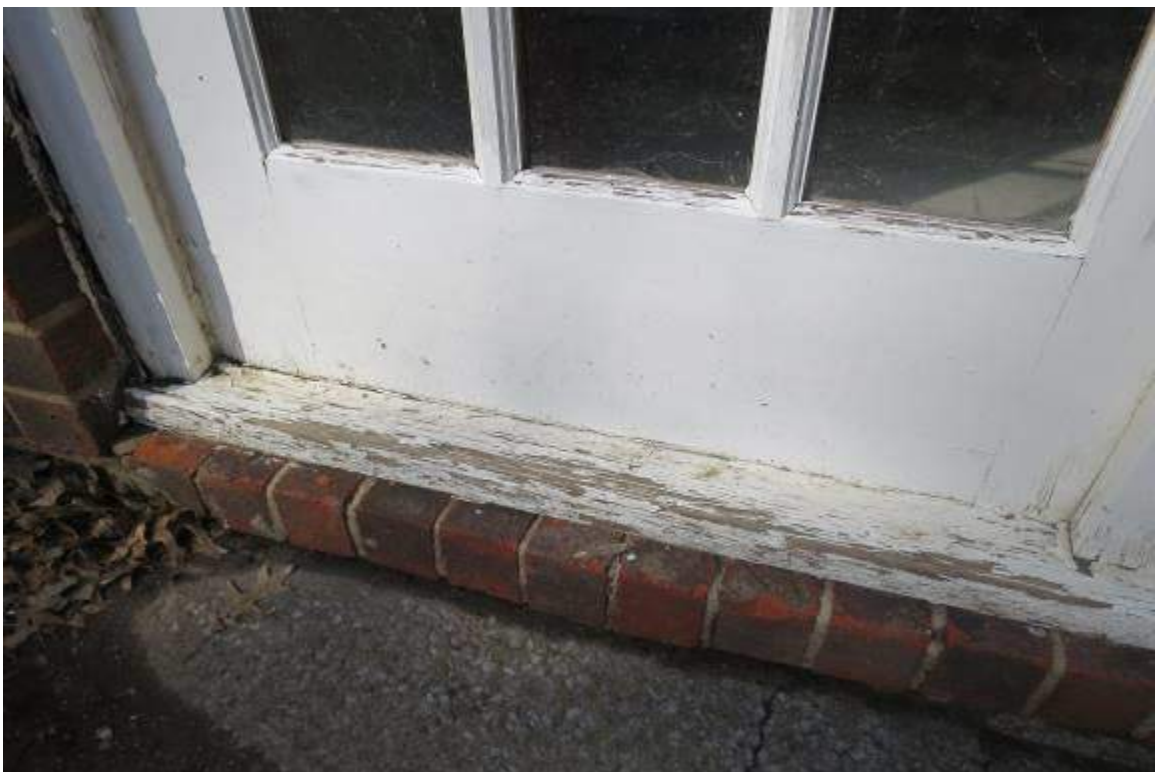
**DOOR DETERIORATION – 2644 E 29<sup>TH</sup> STREET**

South Elevation

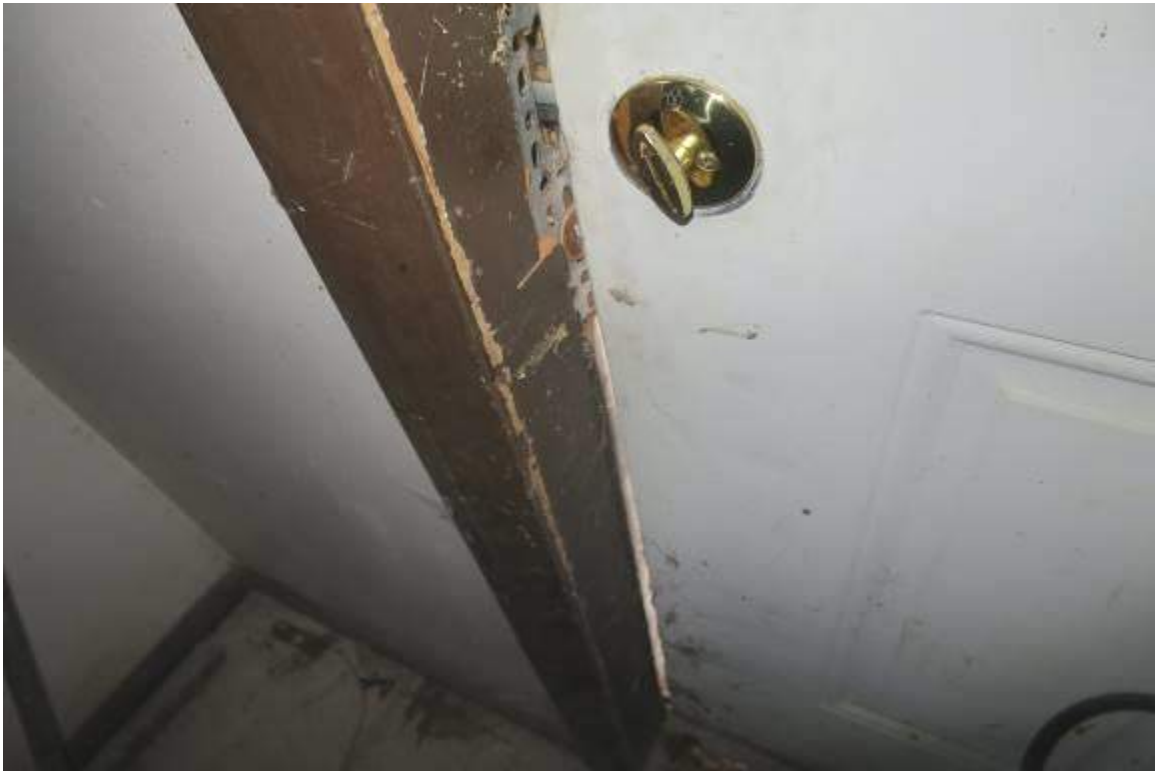
**DOOR DETERIORATION – 2644 E 29<sup>TH</sup> STREET**

Damaged & Ill-Fitting Entry Door

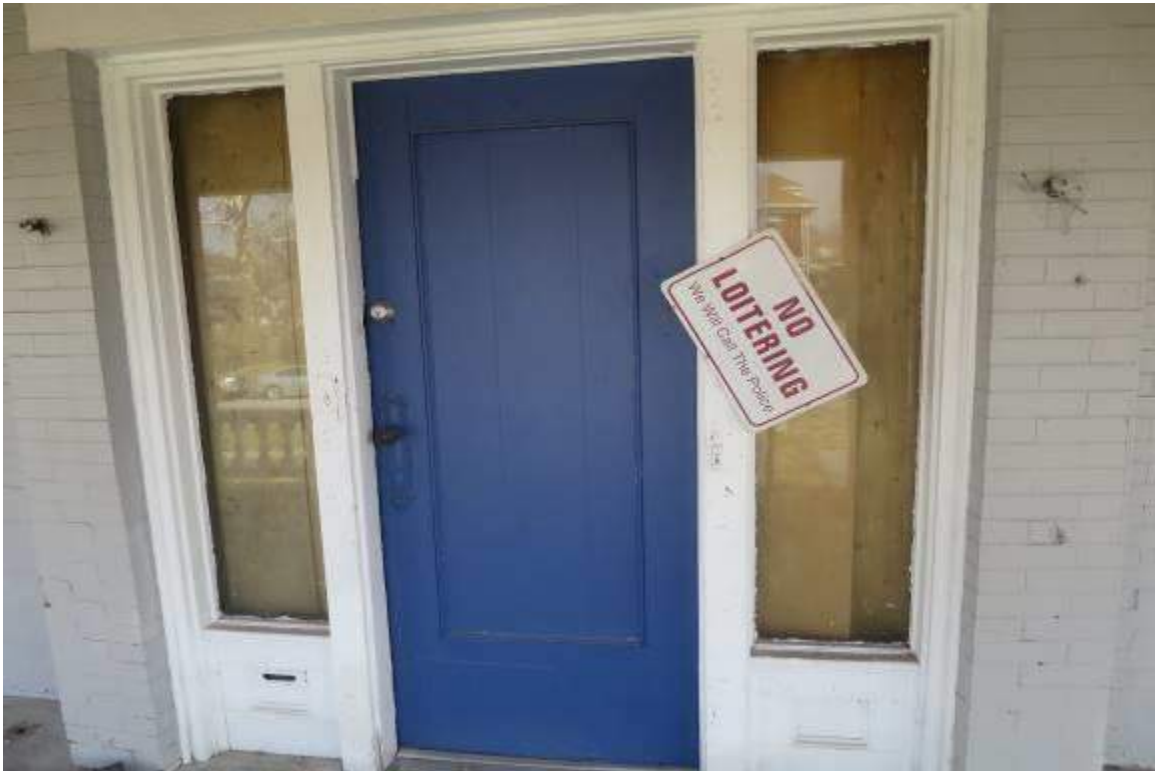
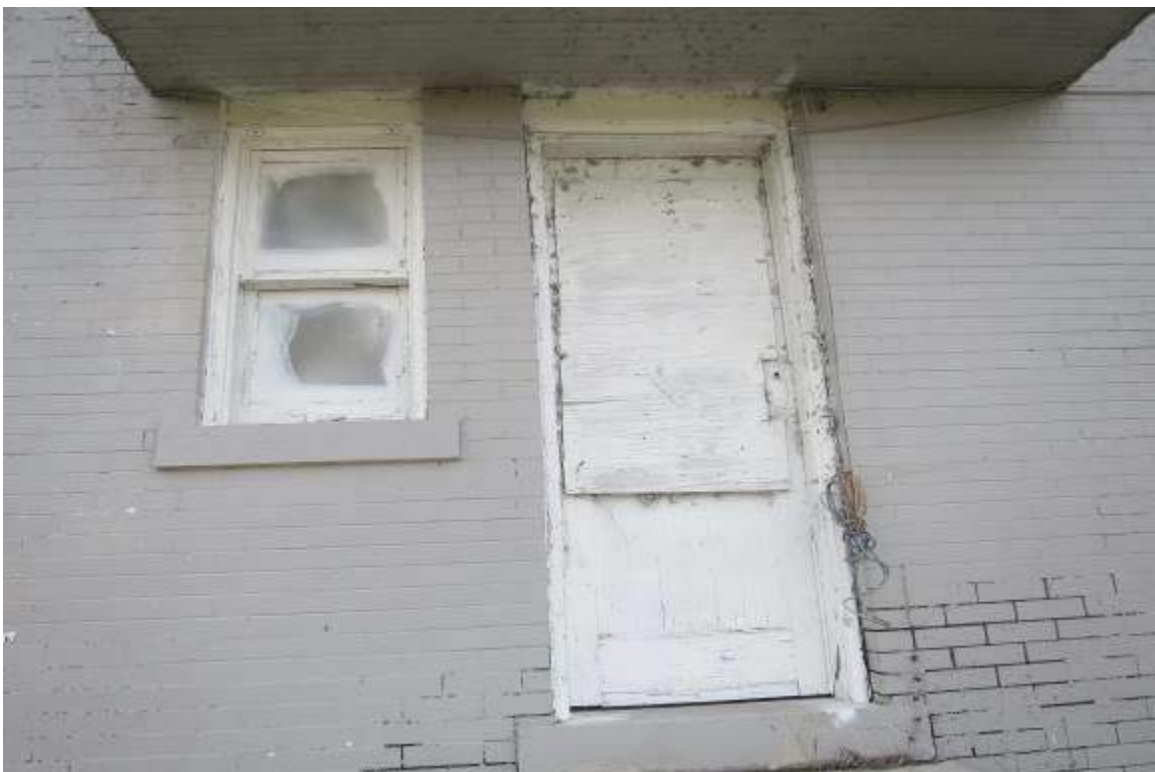
## DOOR DETERIORATION – 2651 VICTOR STREET

North Elevation

East Elevation

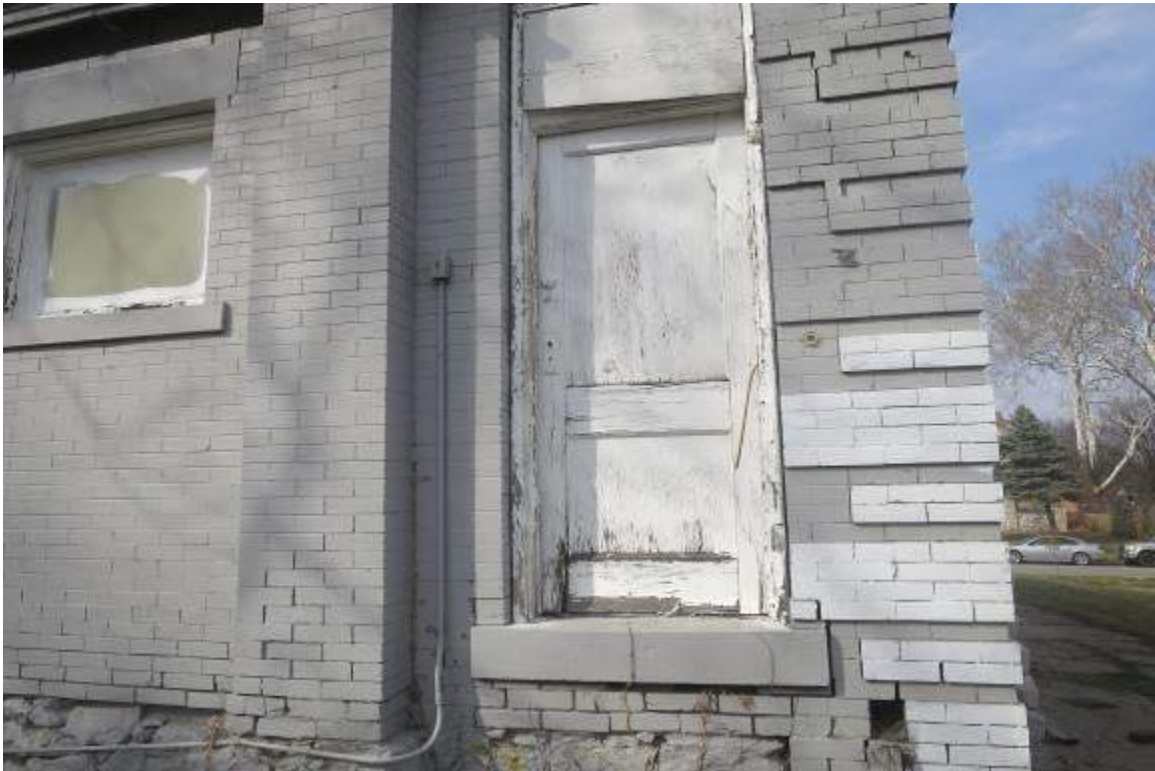
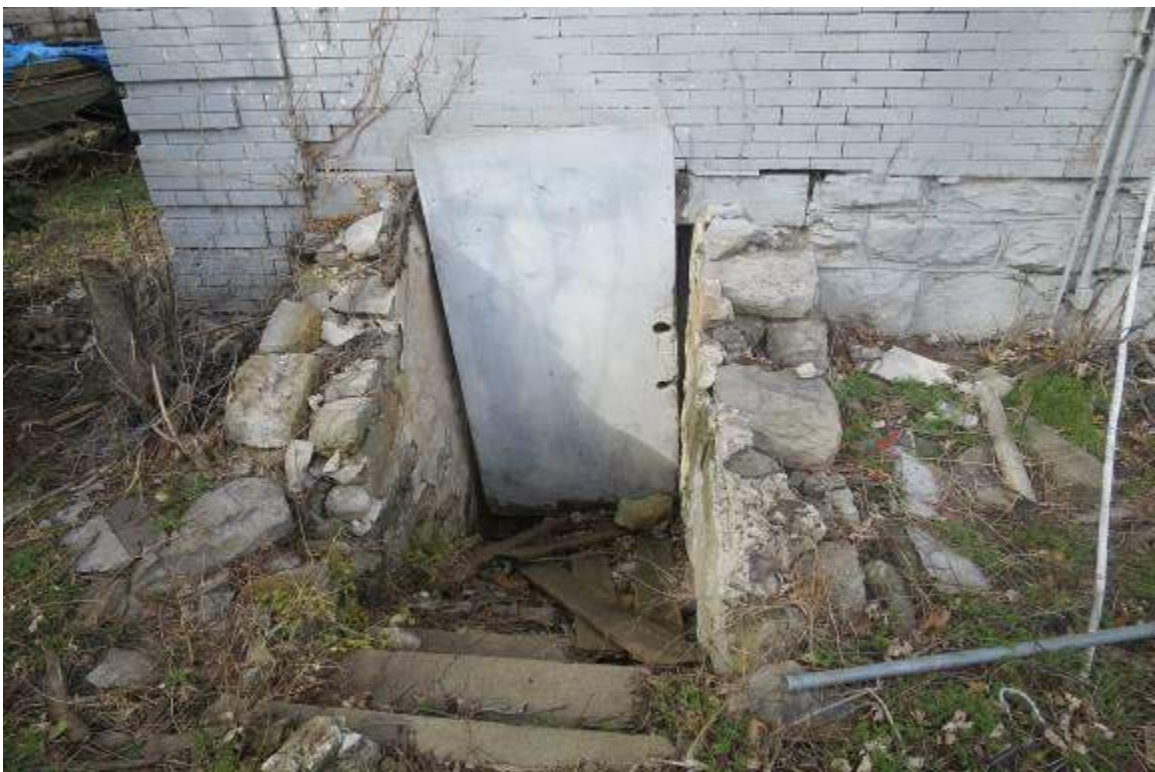
**DOOR DETERIORATION – 2651 VICTOR STREET**

South Elevation

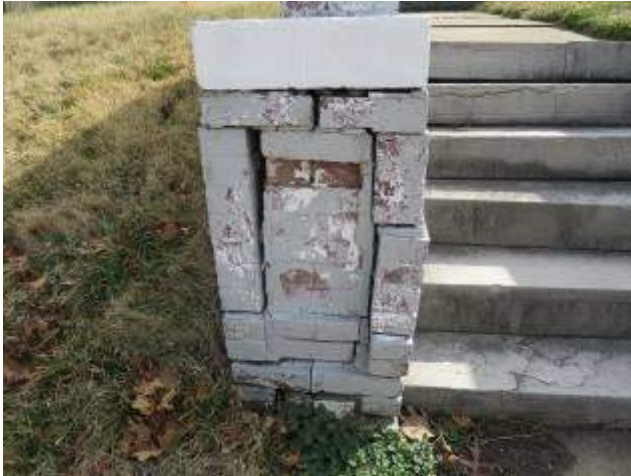
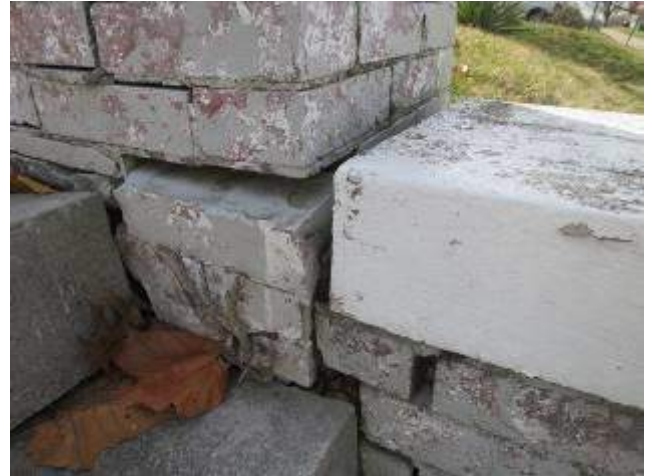
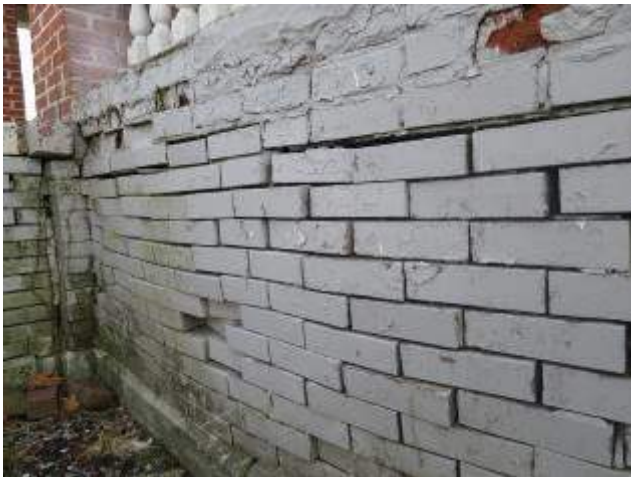
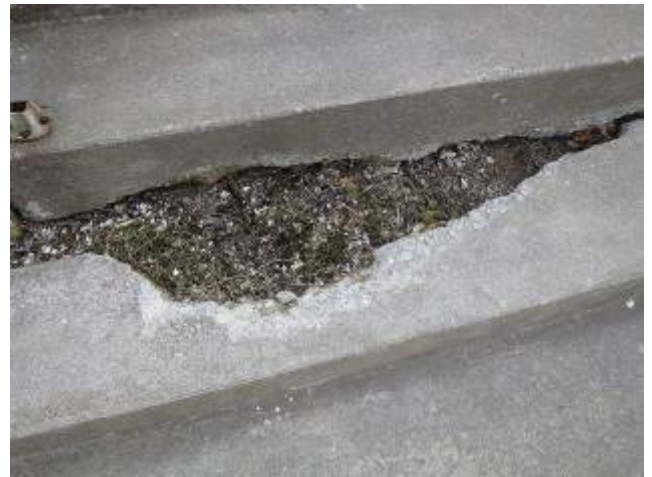
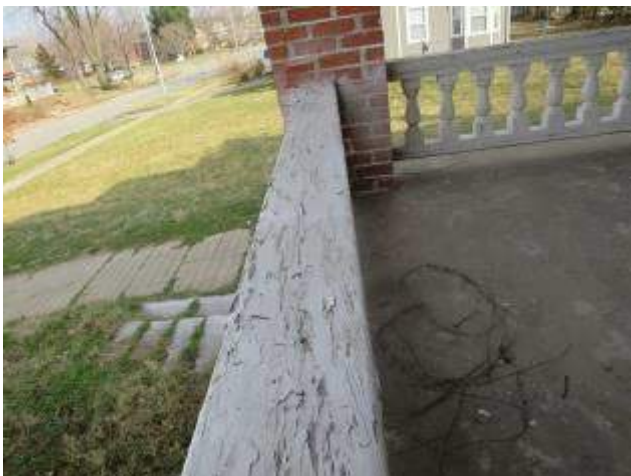
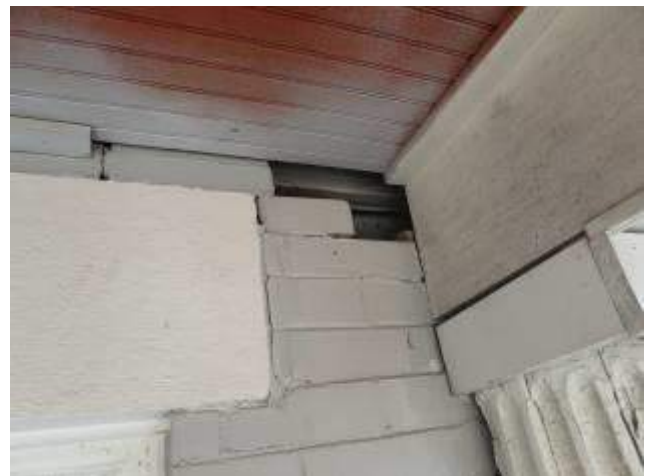
## PORCH DETERIORATION

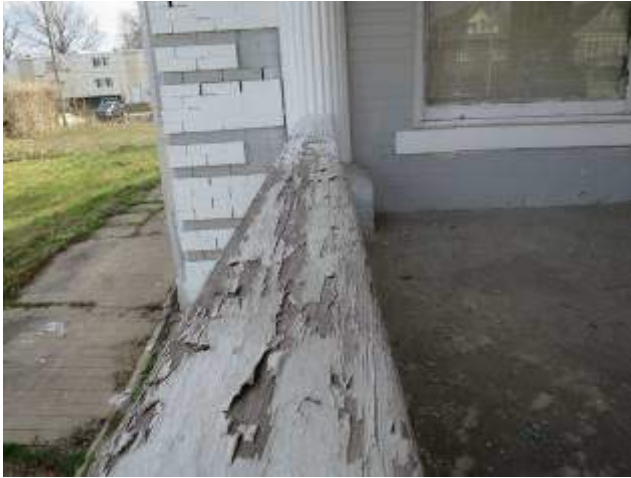
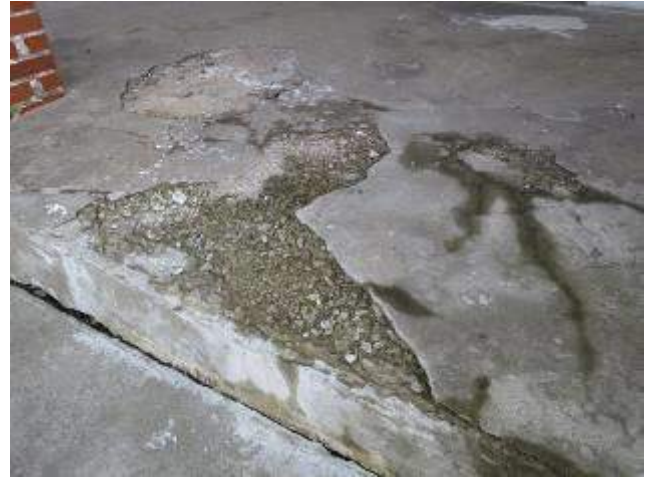
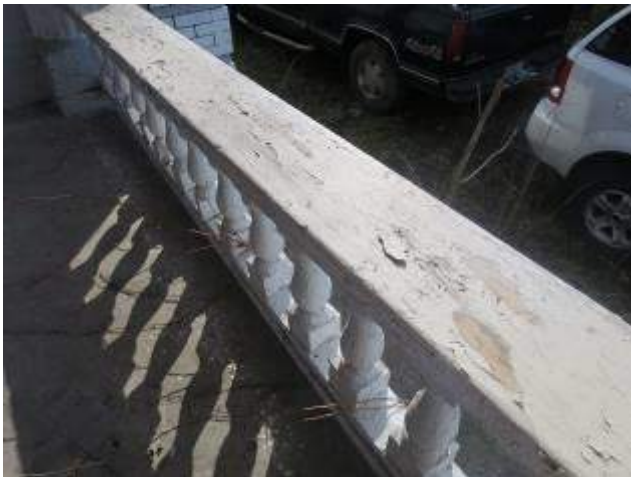
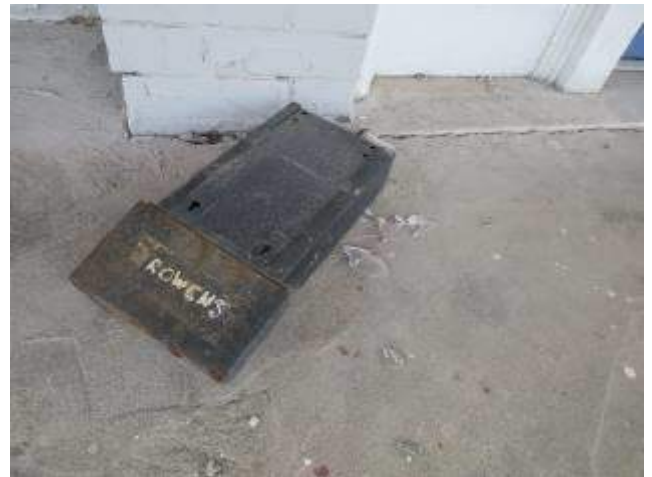
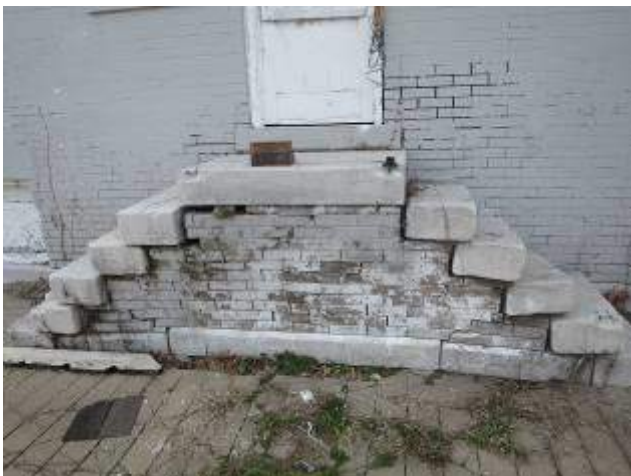
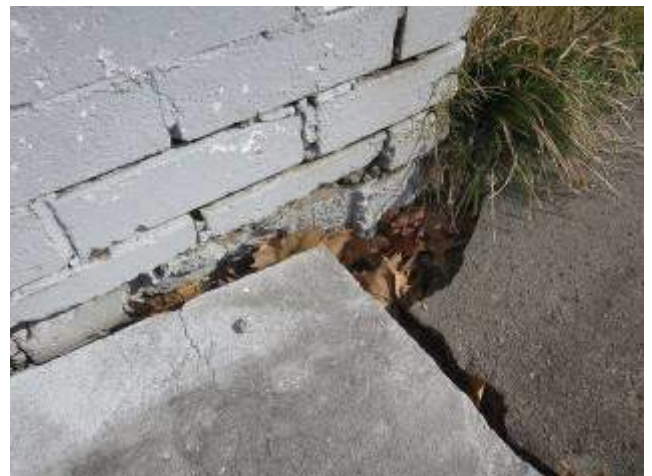
## PORCH DETERIORATION

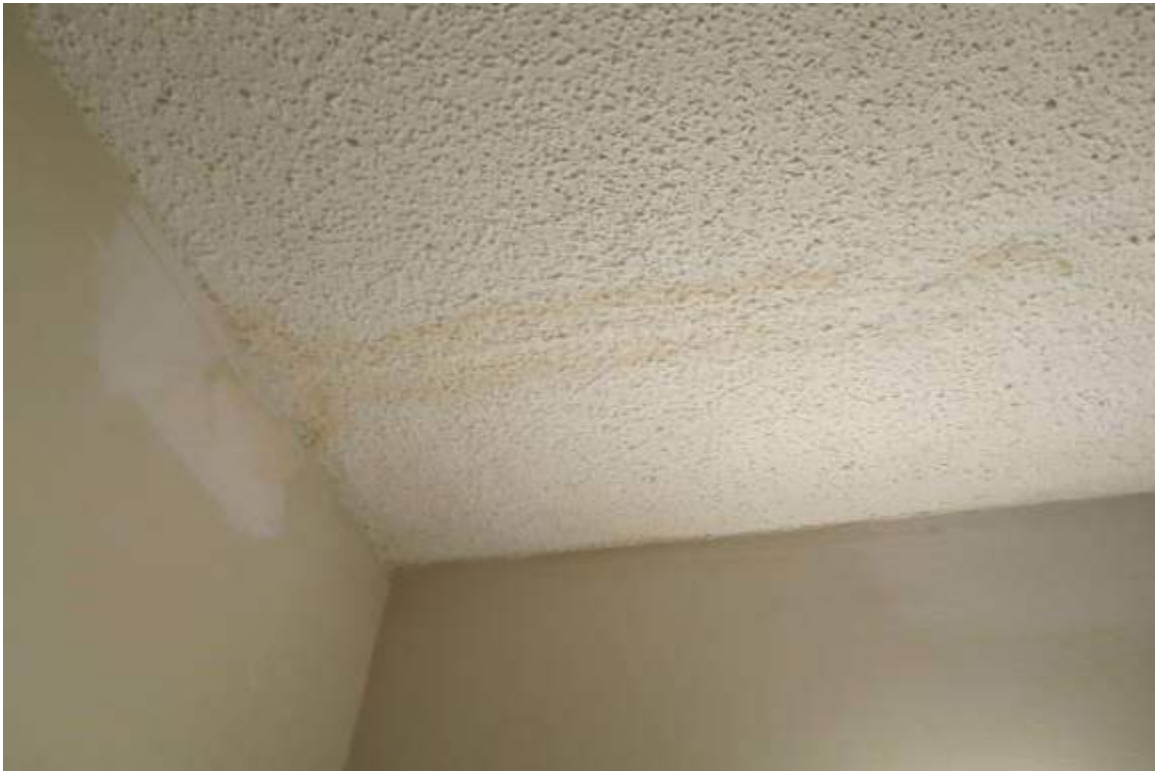
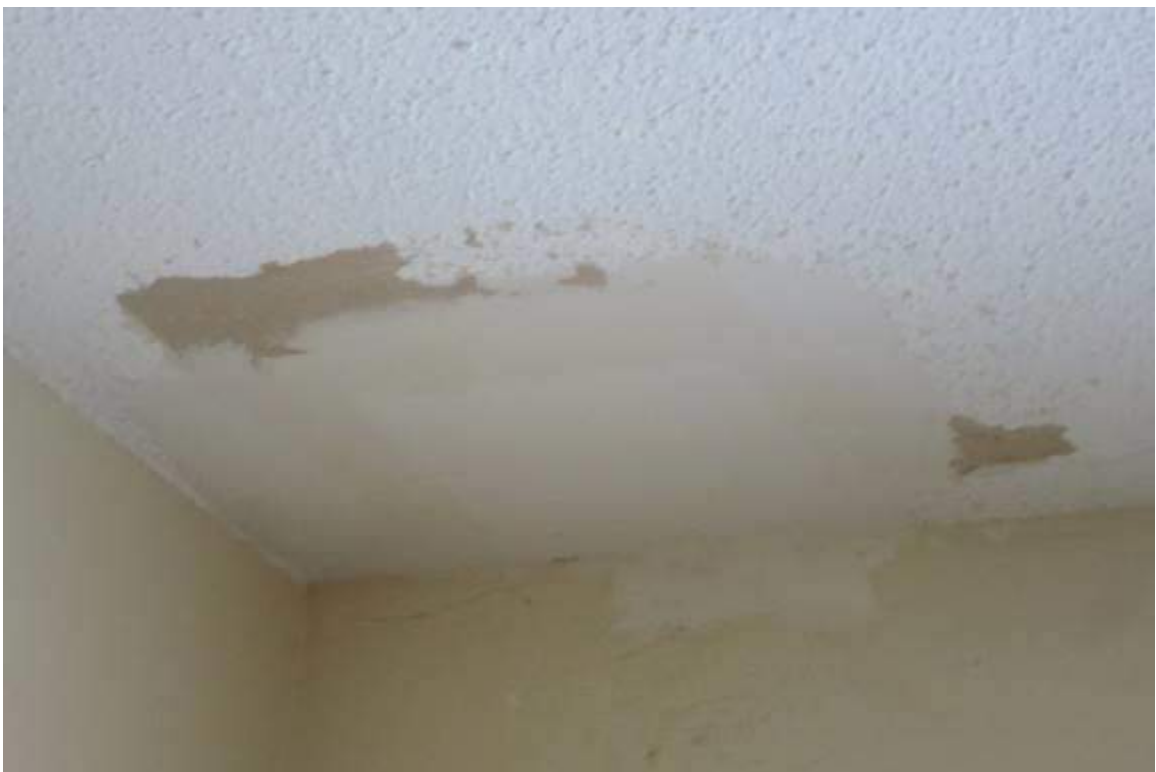
**CEILING DETERIORATION – 2702 E 29<sup>TH</sup> STREET**

Upper Level Apartment Unit

Upper Level Hallway

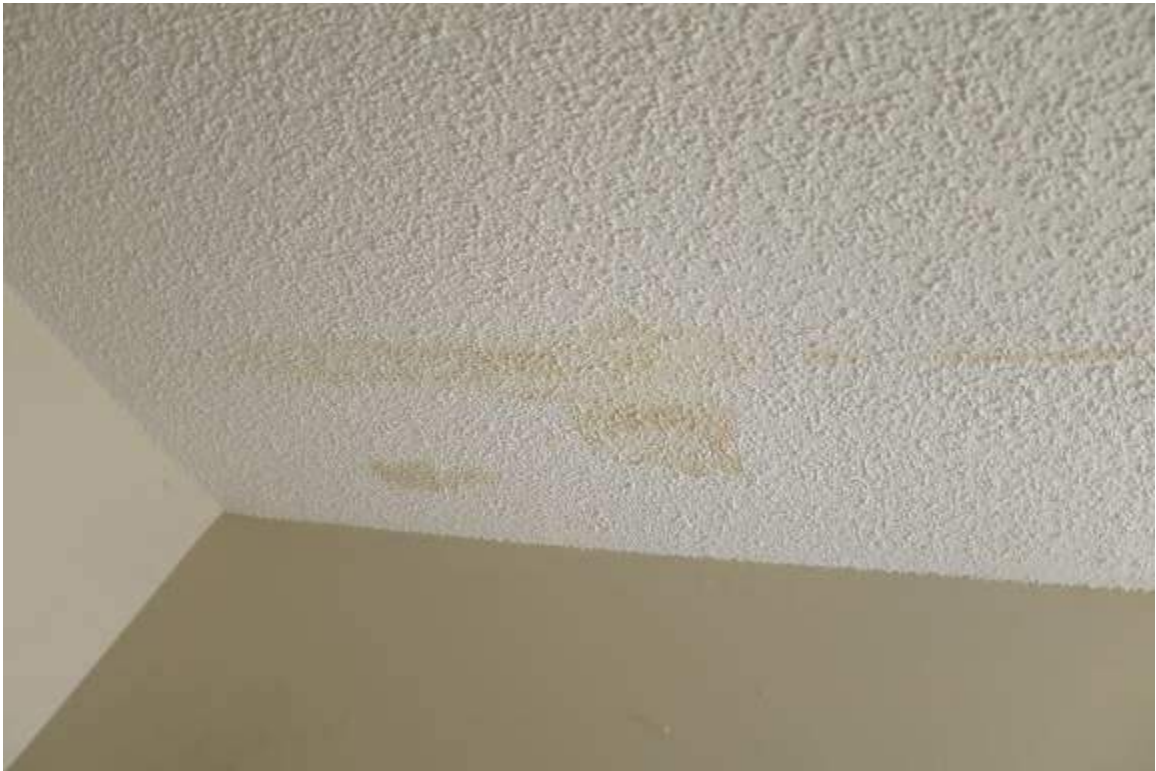
Upper Level Apartment Unit

**CEILING DETERIORATION – 2702 E 29<sup>TH</sup> STREET**

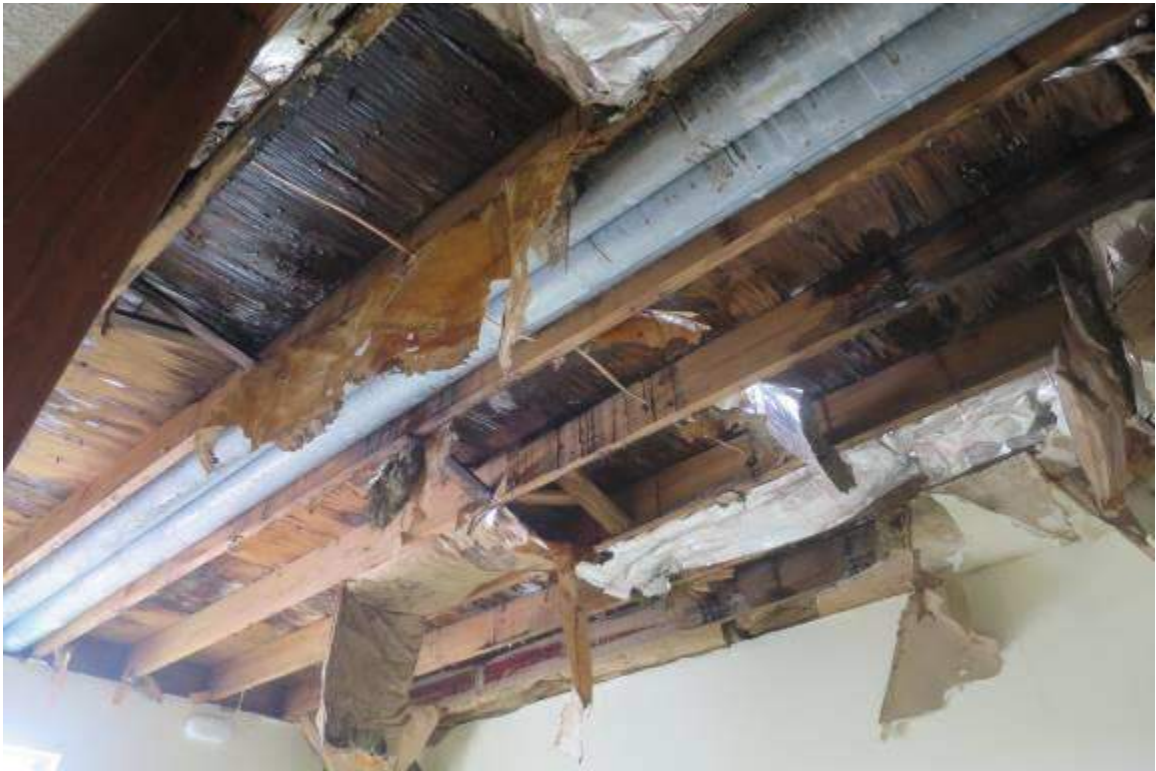
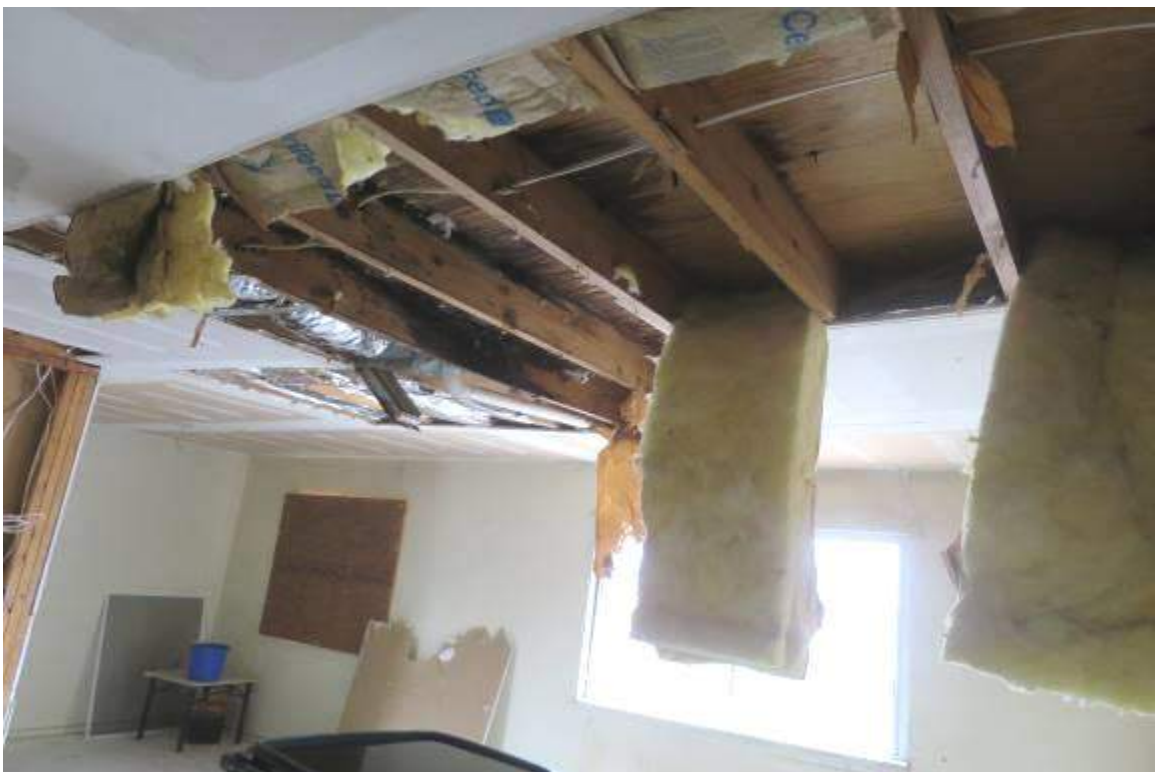
**CEILING DETERIORATION – 2644 E 29<sup>TH</sup> STREET**

Upper Level Unit

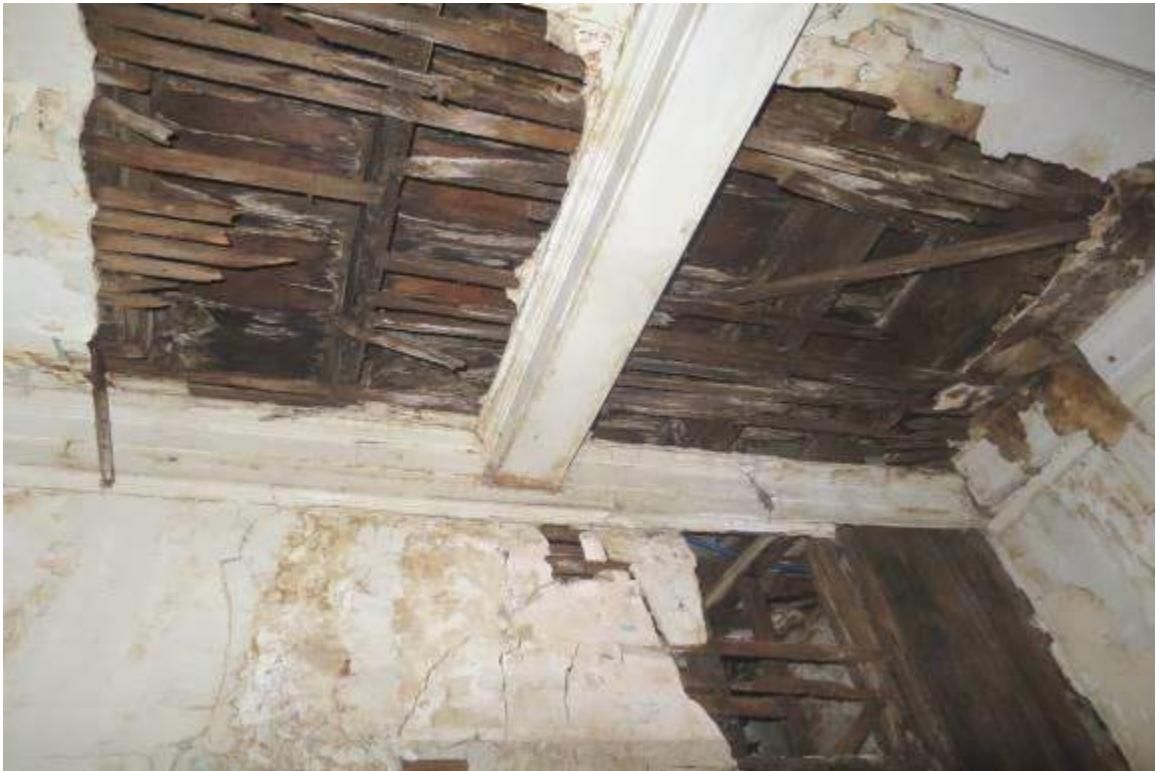
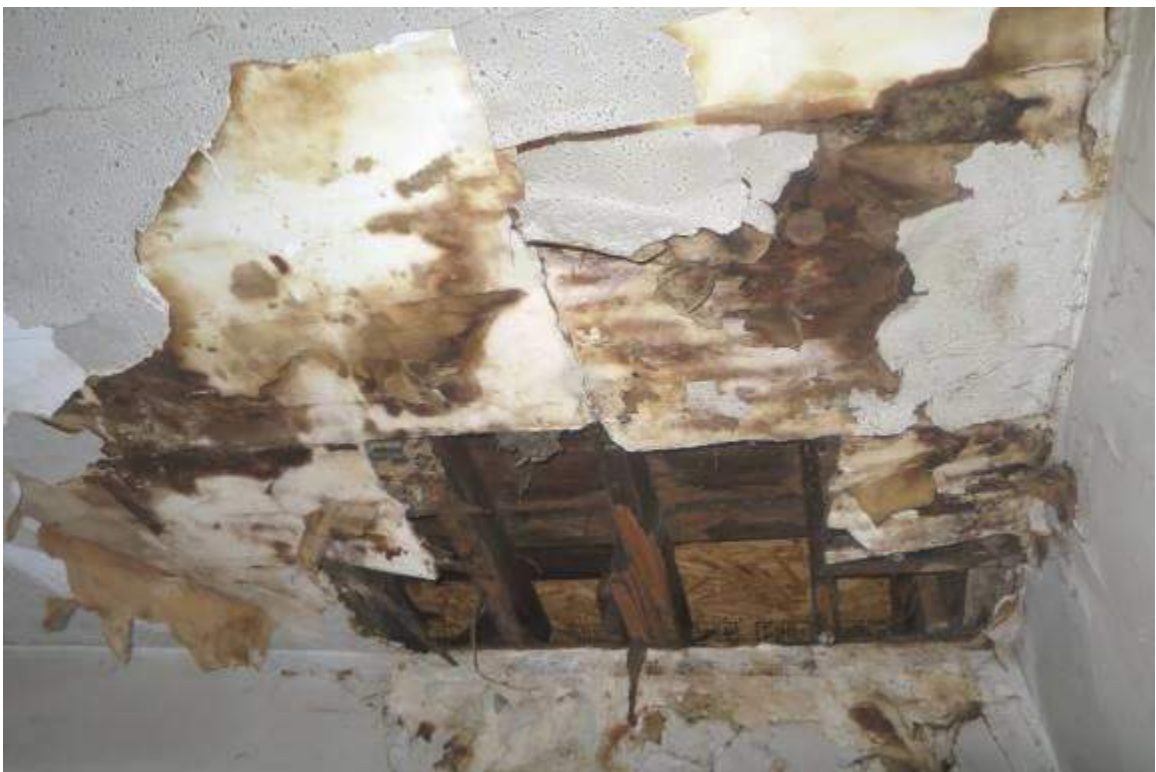
### CEILING DETERIORATION – 2651 VICTOR STREET

1<sup>st</sup> Floor Ceiling

3<sup>rd</sup> Floor Ceiling

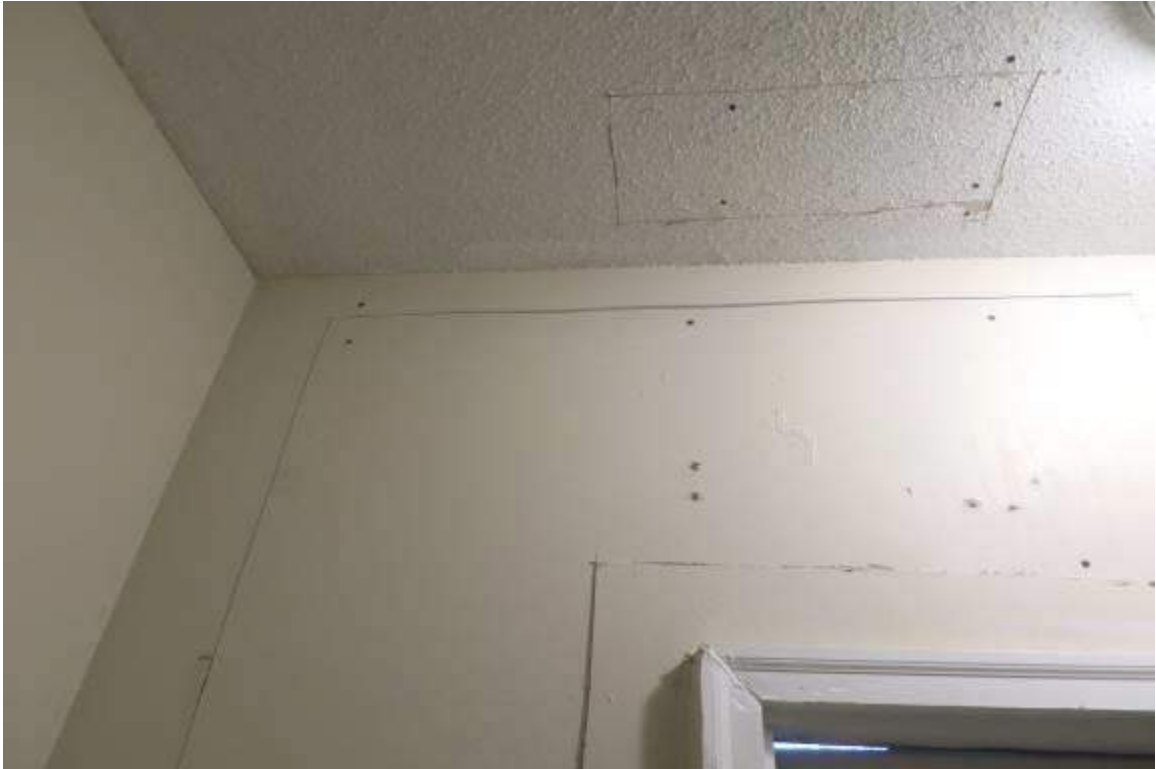
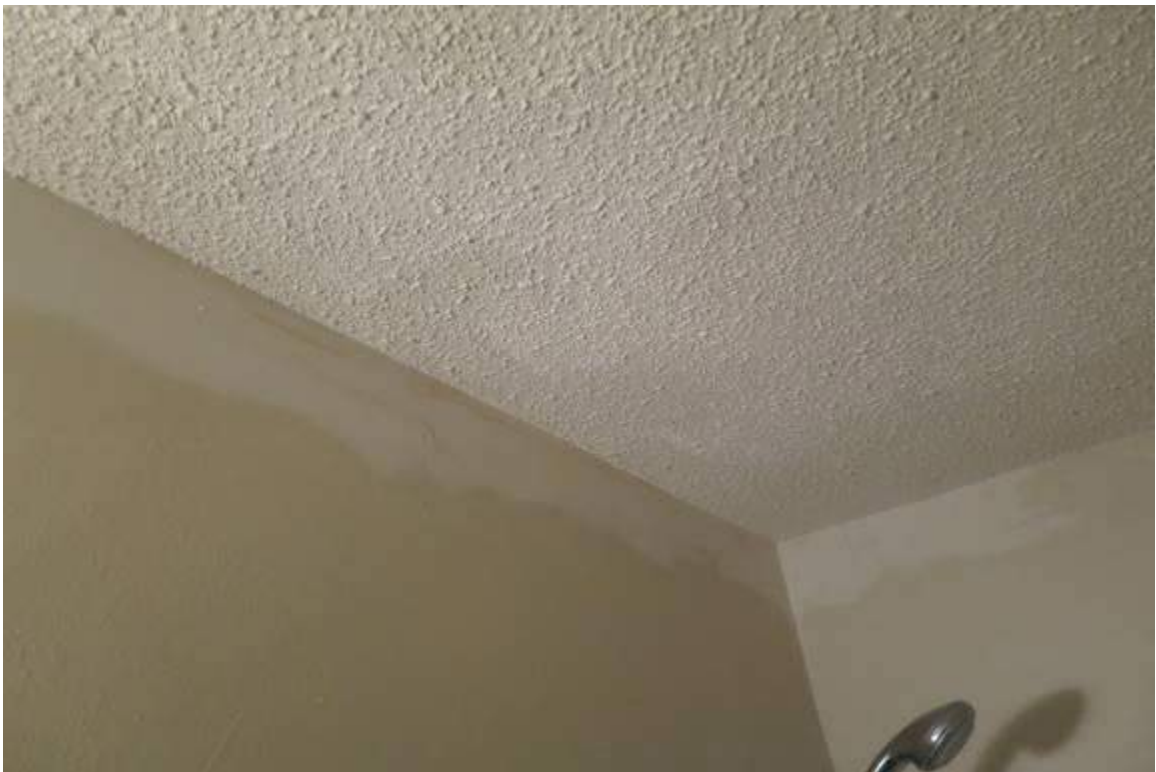
**INTERIOR WALL DETERIORATION – 2702 E 29<sup>TH</sup> STREET**

Hallway

Apartment Unit Bathroom

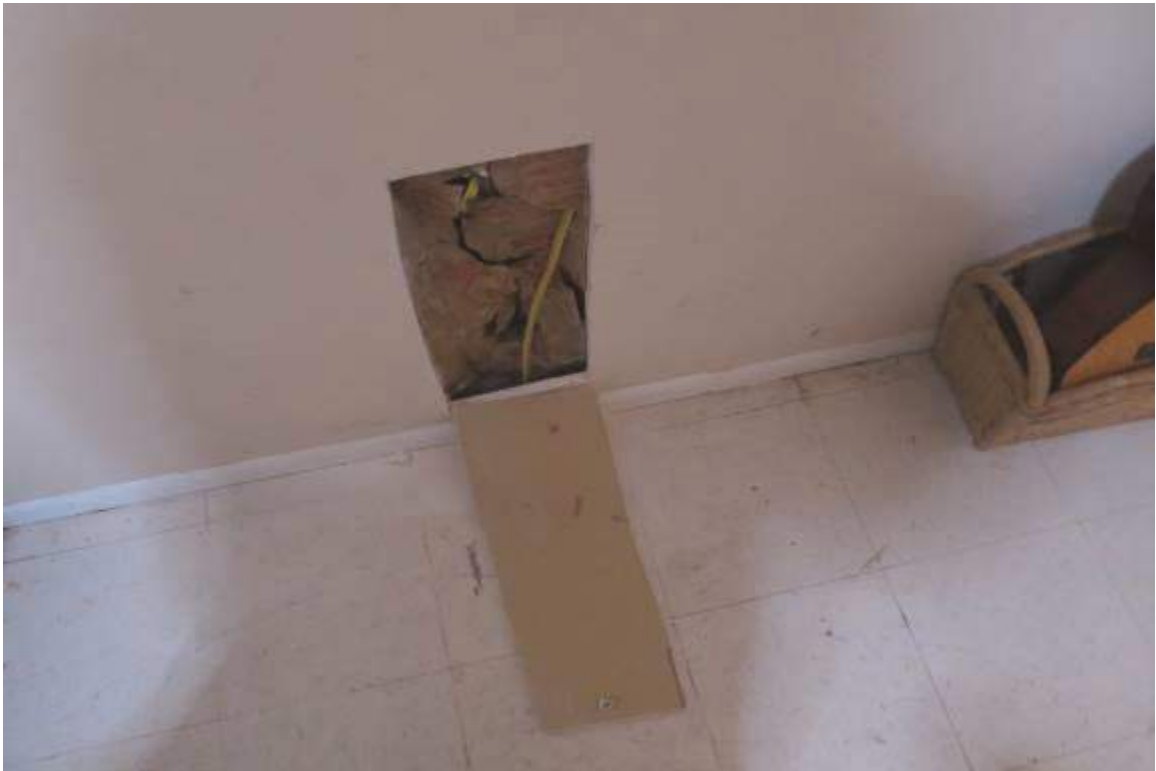
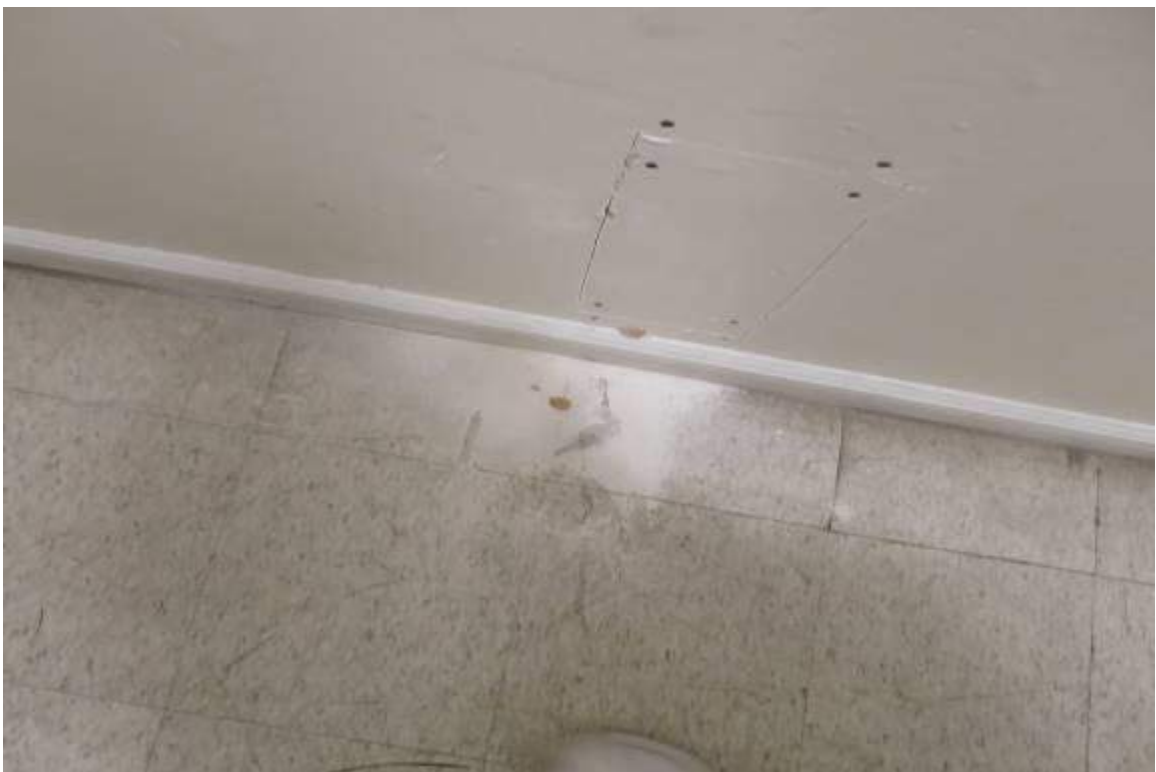
**INTERIOR WALL DETERIORATION – 2702 E 29<sup>TH</sup> STREET**

Hallway

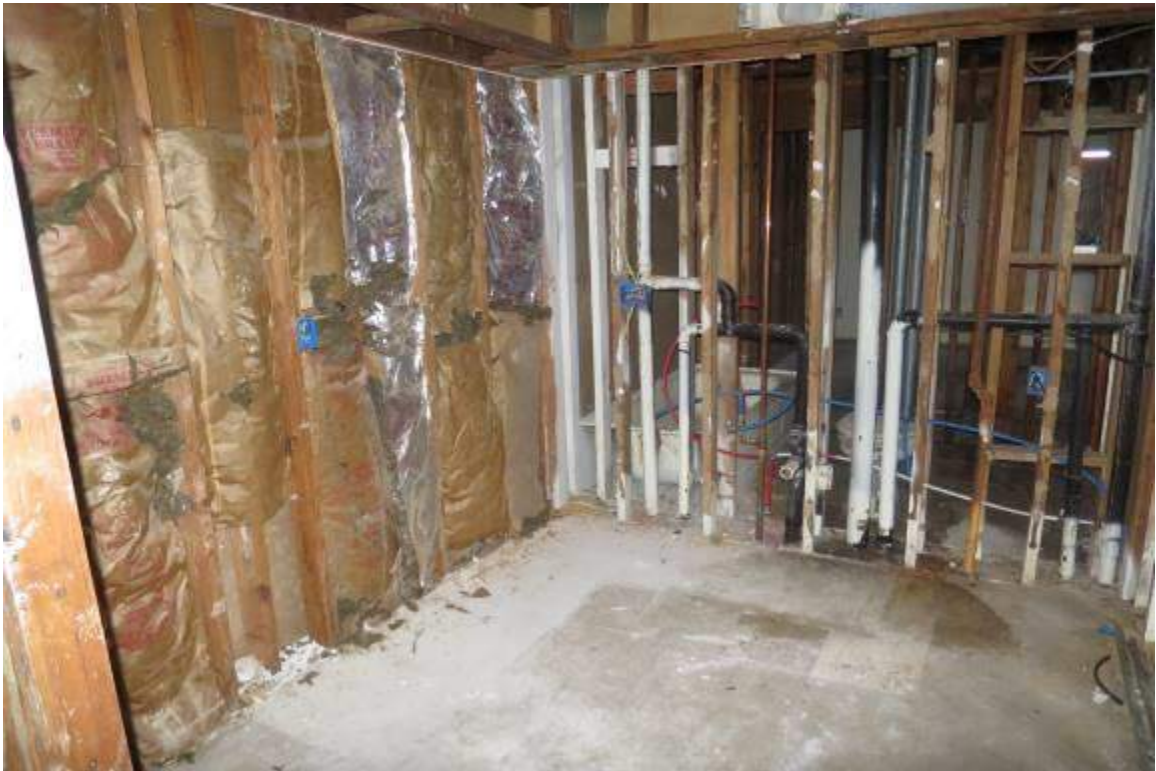
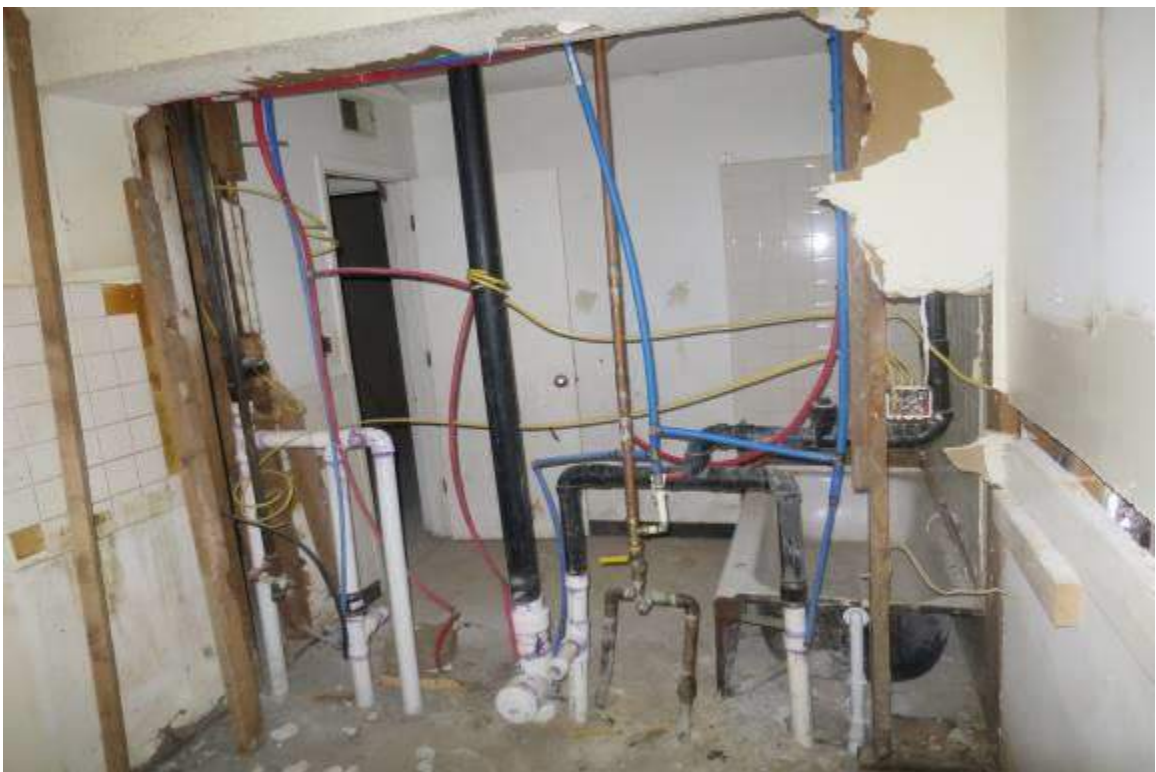
**INTERIOR WALL DETERIORATION – 2644 E 29<sup>TH</sup> STREET**

1<sup>st</sup> Floor Unit

2<sup>nd</sup> Floor Unit
