# QUALIFICATION ANALYSIS

29<sup>TH</sup> & BENTON PIEA STUDY AREA  
NWQ BENTON BOULEVARD & E 29<sup>TH</sup> STREET  
KANSAS CITY, MISSOURI

APRIL 3, 2020  
RECORD NO. 1730

BELKE APPRAISAL & CONSULTING SERVICES, INC.

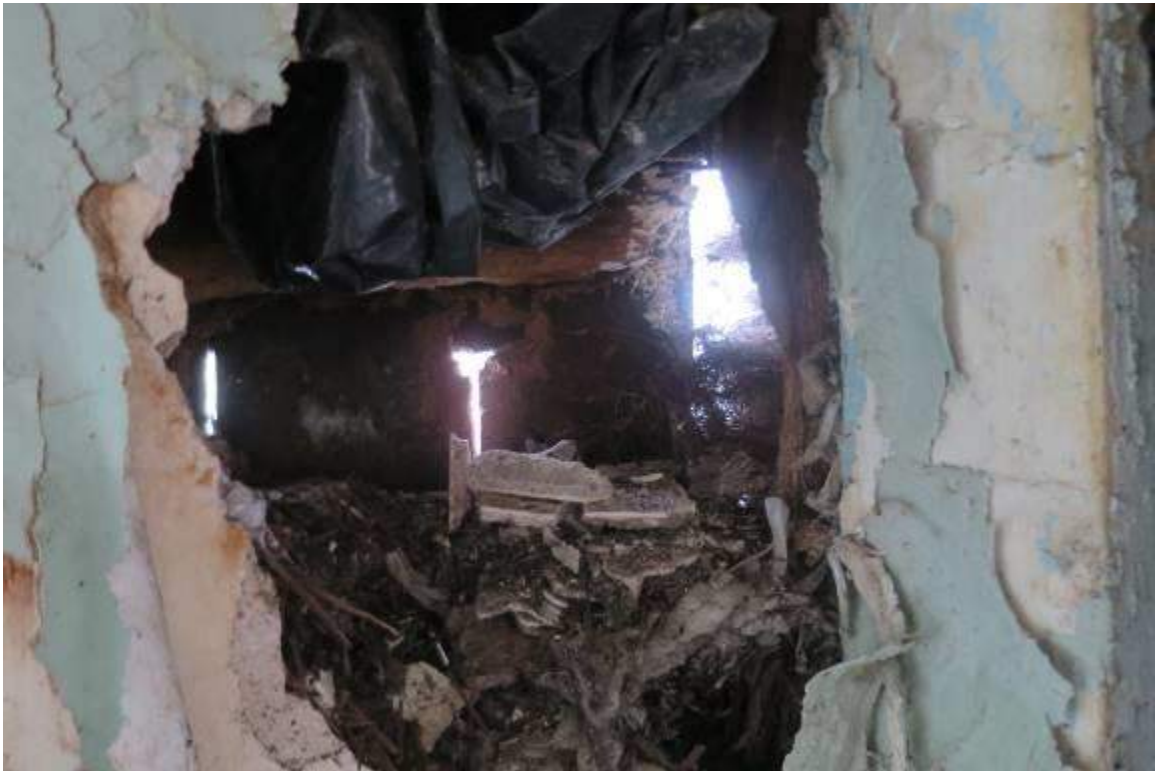
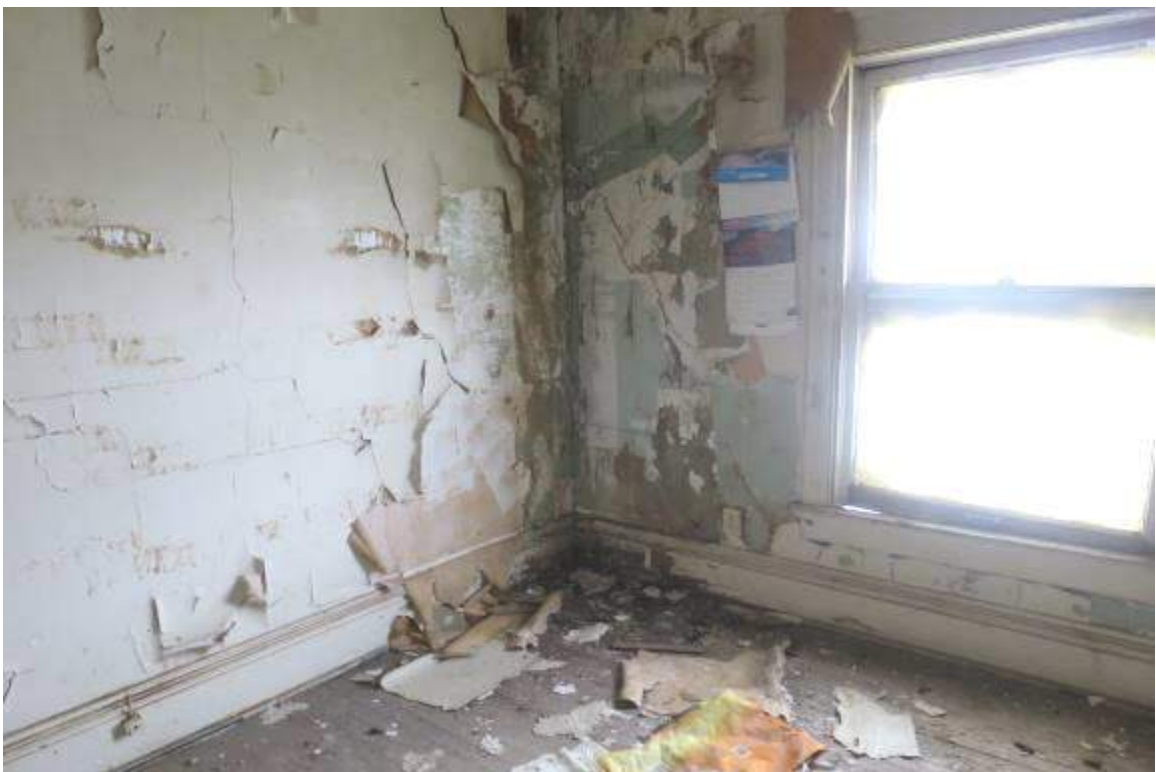
**INTERIOR WALL DETERIORATION – 2651 VICTOR STREET**

1<sup>st</sup> Floor

2<sup>nd</sup> Floor

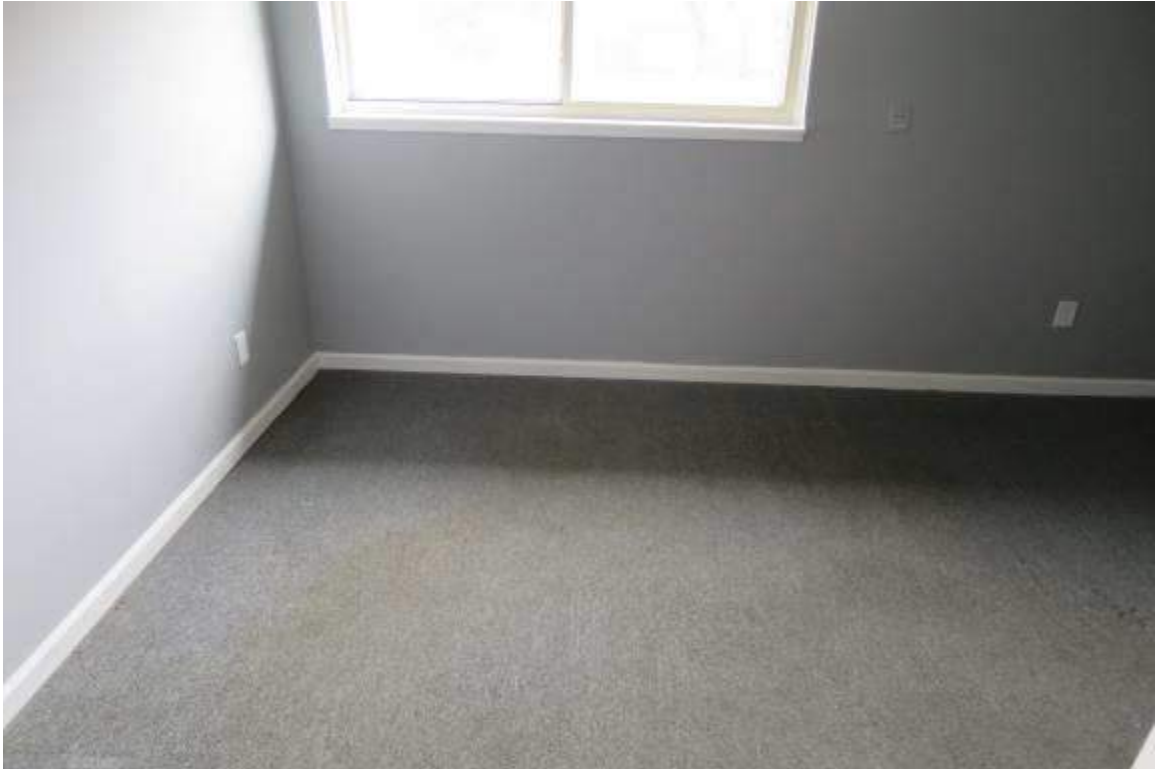
**FLOOR DETERIORATION – 2702 E 29<sup>TH</sup> STREET**

Stained Bedroom Carpet

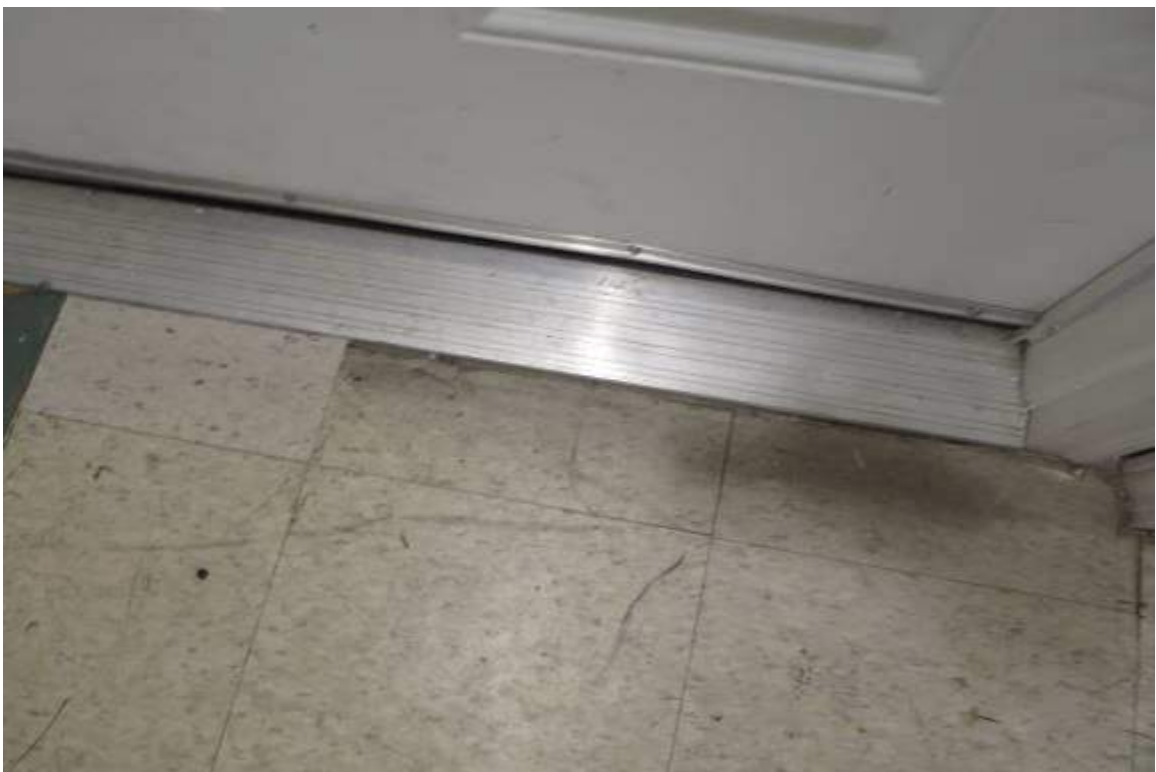
Hallway – Unit Entrance

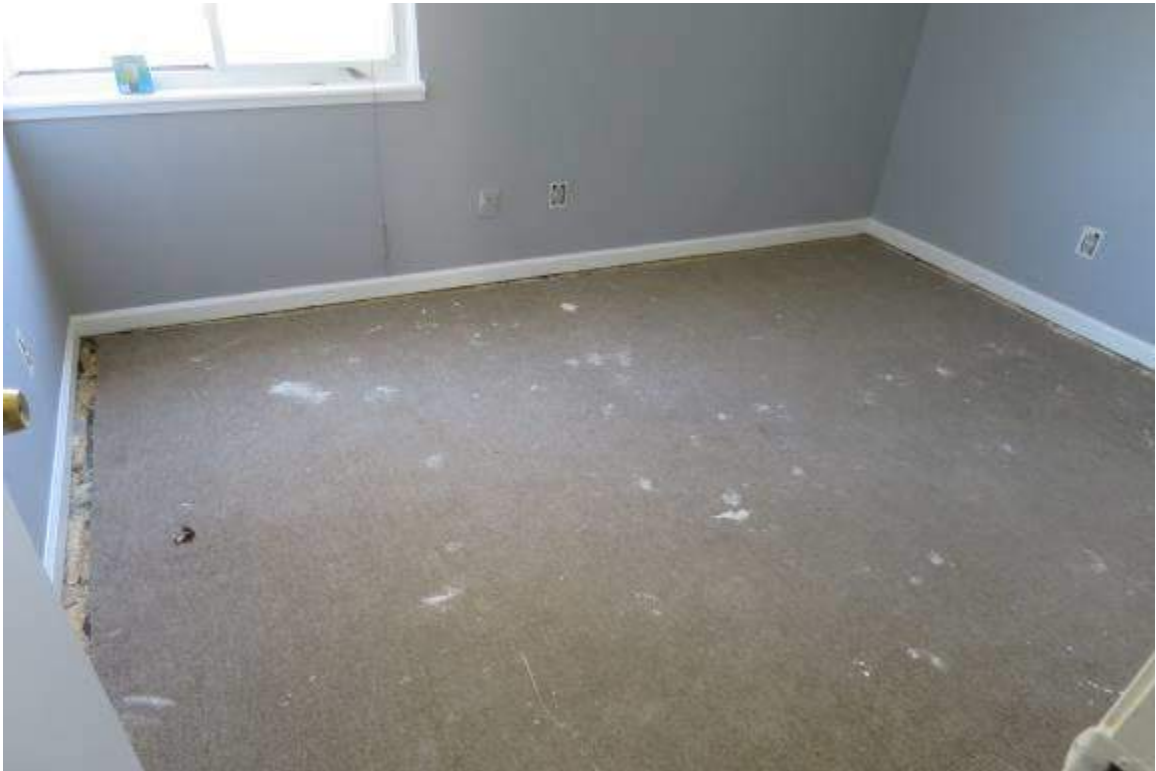
**FLOOR DETERIORATION – 2702 E 29<sup>TH</sup> STREET**

Dated Carpet In Bedroom

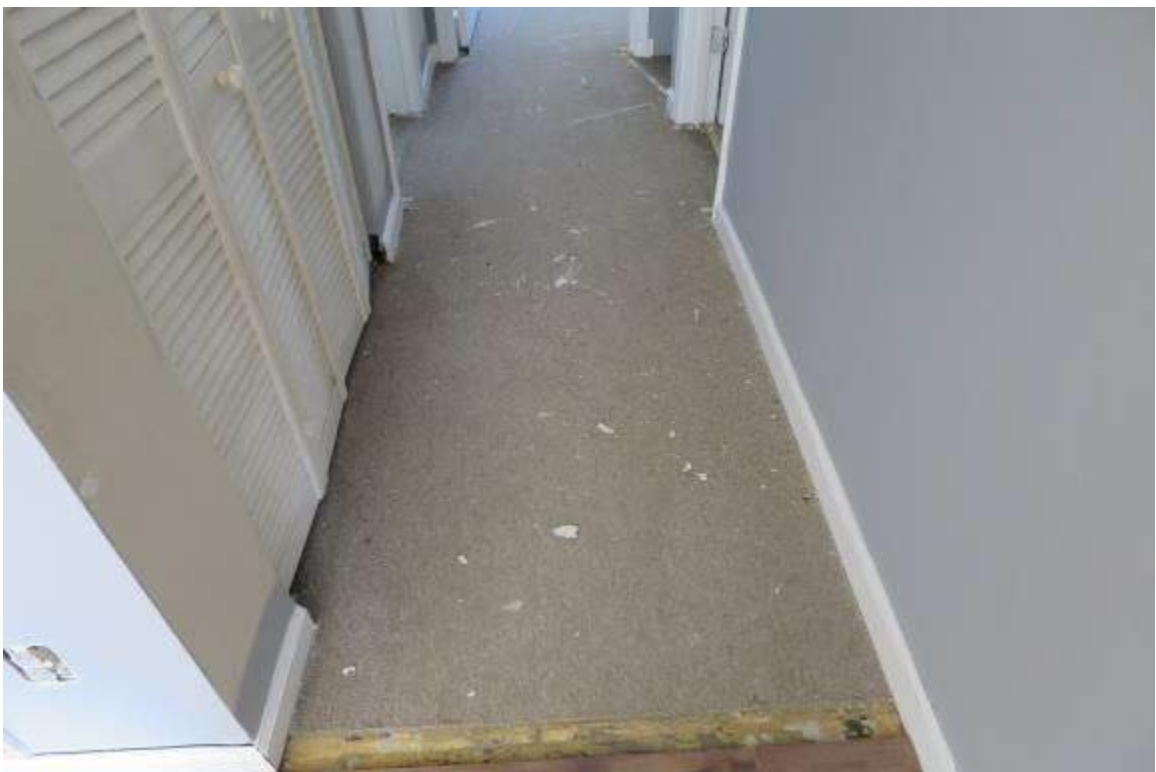
Dated Carpet In Hallway In 1BR Unit

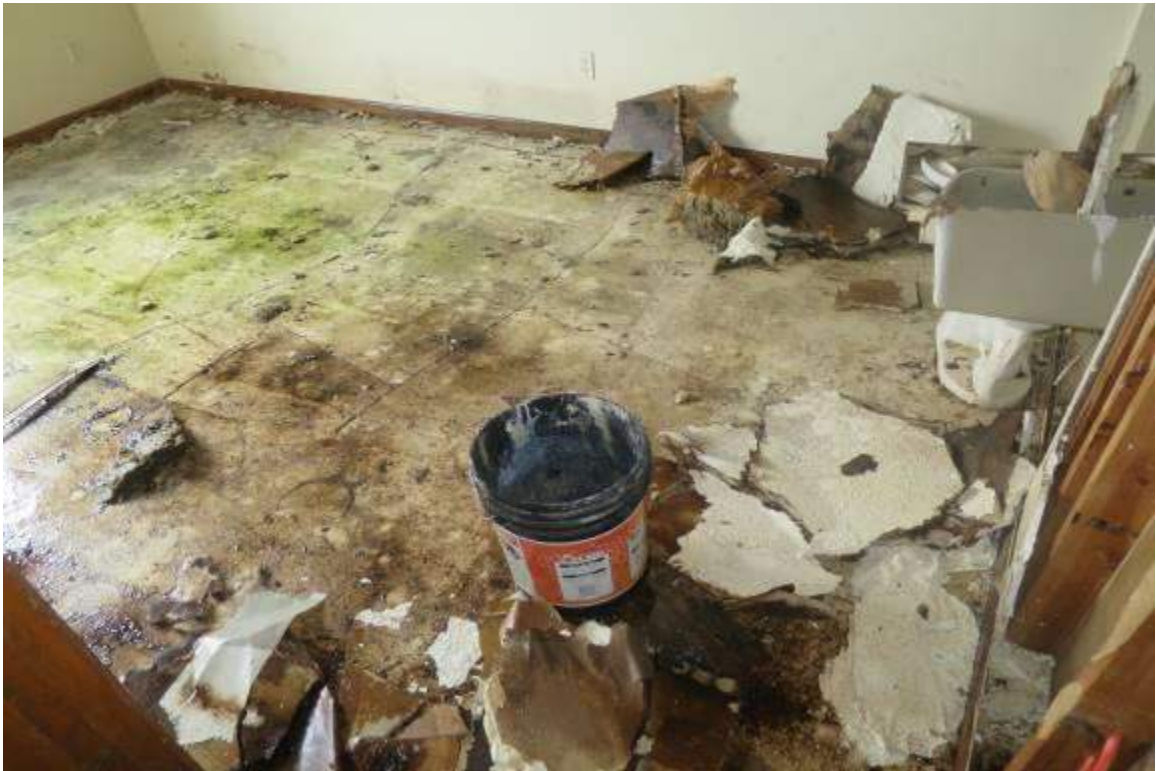
2<sup>nd</sup> Floor Unit

**FLOOR DETERIORATION – 2644 E 29<sup>TH</sup> STREET**

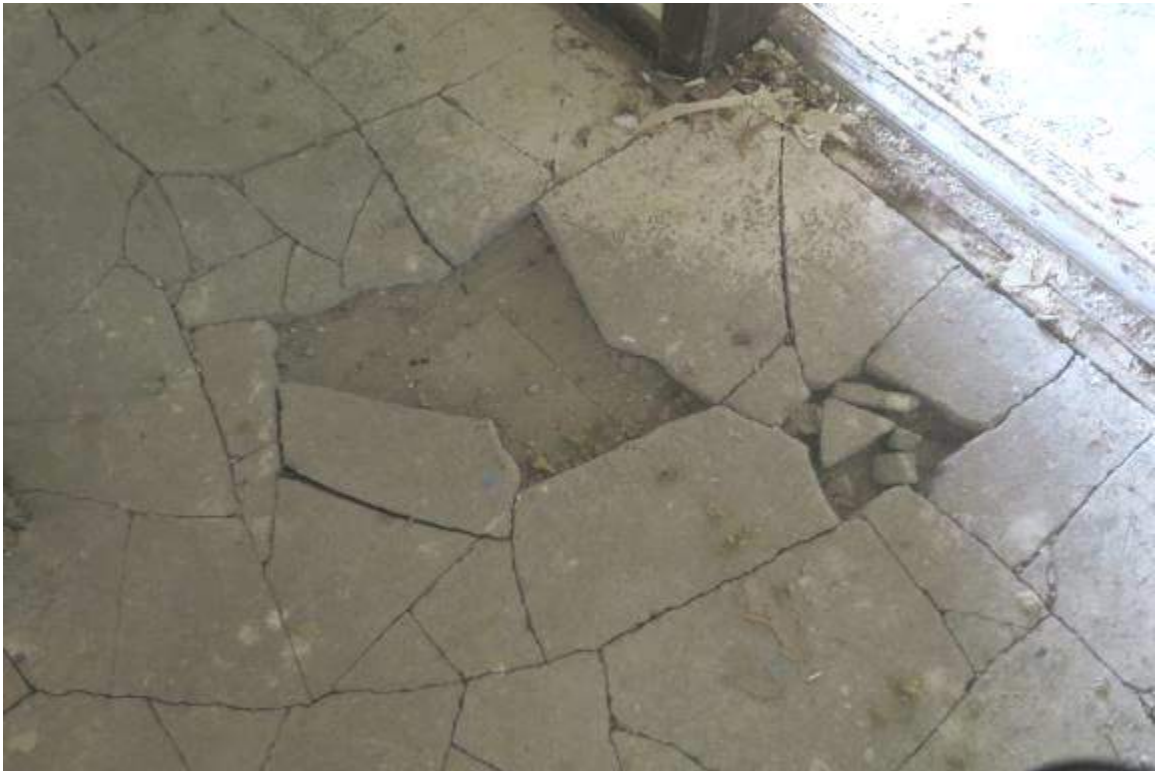
2<sup>nd</sup> Floor – Subfloor

**FLOOR DETERIORATION – 2644 E 29<sup>TH</sup> STREET**

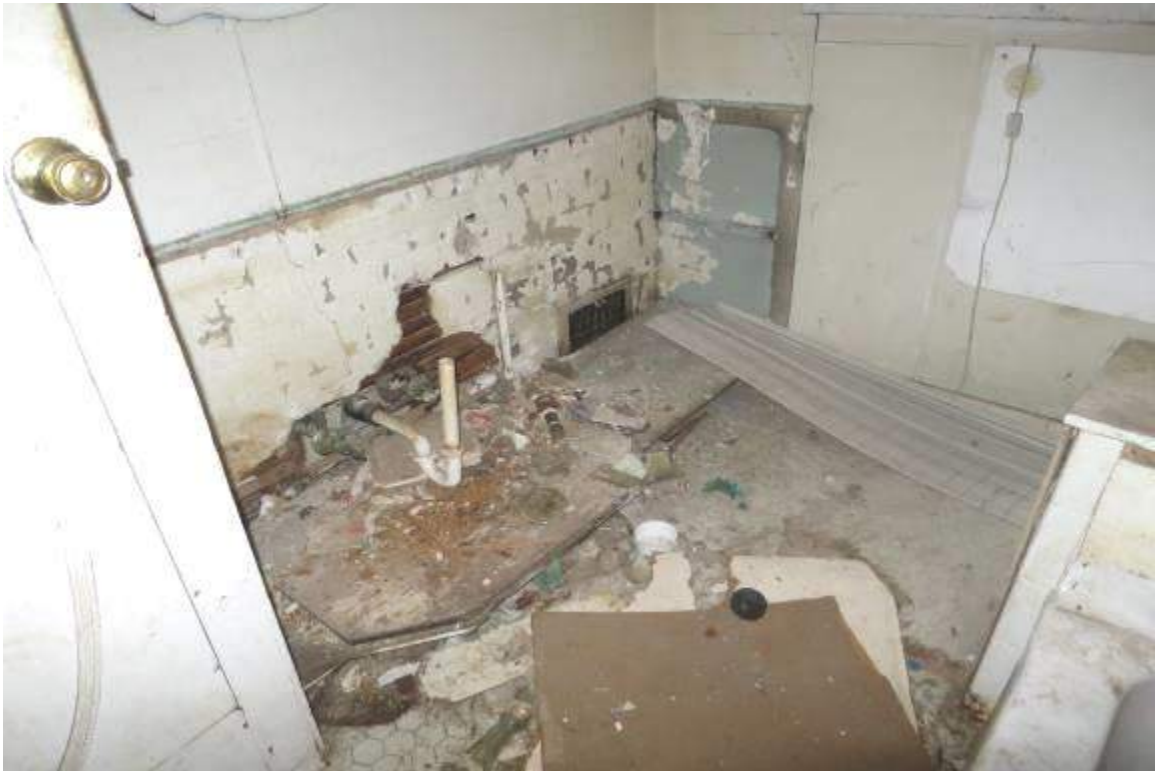
1<sup>st</sup> Floor

**FLOOR DETERIORATION – 2644 E 29<sup>TH</sup> STREET**

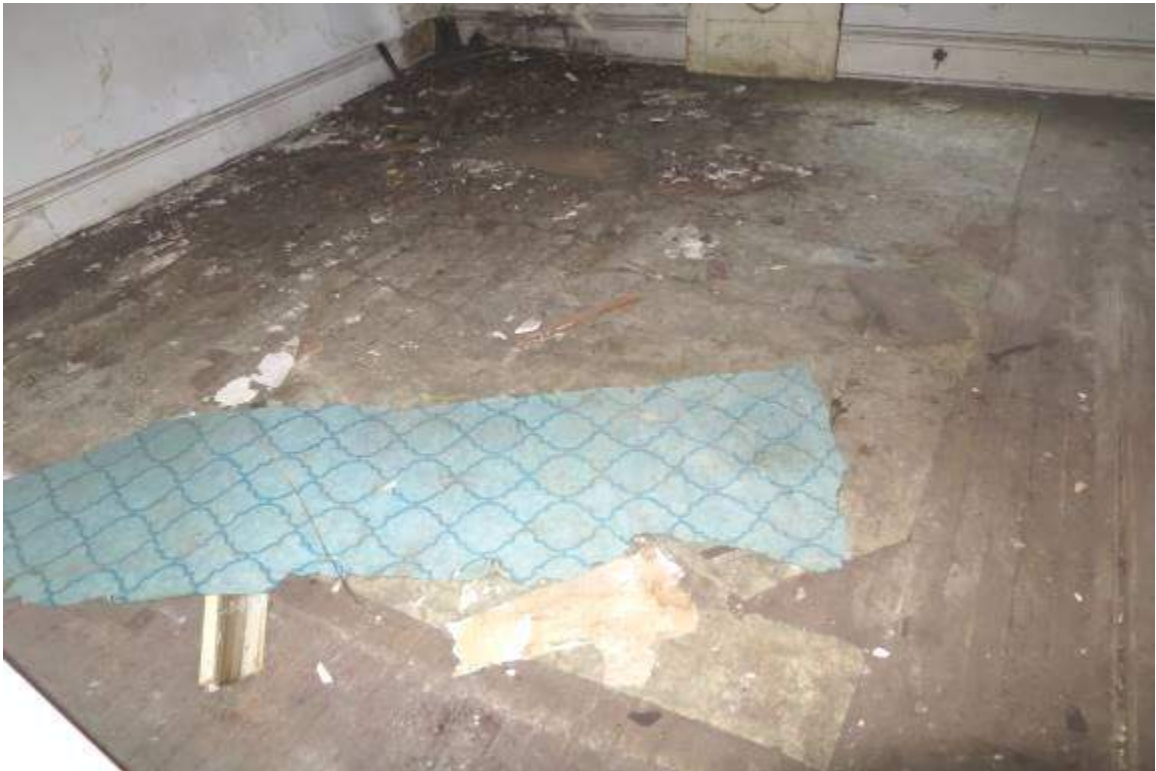
2<sup>nd</sup> Floor

**FLOOR DETERIORATION – 2644 E 29<sup>TH</sup> STREET**

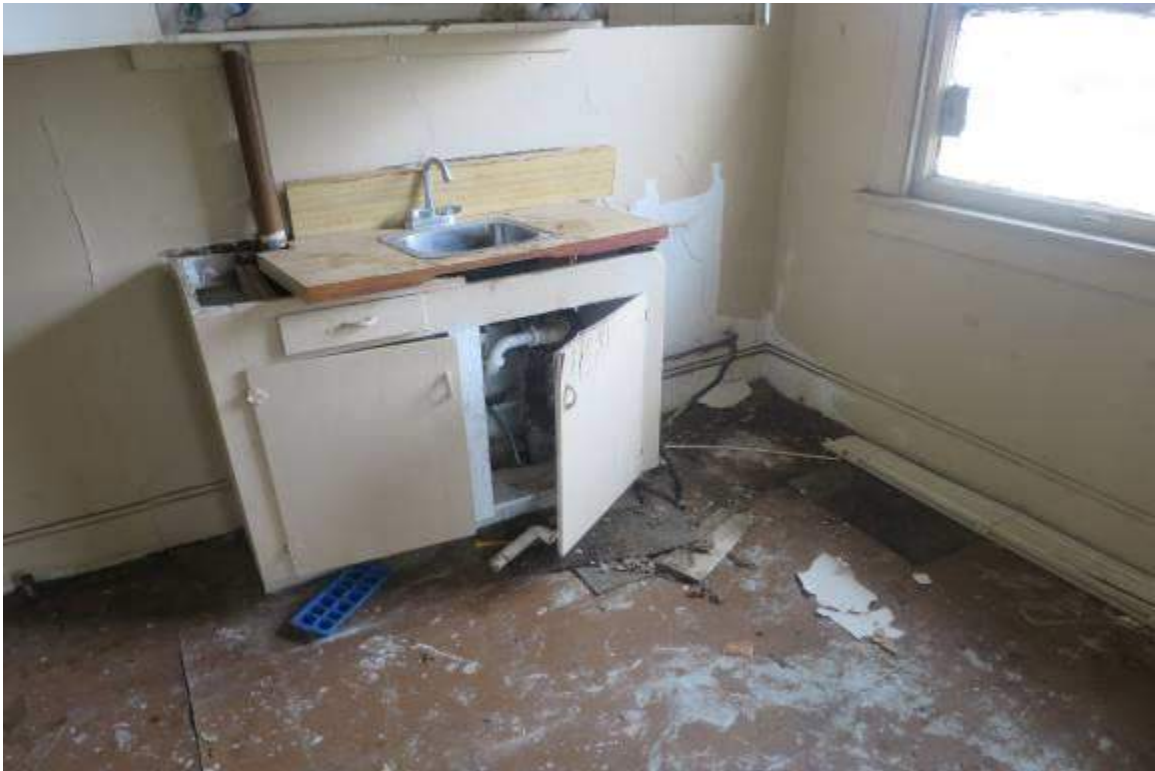
2<sup>nd</sup> Floor

### KITCHEN DETERIORATION – 2651 VICTOR STREET

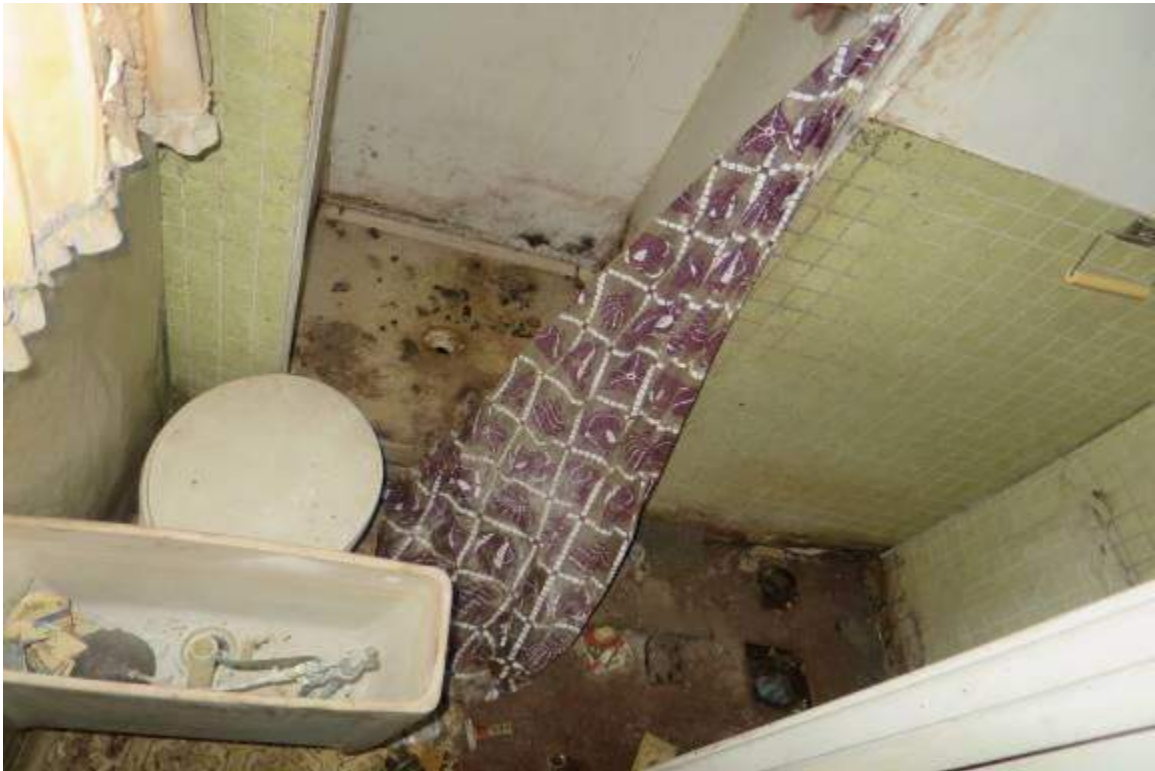
1<sup>st</sup> Floor

**RESTROOM DETERIORATION – 2651 VICTOR STREET**

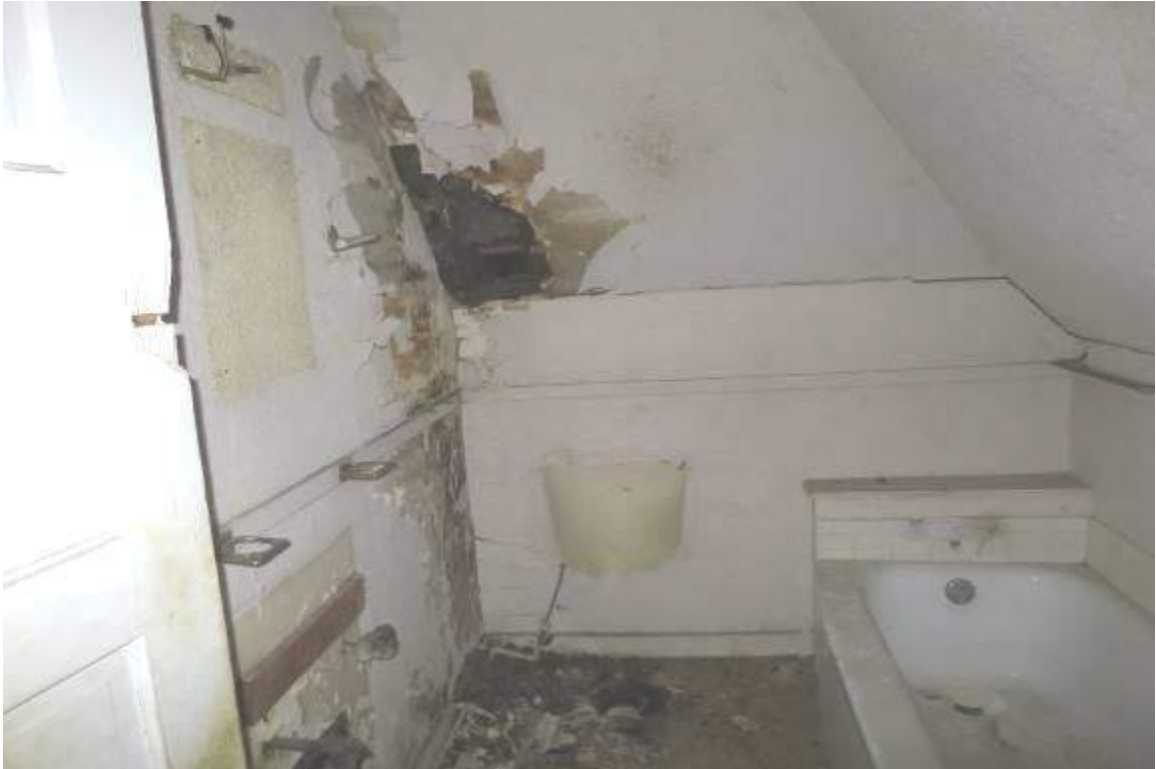
3<sup>rd</sup> Floor

**RESTROOM DETERIORATION – 2651 VICTOR STREET**

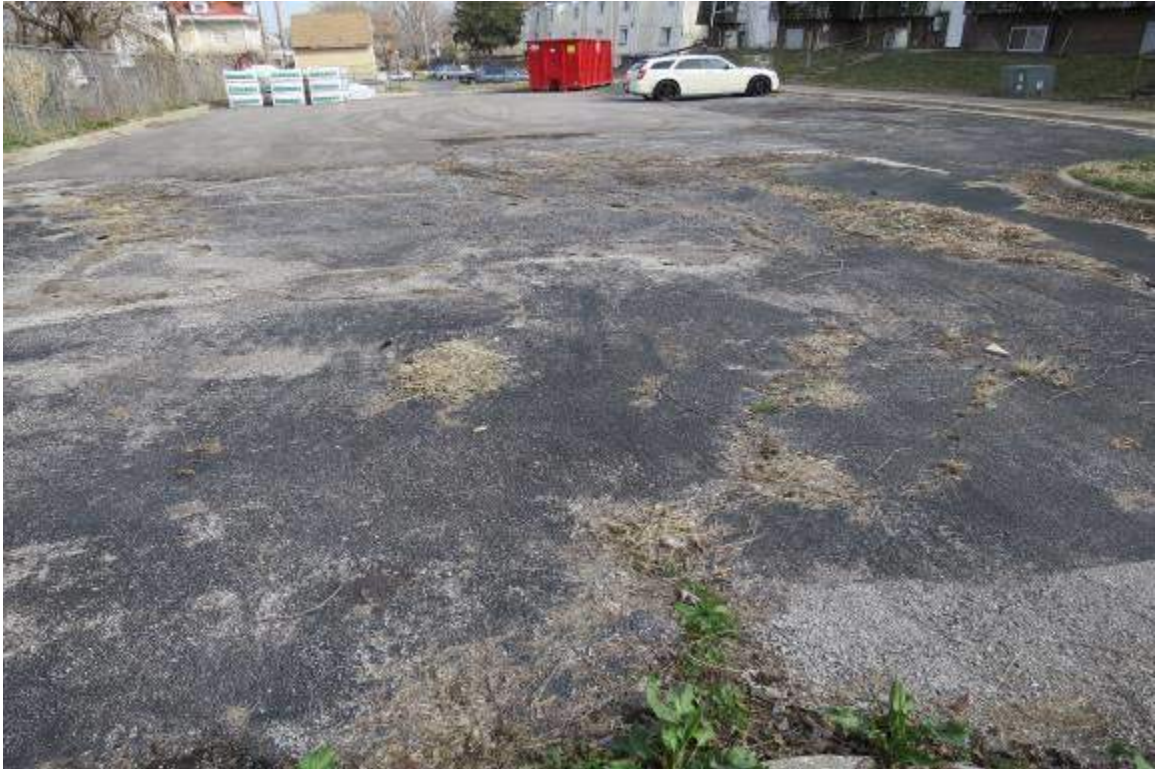
Apartment Building Parking Lot – 2644 E 29<sup>th</sup> Street

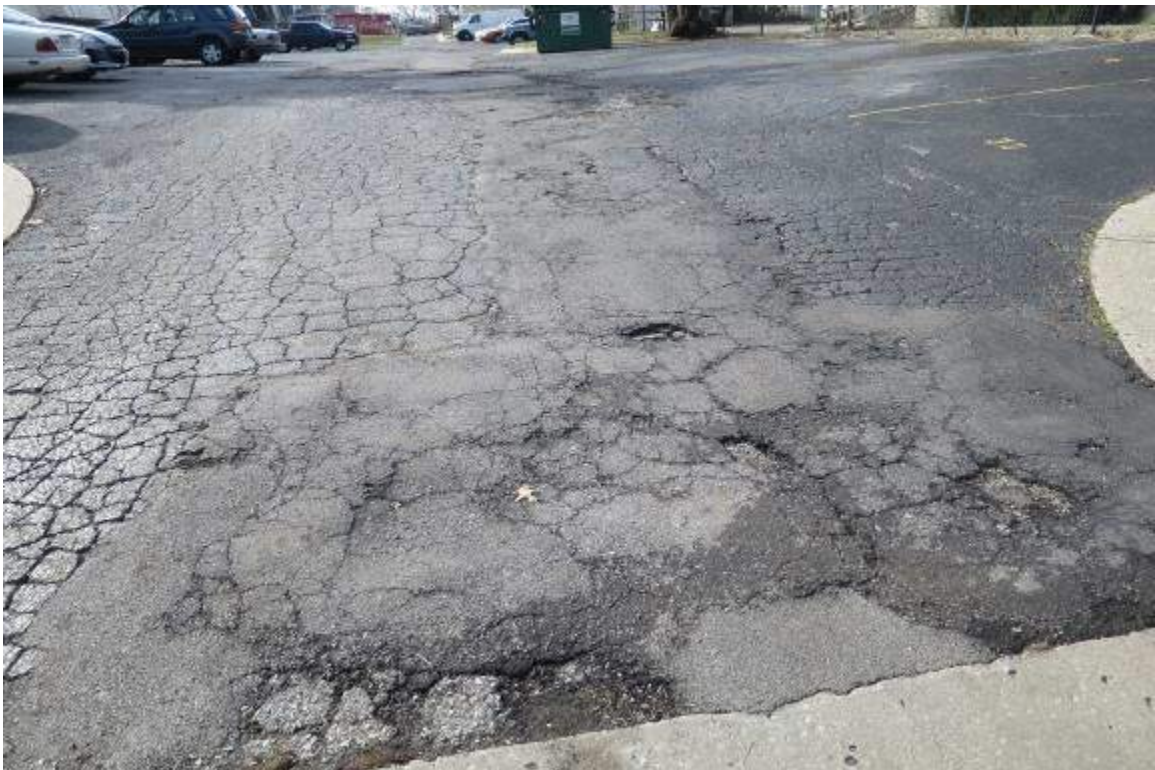
Apartment Building Parking Lot – 2702 E 29<sup>th</sup> Street

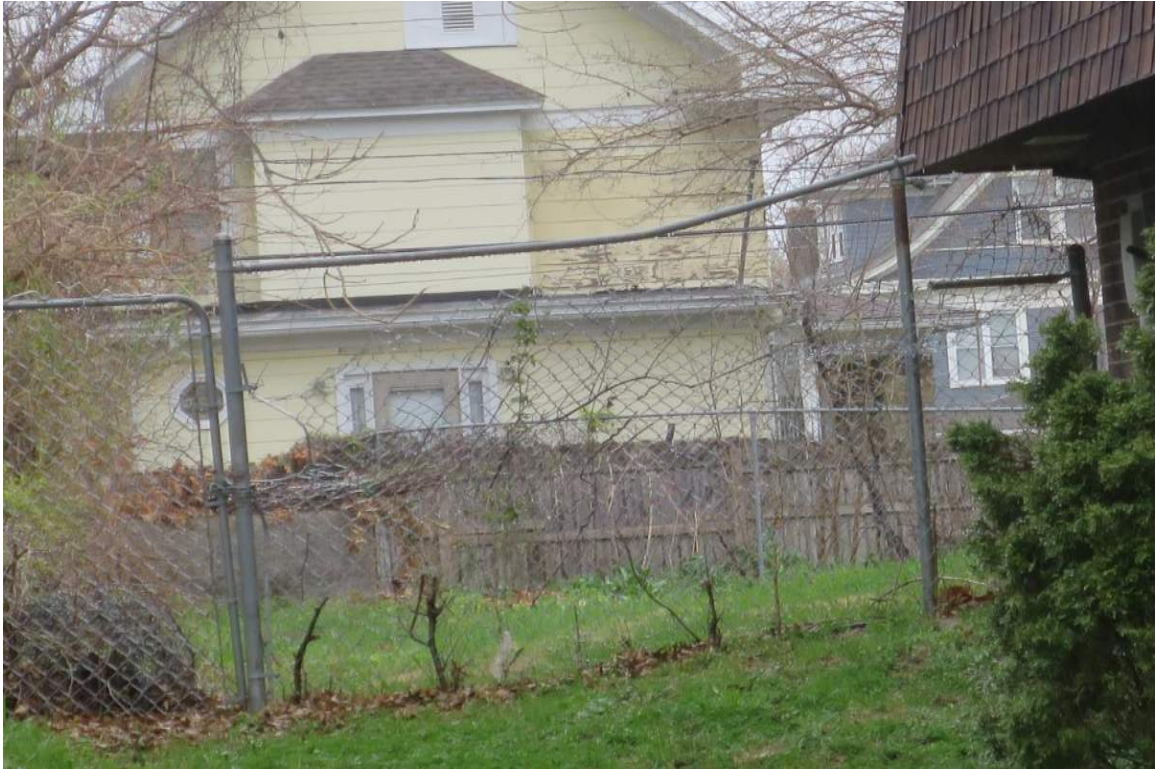
Damaged Chain-Link Fencing – 2644 E 29<sup>th</sup> Street

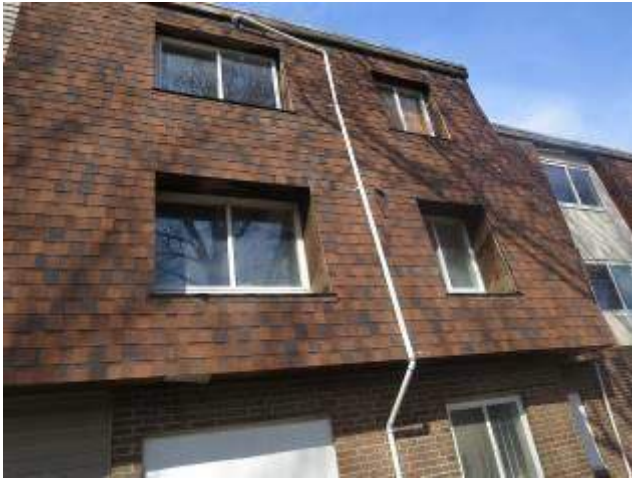
Unsightly &amp; Improper Roof Drainage – 2644

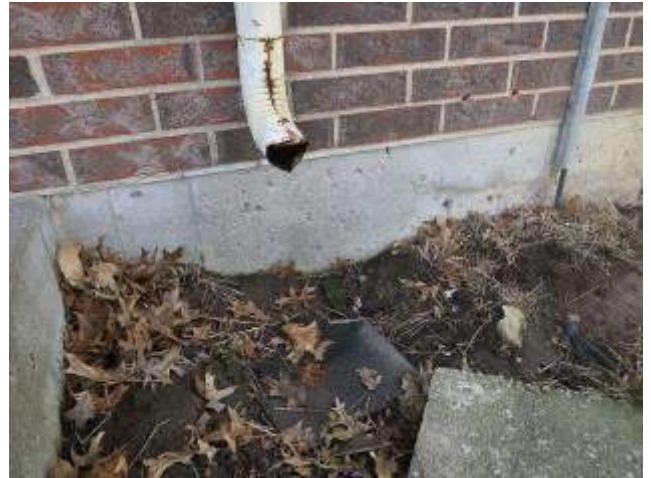
Poor Drainage &amp; Erosion – 2644

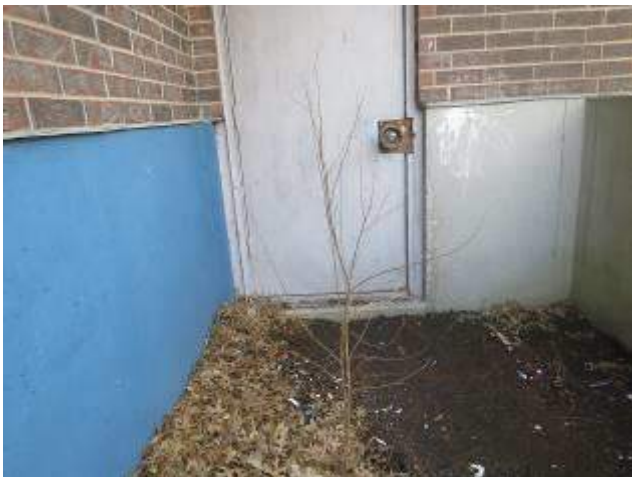
Poor Drainage At Entrance – 2644

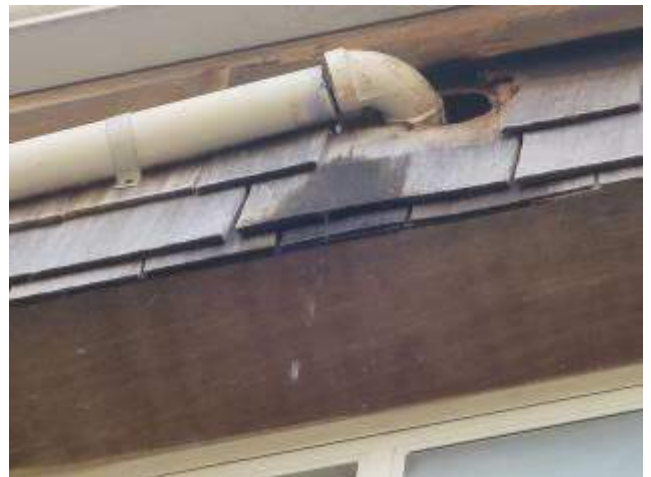
Poor Drainage – 2644

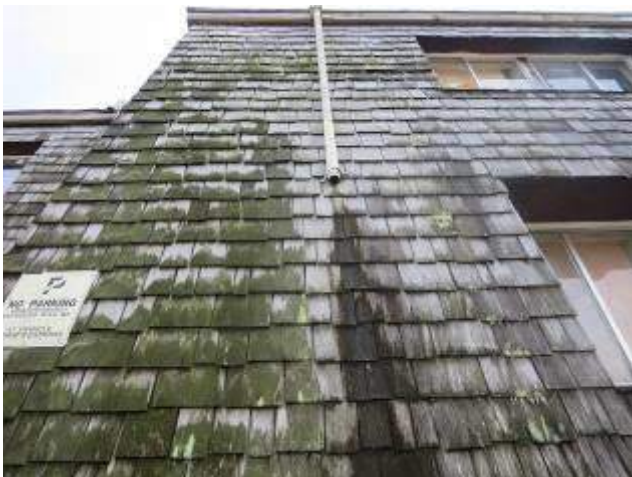
Poor Drainage – 2644

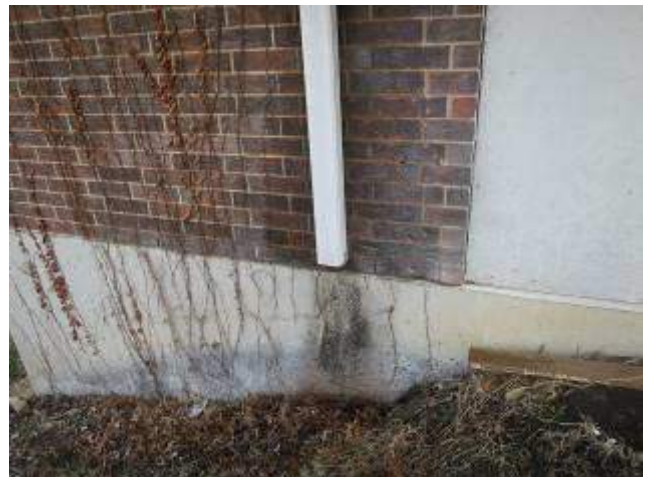
Poor Drainage &amp; Erosion – 2644

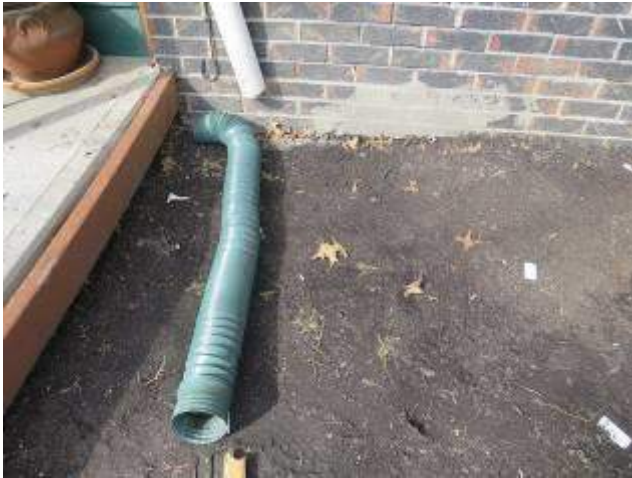
Improper Drainage – 2702

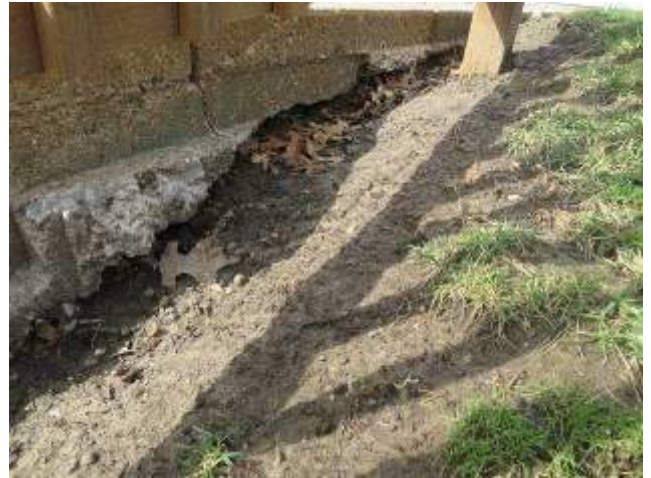
Poor Drainage &amp; Erosion – 2702

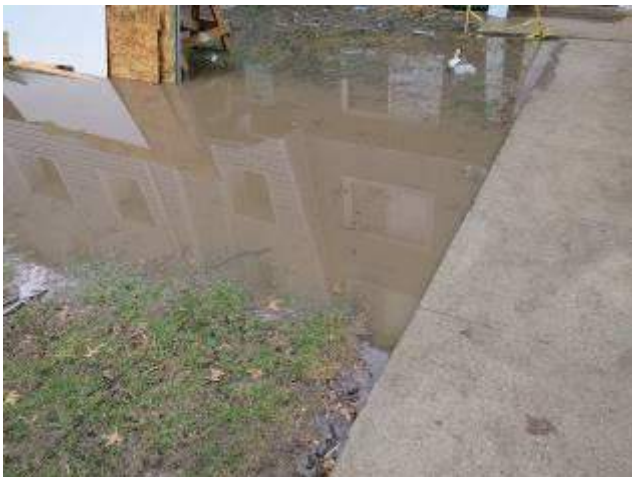
Poor Drainage

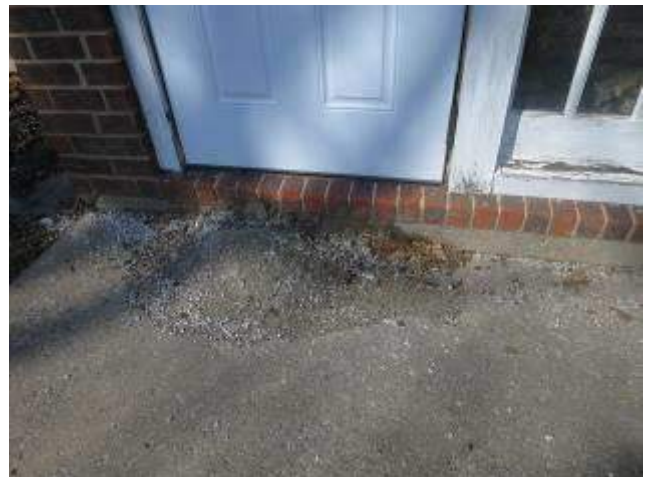
Step Up At Apartment Entrance – 2644

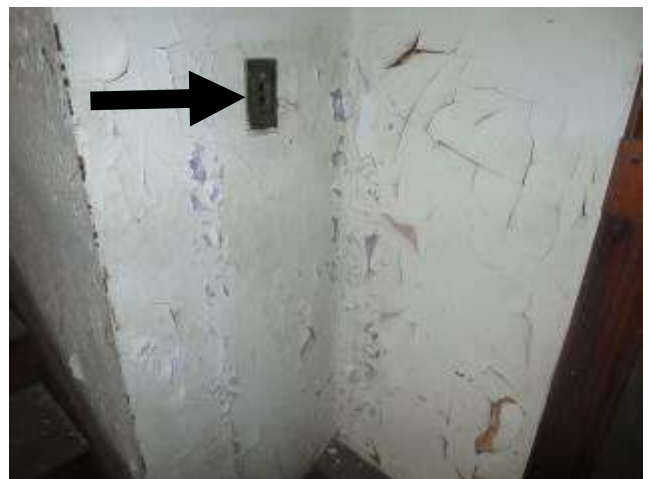
Old Electrical Wiring &amp; Fixtures – 2651

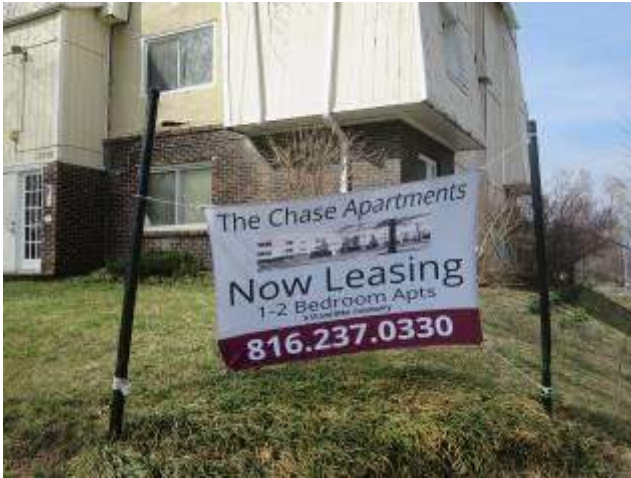
Unsightly Signage

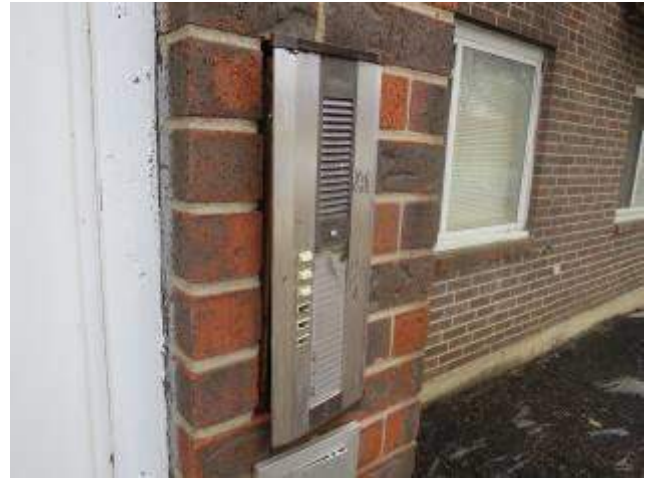
Dysfunctional Intercom – 2644

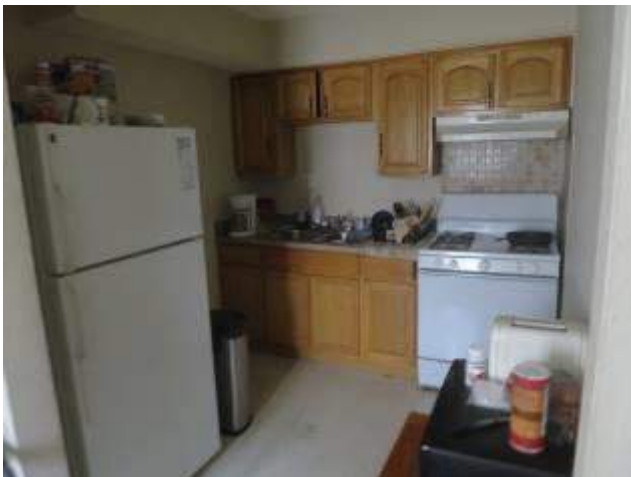
Small Poorly Equipped Kitchens – 2702

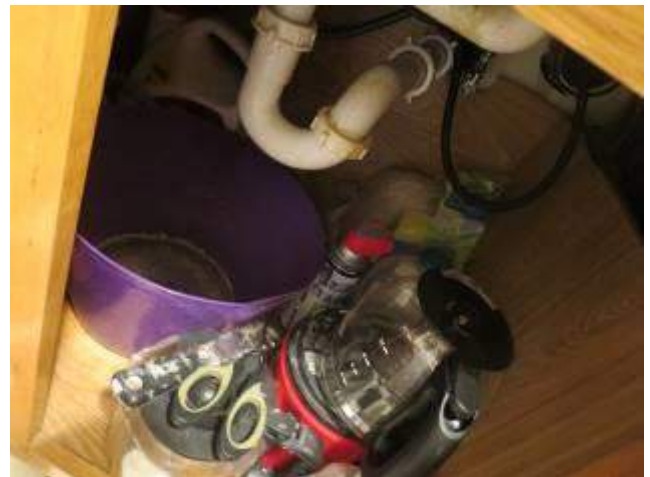
Lack Of Disposals – 2702

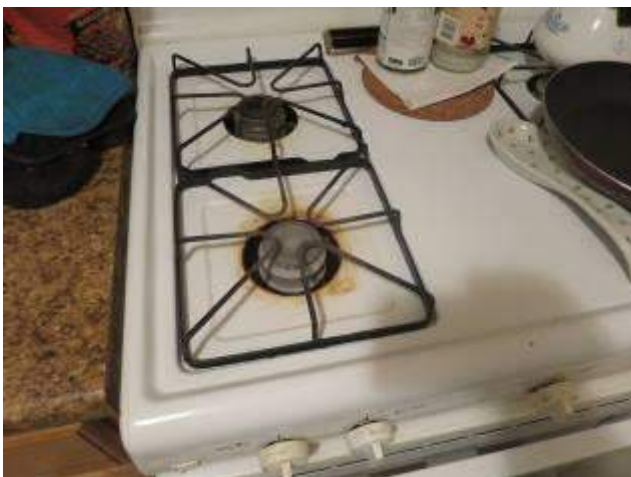
Older Gas Stoves – 2702

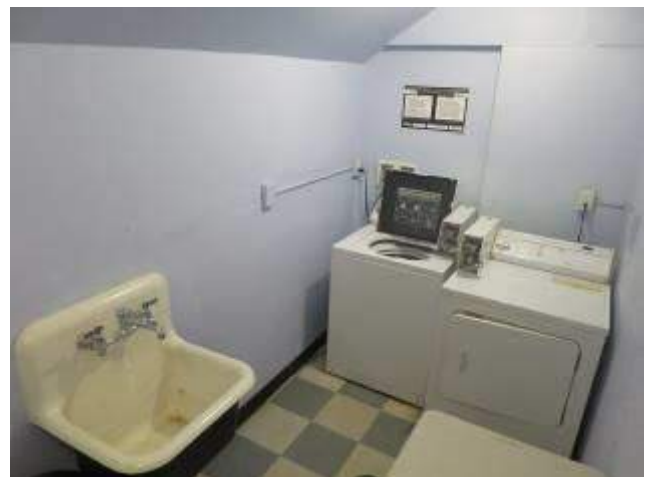
Common Laundry Rooms – 2702

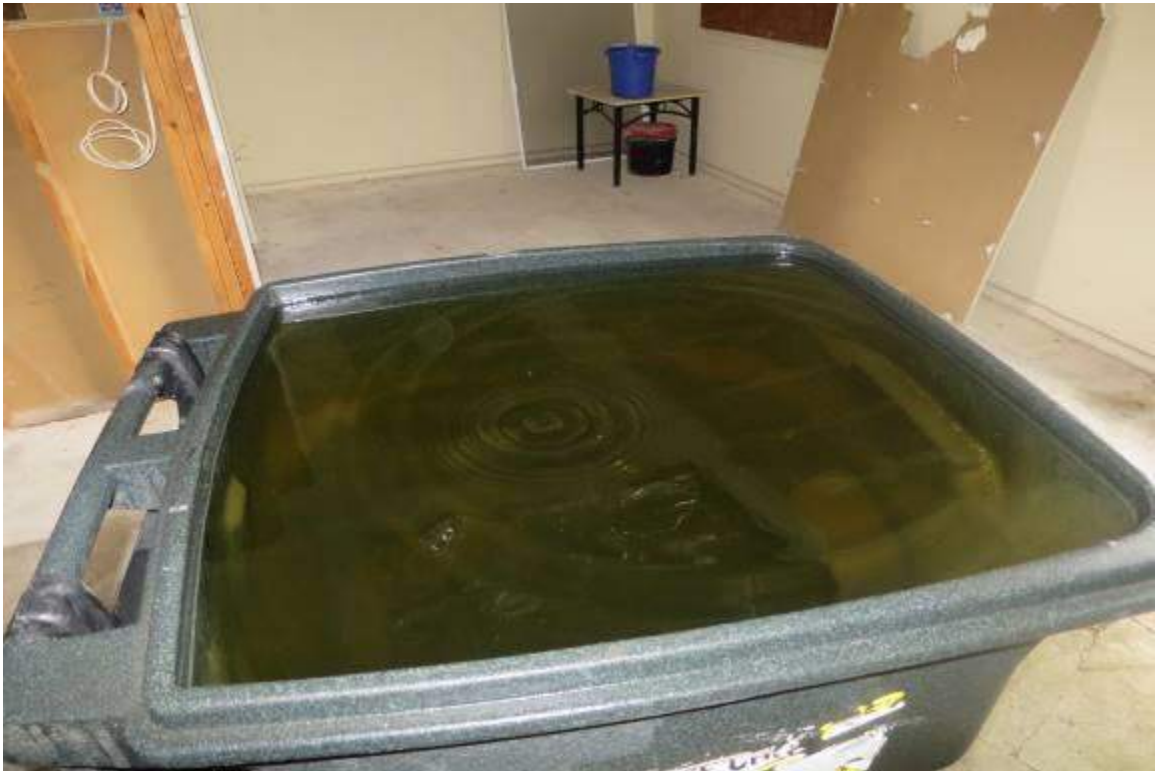
Water Infiltration At 2644 E 29<sup>th</sup> Street

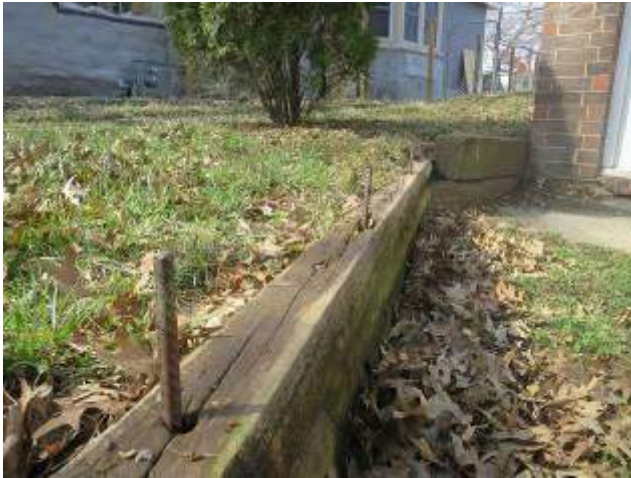
Exposed Steel Posts & Unguarded Drop Off – 2644

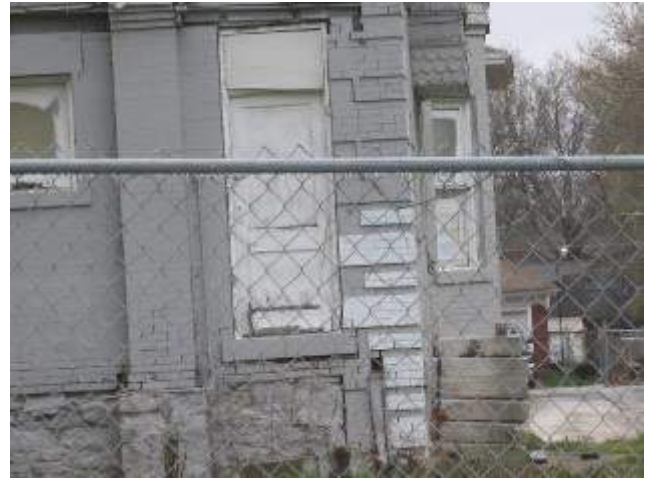
Doorway Lacking Landing – 2651

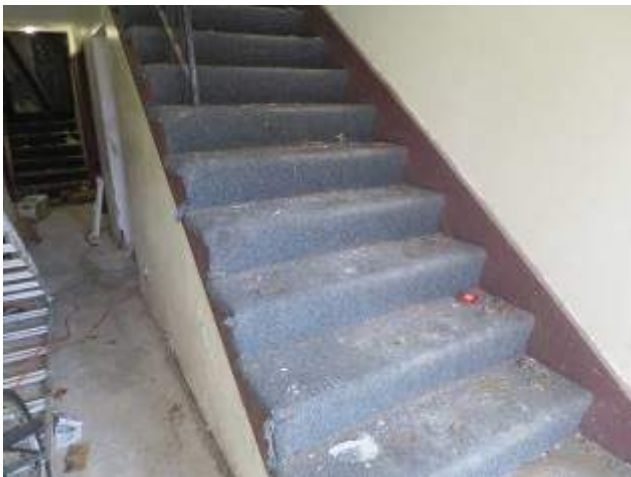
Lack Of Safety Railings On Stairway – 2644

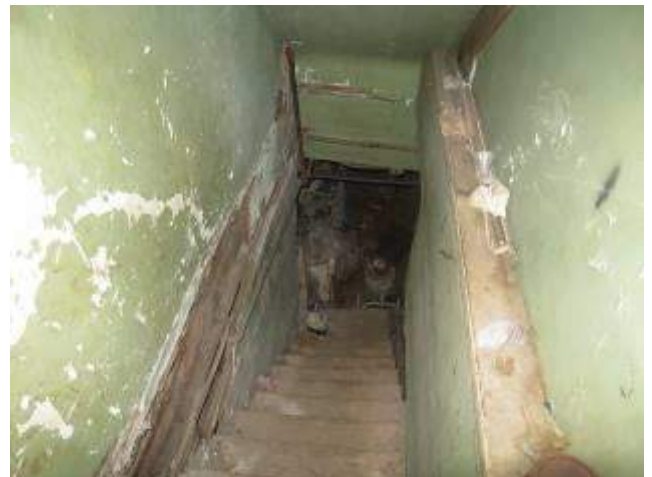
Unsafe Stairway – 2651

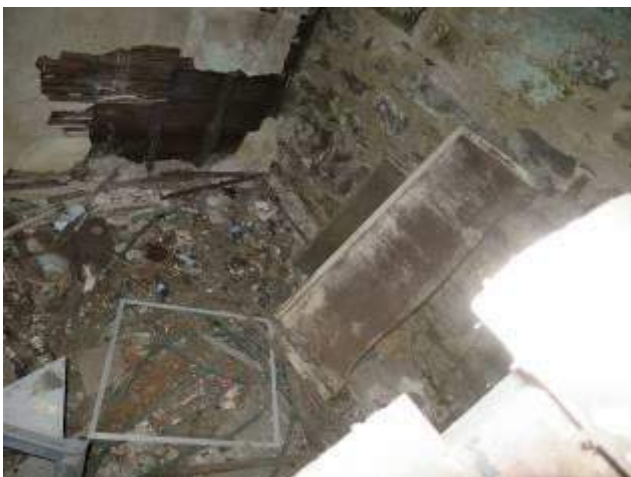
Trespassing – 2651

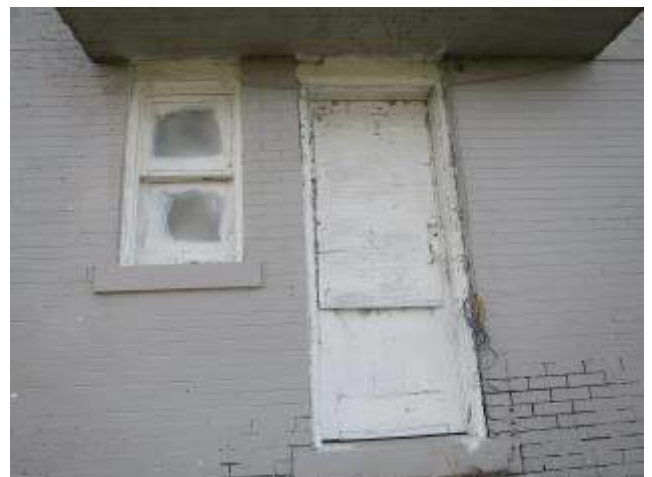
Doorway Lacking Landing – 2651

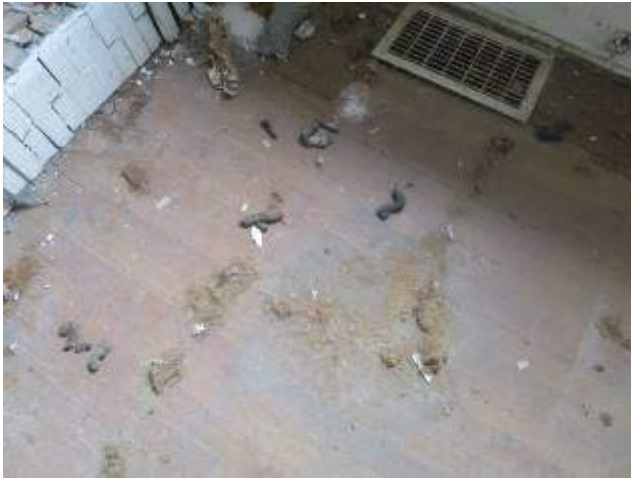
Insanitary Droppings – 2651

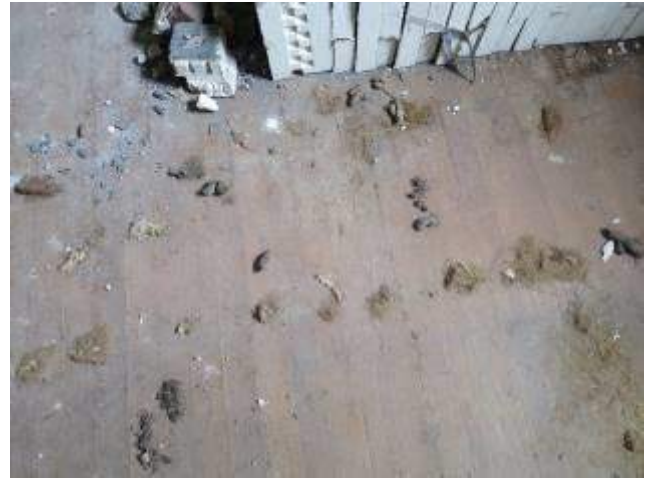
Insanitary Droppings – 2651
