# QUALIFICATION ANALYSIS

29<sup>TH</sup> & BENTON PIEA STUDY AREA  
NWQ BENTON BOULEVARD & E 29<sup>TH</sup> STREET  
KANSAS CITY, MISSOURI

APRIL 3, 2020  
RECORD NO. 1730

BELKE APPRAISAL & CONSULTING SERVICES, INC.

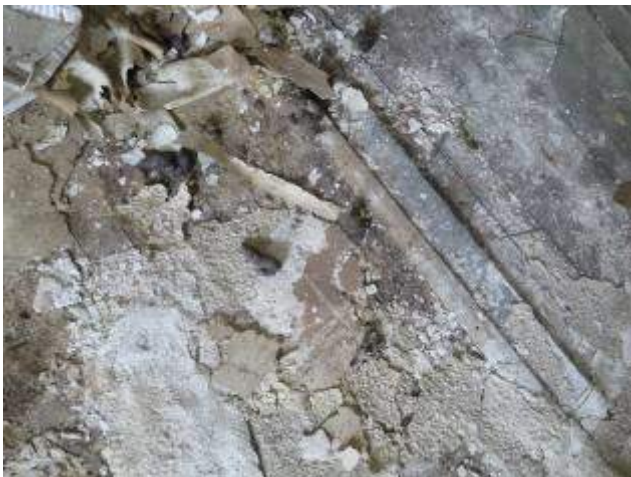
Insanitary Droppings – 2651

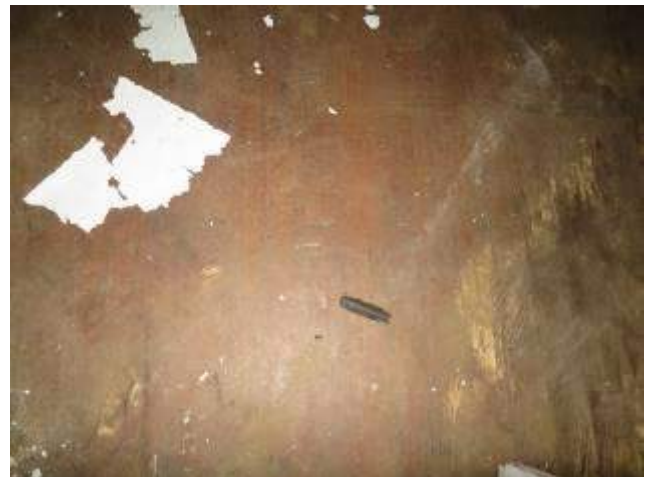
Insanitary Droppings – 2651

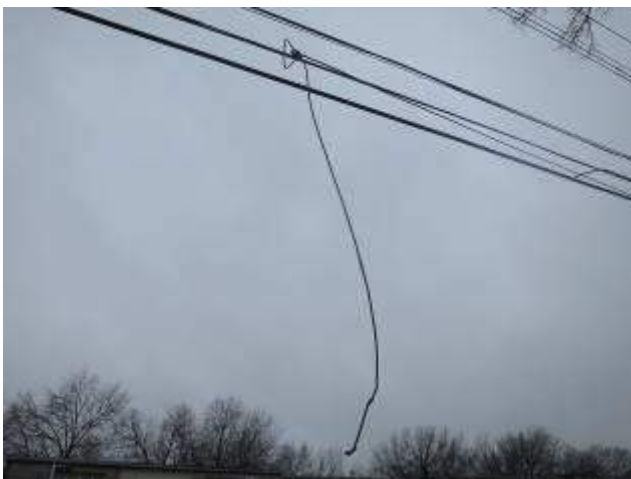
Hanging Power Line Over Parking Lot

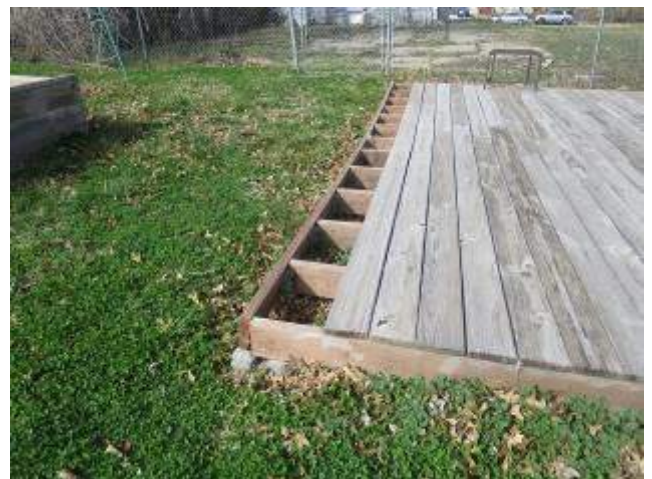
Missing Deck Planks

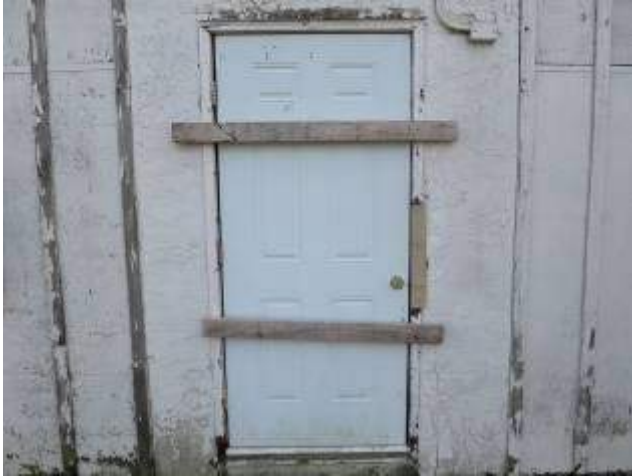
Vandalism - 2644

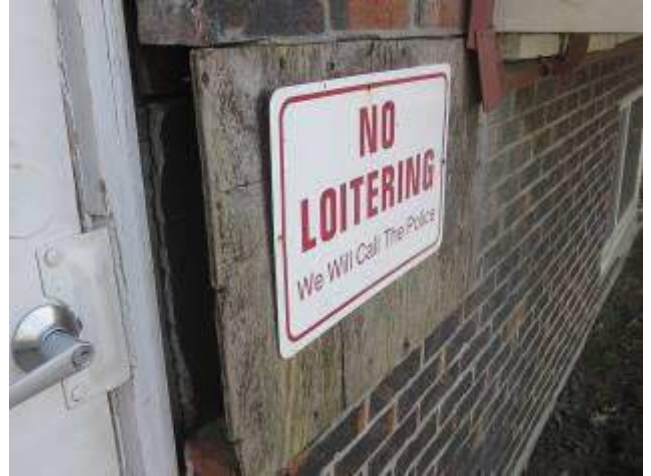
Vandalism - 2644

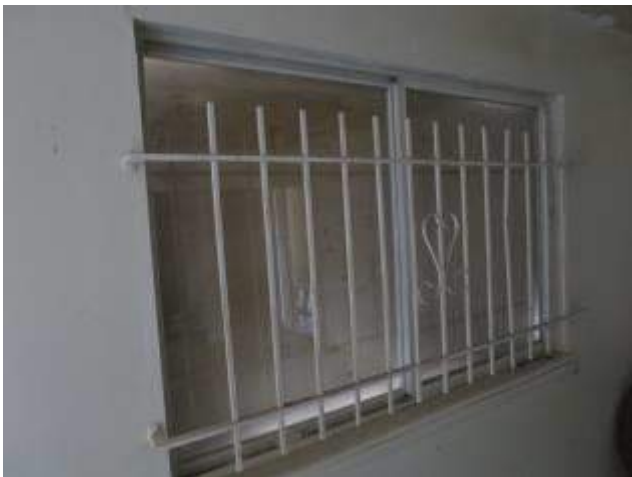
Vandalism - 2644

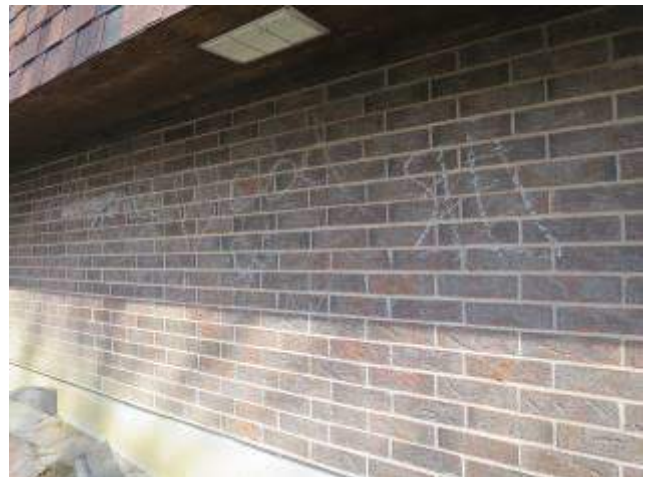
Vandalism - 2644

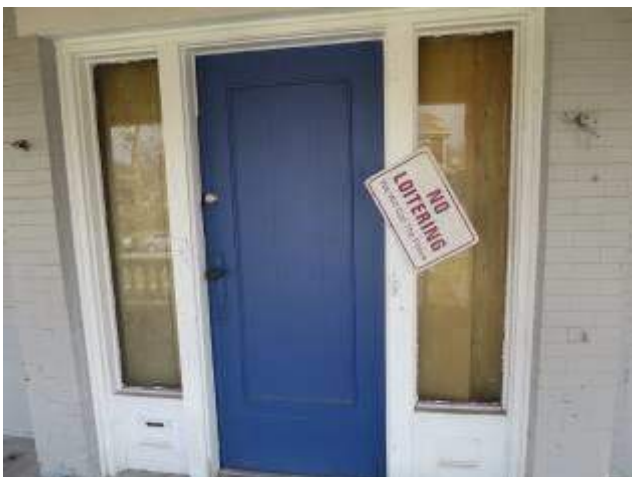
Vandalism - 2651

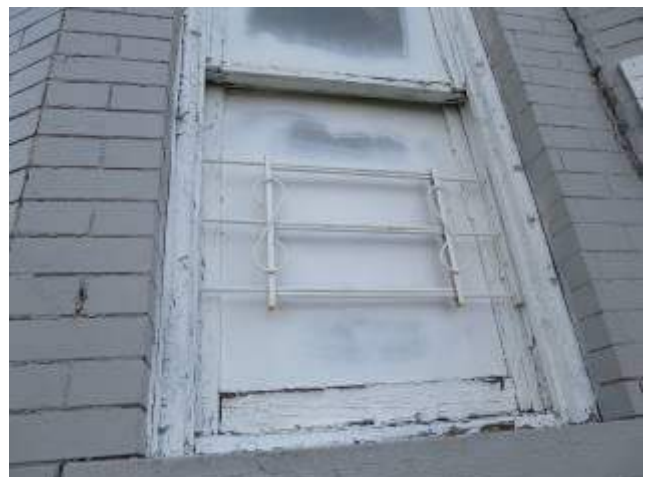
Vandalism - 2651

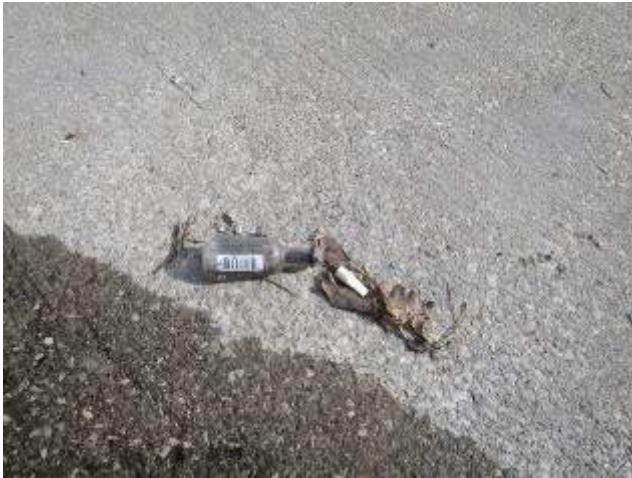
Loitering – 2651

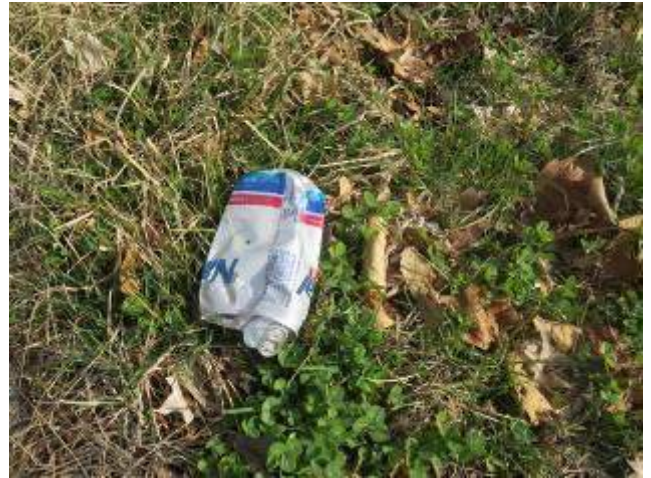
Loitering – 2651

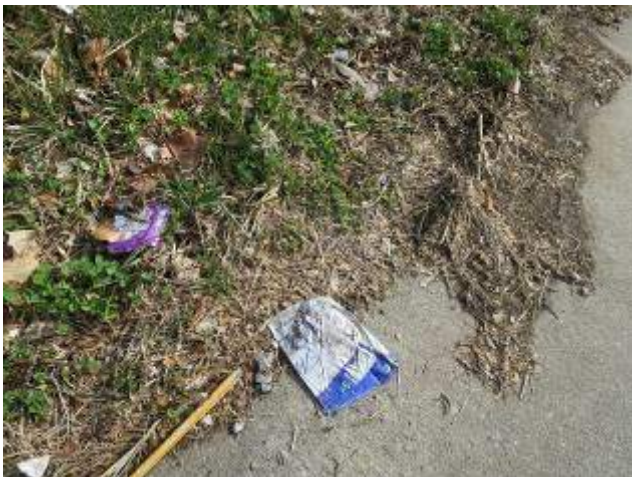
Loitering – 2651

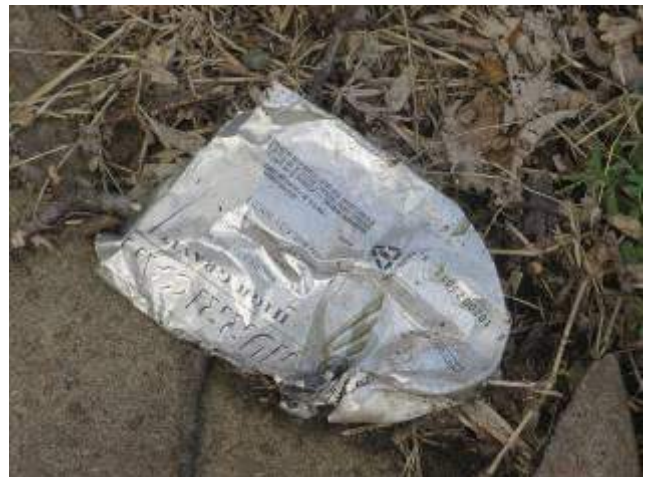
Loitering – 2651

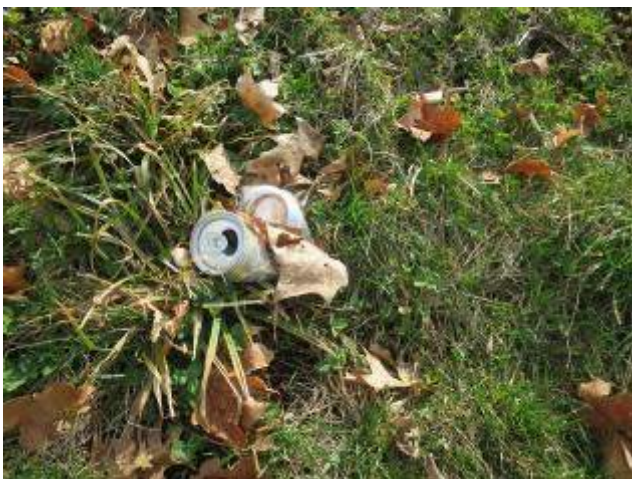
Loitering – 2651

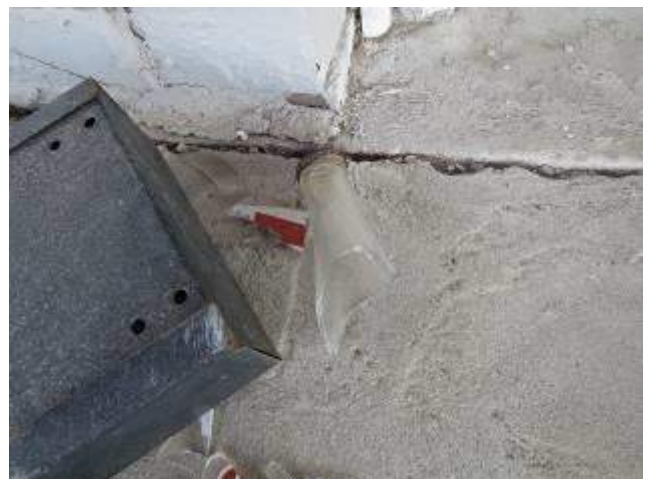
Broken Glass – Porch 2651

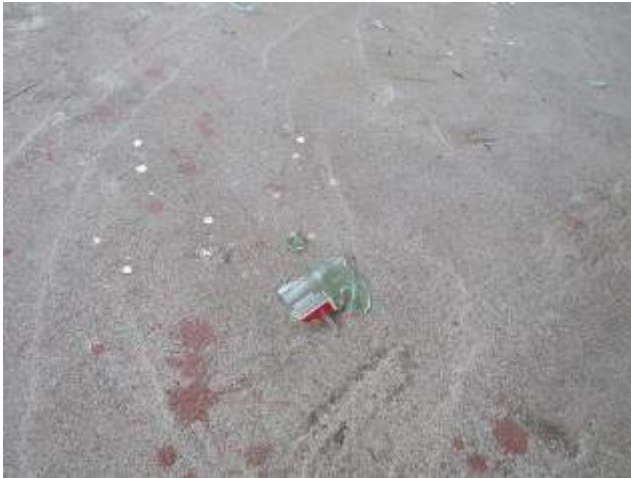
Broken Glass – Porch 2651

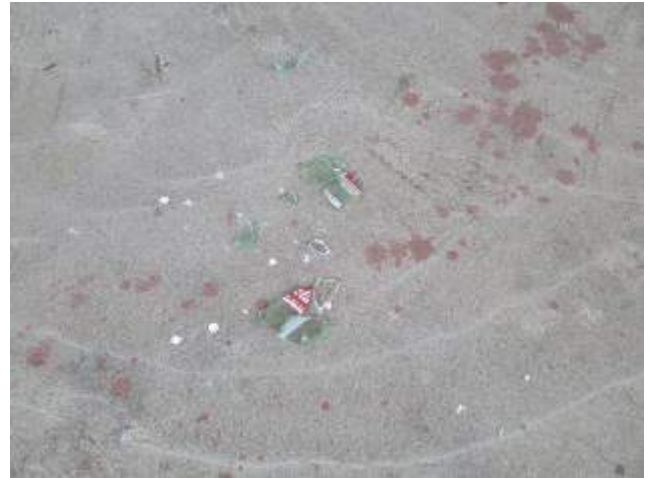
Broken Glass – Porch 2651

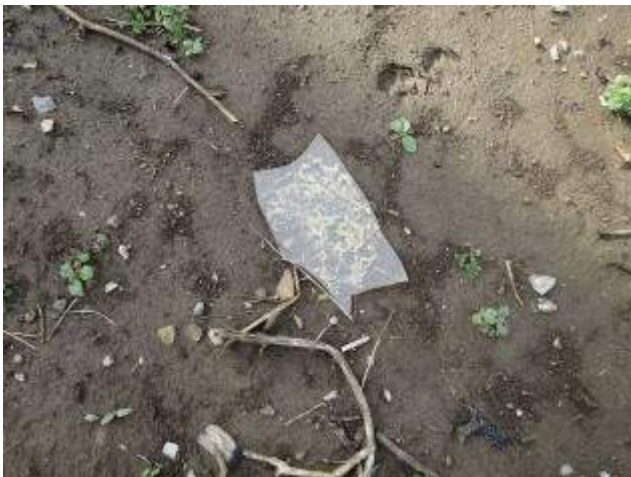
Broken Glass – Vacant Lot 2651

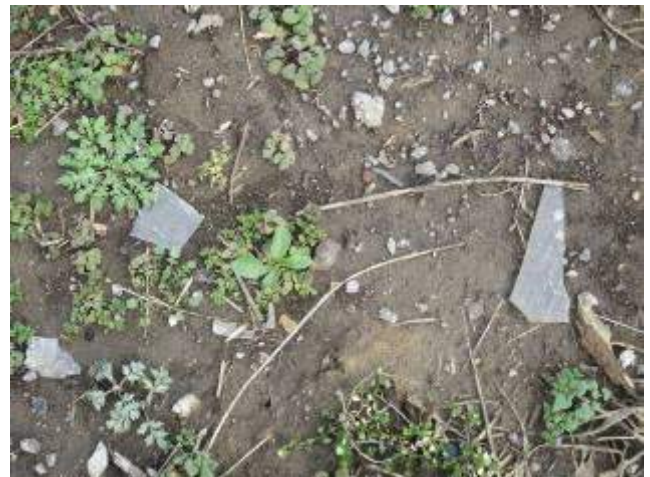
Broken Glass – Vacant Lot 2651

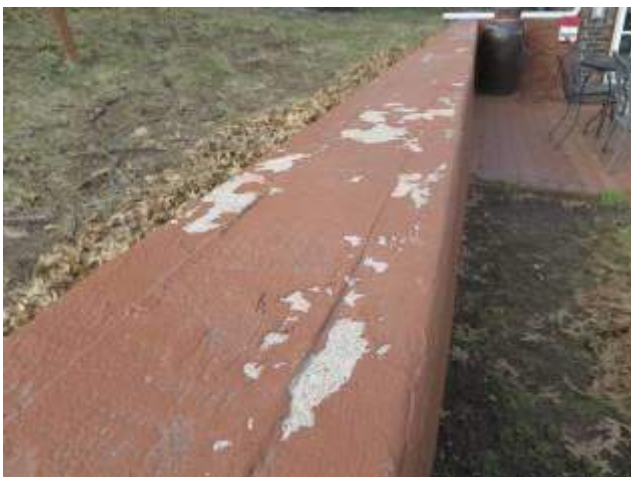
Unguarded Retaining Wall – 2702

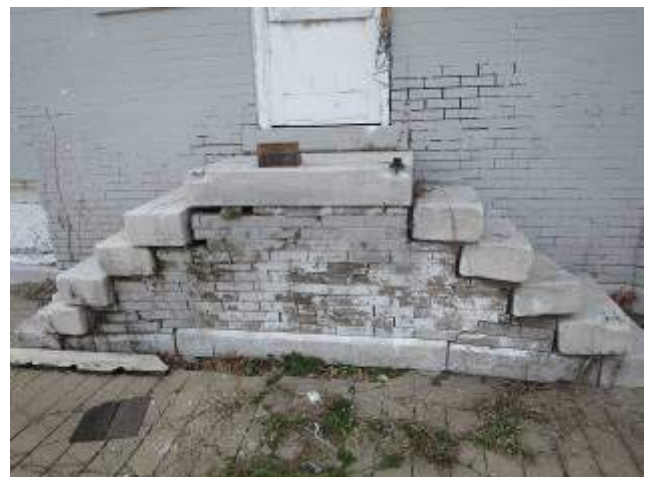
Lack Of Safety Railings – 2651

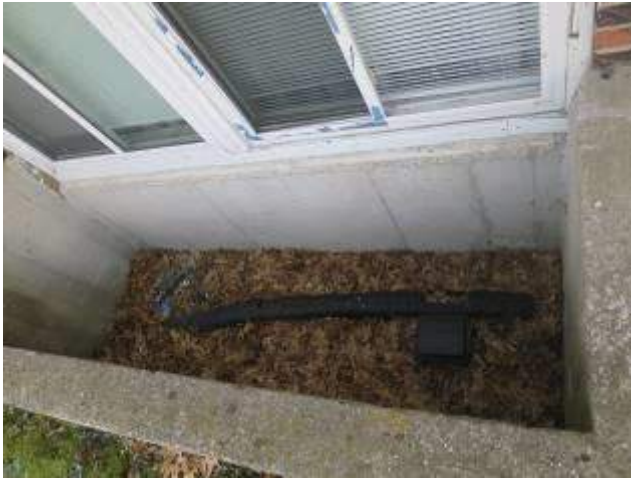
Unguarded Pit & Poor Drainage – 2644

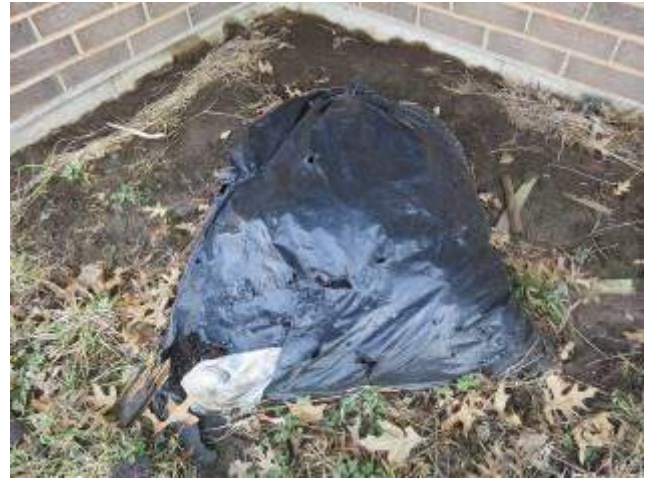
Trash – 2644 E 29<sup>th</sup> Street

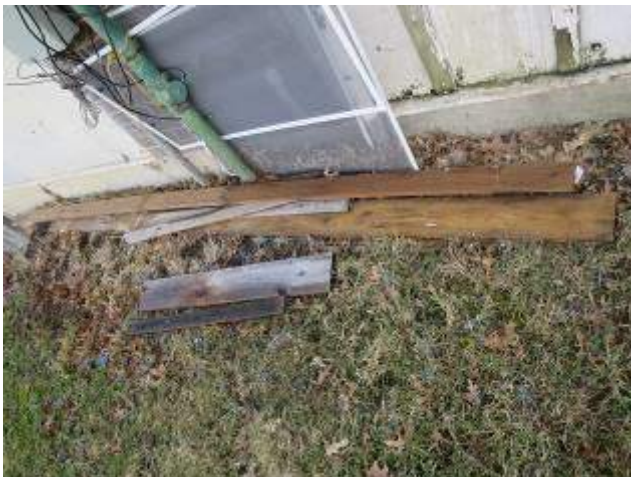
Trash – 2644 E 29<sup>th</sup> Street

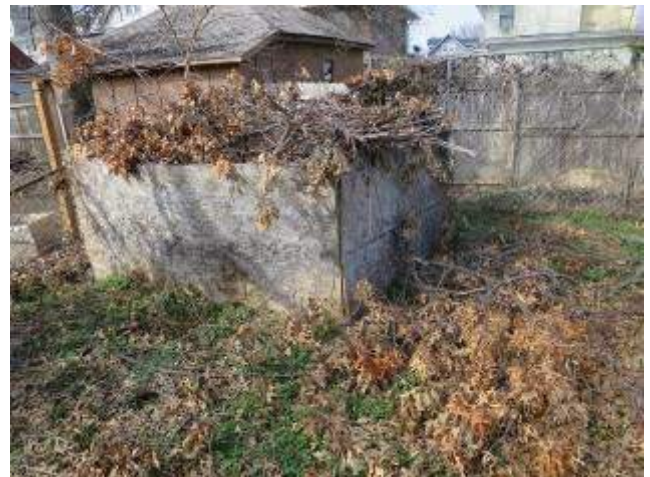
Unightly & Unsafe Brush Pile – 2644

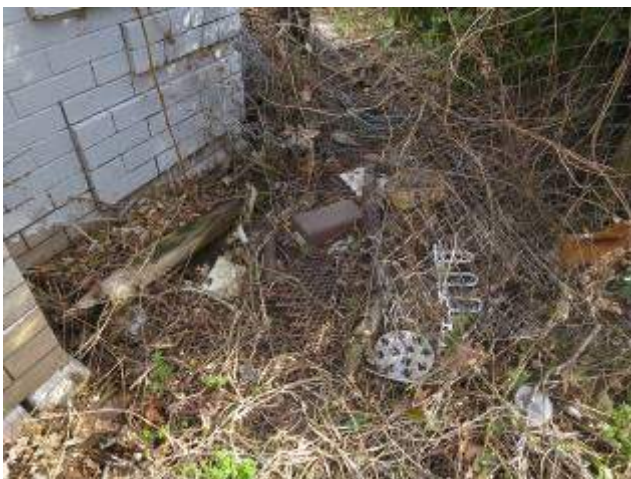
Trash – 2651

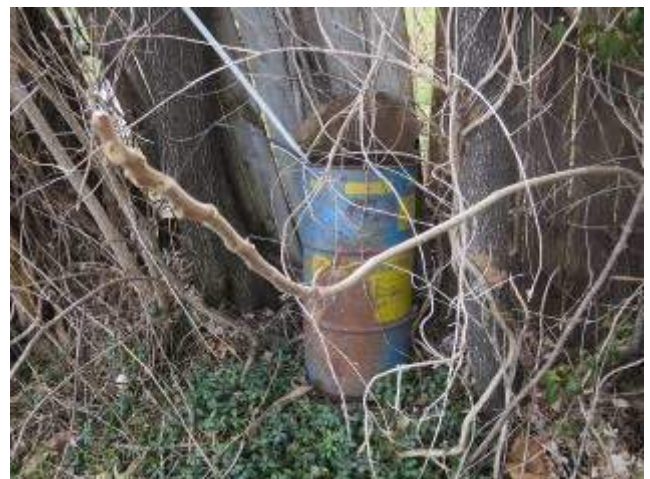
Rusted Barrel – 2651

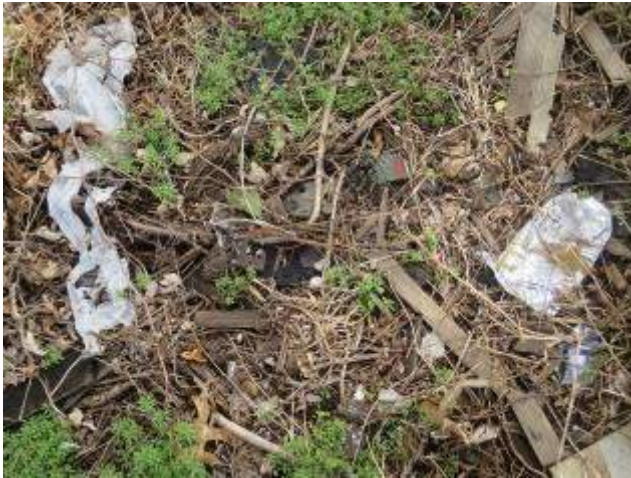
Trash – 2651

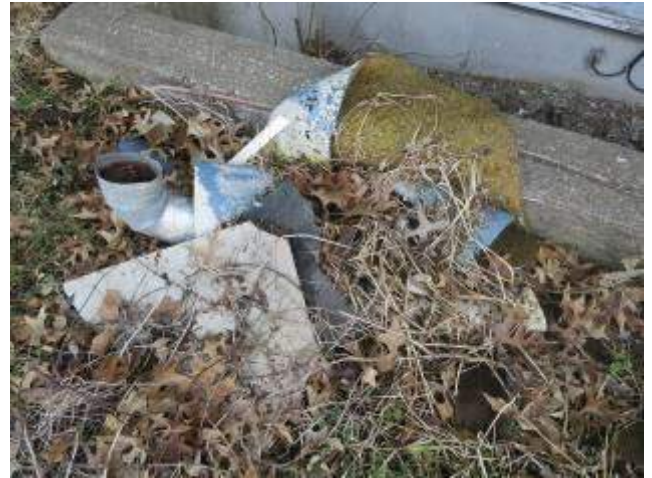
Trash – 2651

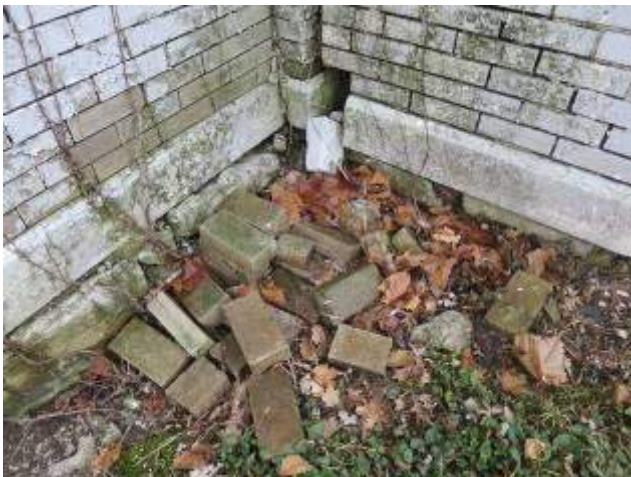
Rubbish – 2651

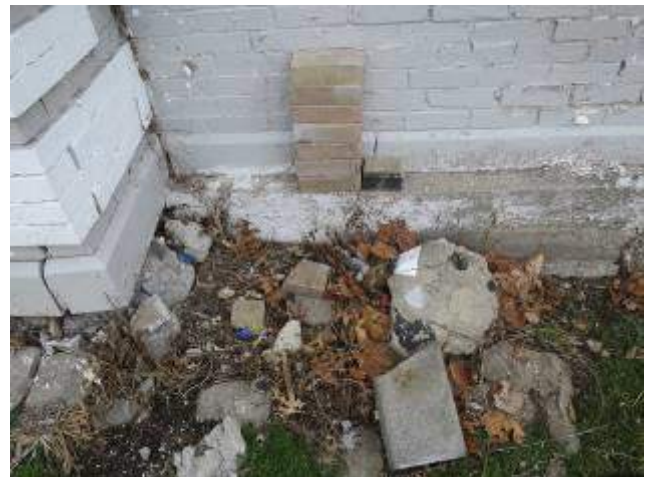
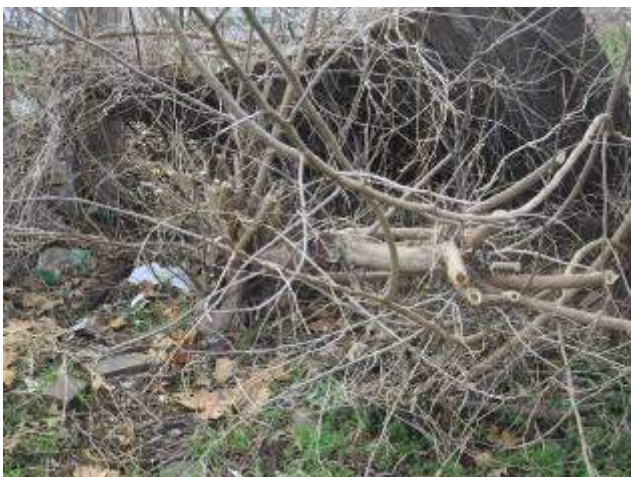
Trash – 2651

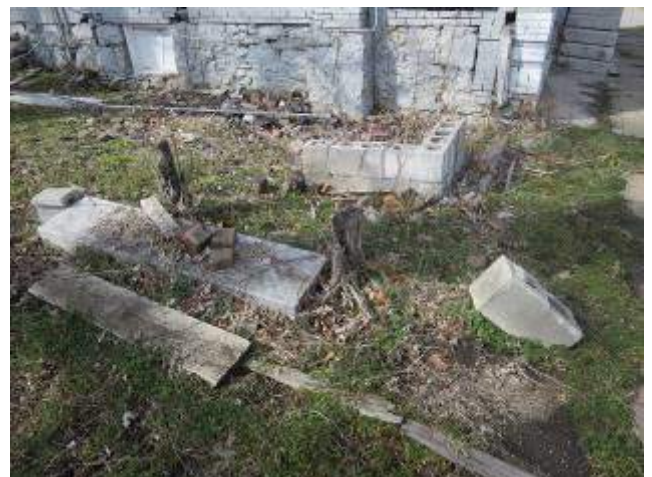
Rubbish – 2651
